Batchelor's Row, Christ Church Oxford

Structural Inspection of Roof Soffit

Prepared by: Ian Flewitt MEng MSc CEng MIStructE
Reviewed by: Stephen Williams MEng CEng MIStructE
Job Number: 29414

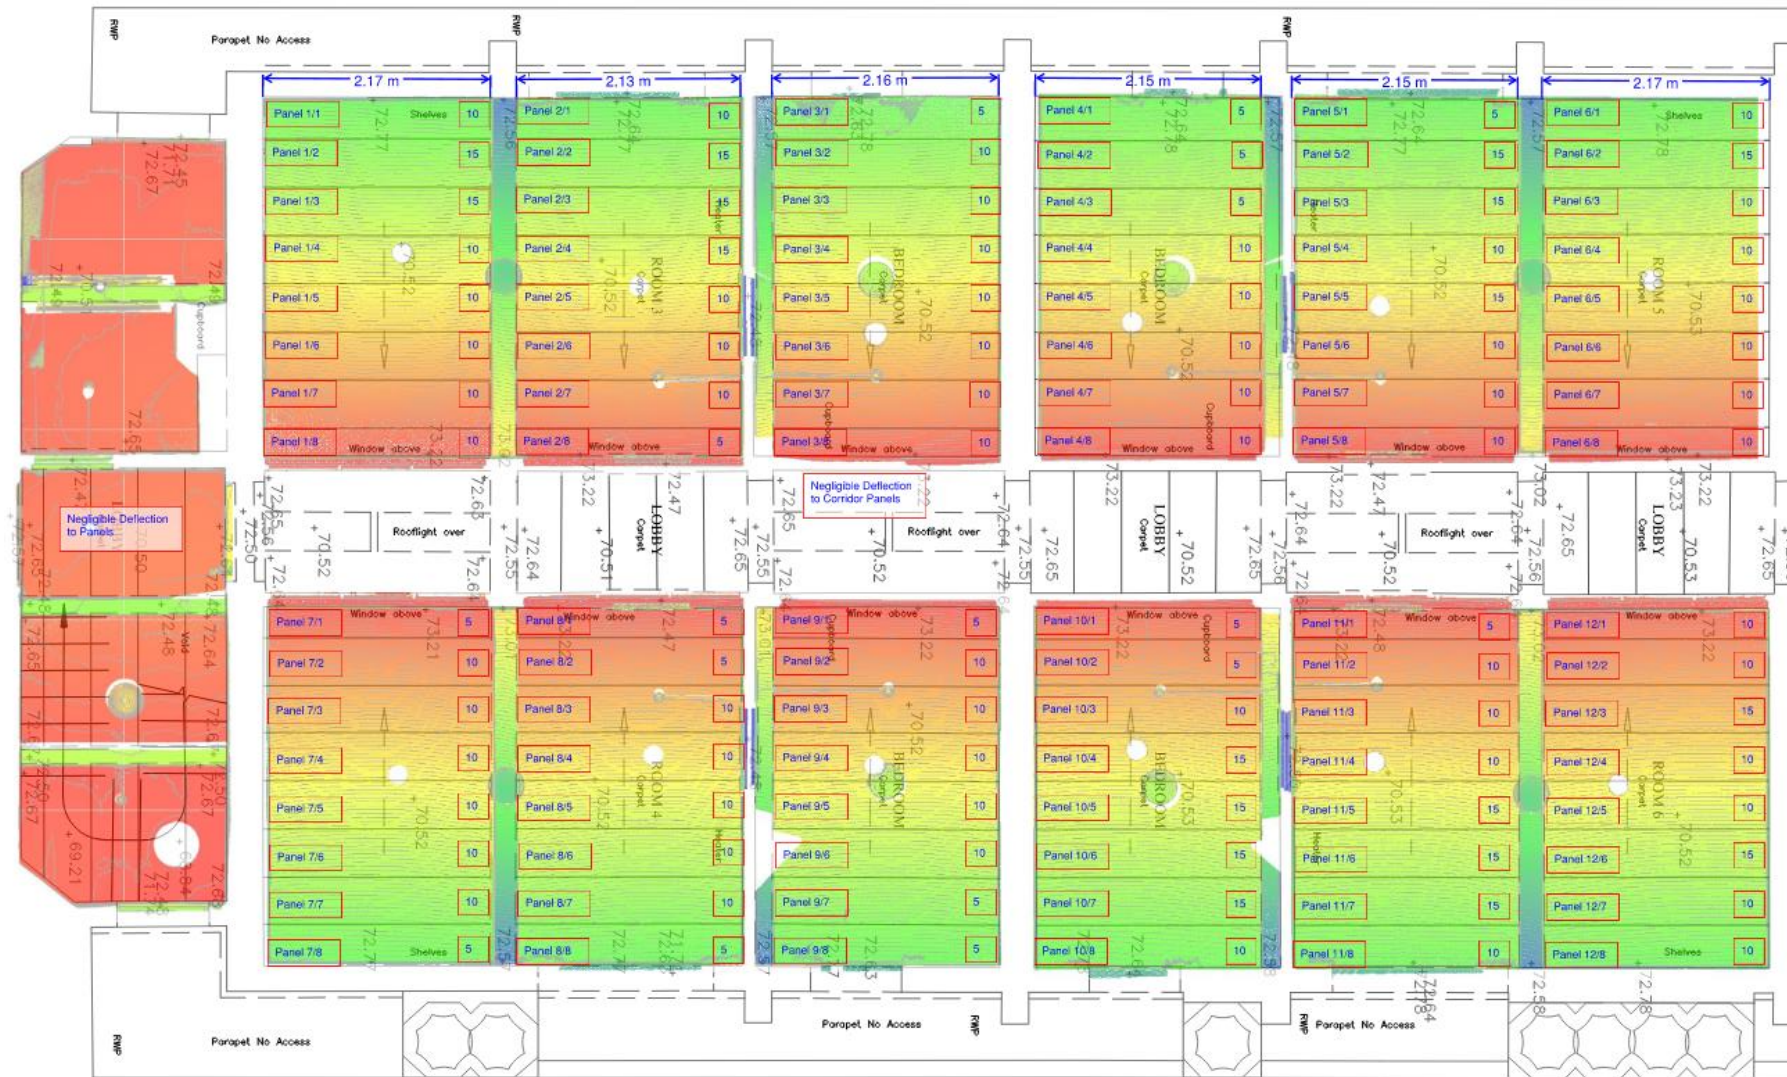
Figure 2 – Batchelor’s Row – South – Roof Soffit Contours (James Brennan Assoc)

In order to assess the deflection of the panels James Brennan Associates carried out a survey of the RAAC plank soffit. For the longer span panels, generally within bedrooms, these were converted to contour maps in order to estimate relative deflection, see Figures 2 & 3. Estimated values of deflections derived, Table 1 summarises these.

Table 1 shows that the majority of panels, (151 of 192 panels) have a deflection greater than span/200. Of the remainder most have a deflection limit of span/140 to span/145, still significantly below the limit of concern. However 3 panels, panels 19/3-5 have a deflection limit of span/108 and these warranted closer visual inspection.

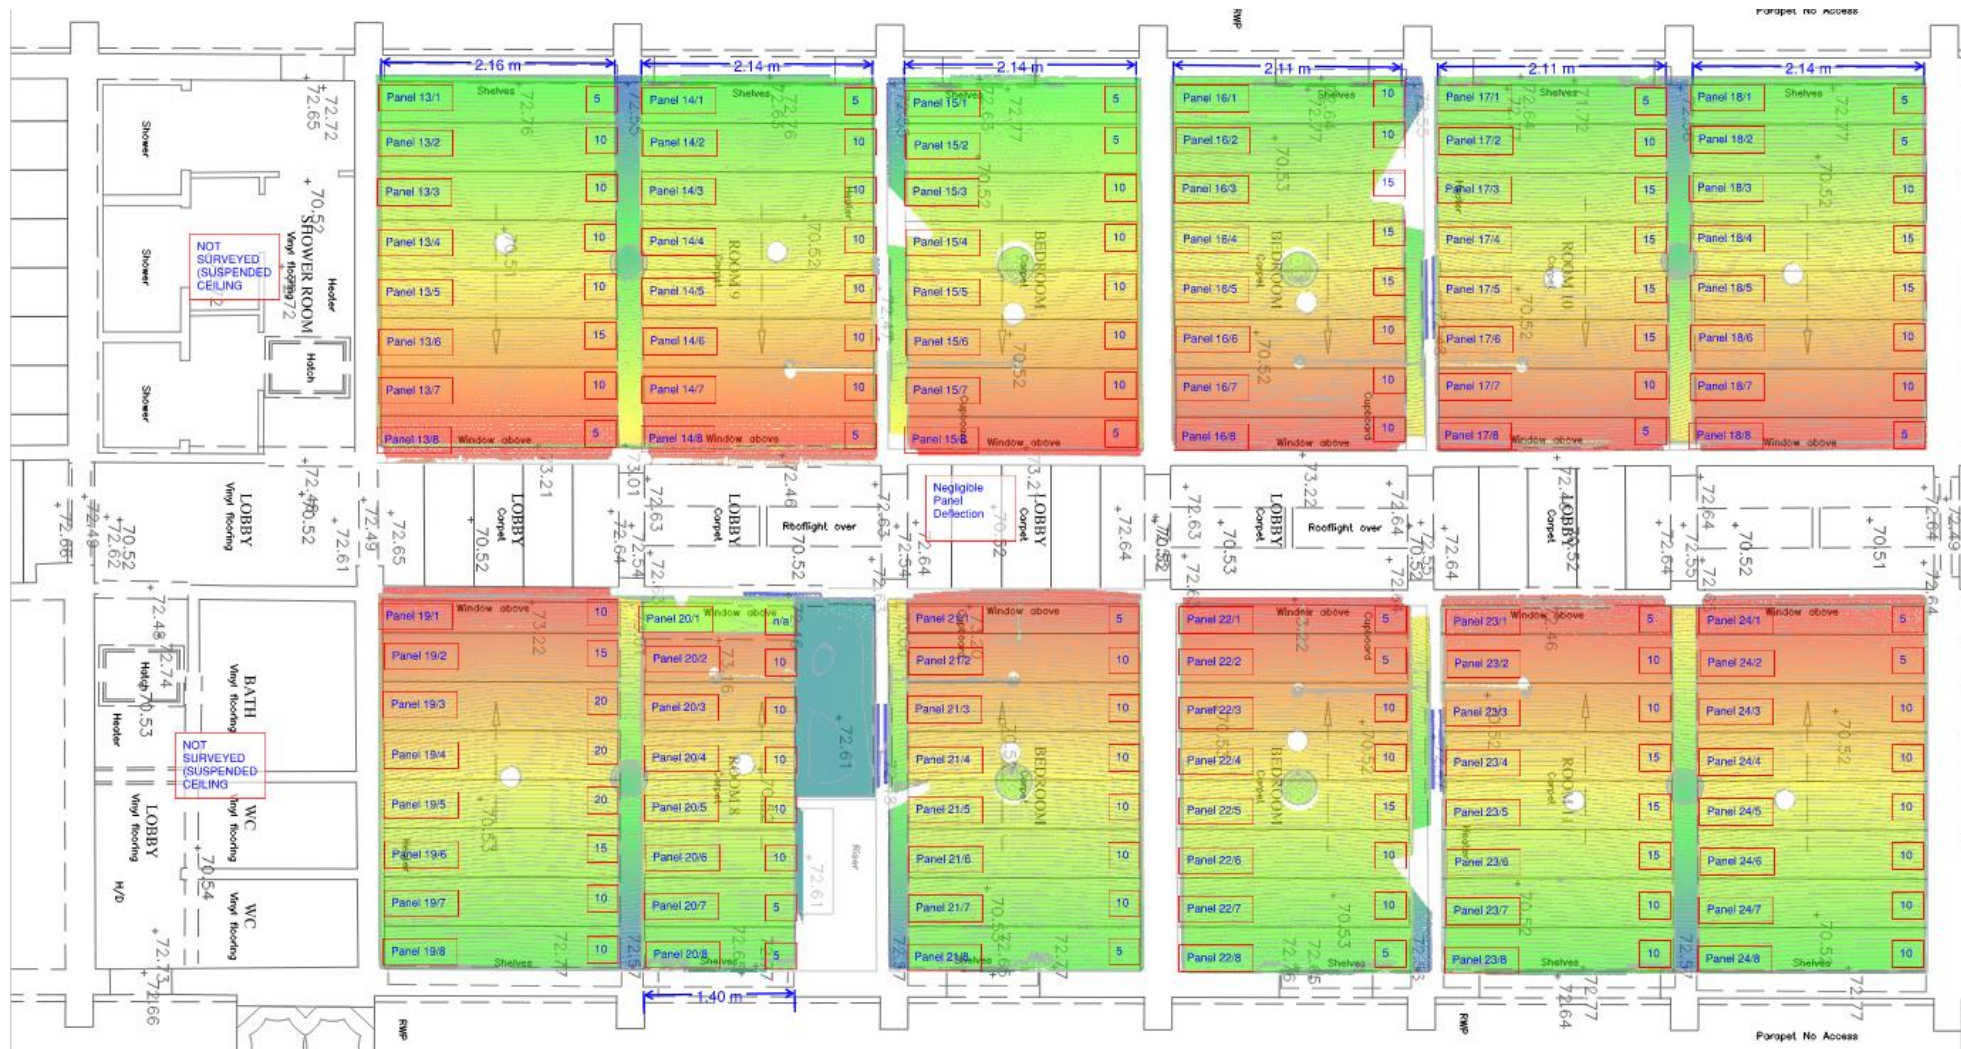
Figure 3 – Batchelor’s Row – North – Roof Soffit Contours (James Brennan Assoc)

Room 8 – This room shows the most significant deflection on the contour mapping, however visually the room does not show exceptional cracking or joint failure.

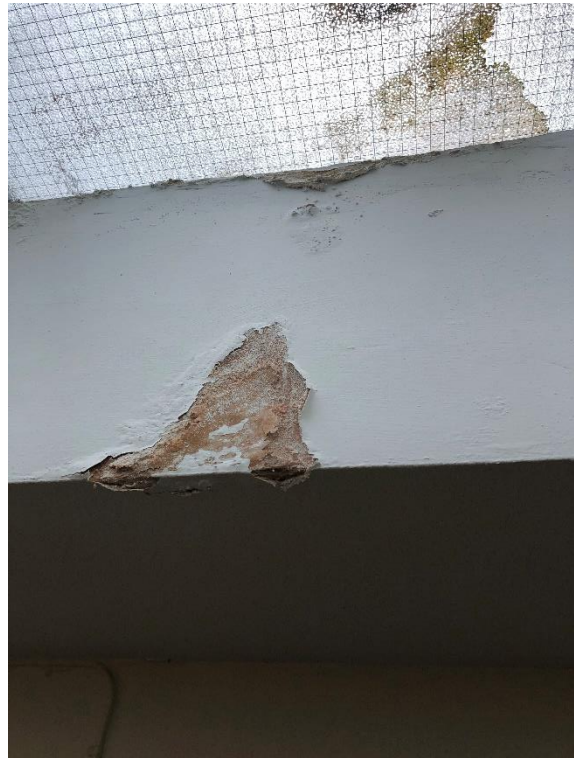
Typically the corridor bays containing rooflights appear to be in good condition. An exception is the first bay when entering the corridor from the south. There is evidence of water ingress resulting in spalling plasterwork, most severely on the right side but also at the ends, see Photograph 2.

Photograph 2- Spalling plasterwork 1st Bay

Localised water ingress at the southern end of the corridor should be investigated and remedied to prevent further damage to finishes and ultimately the structure.

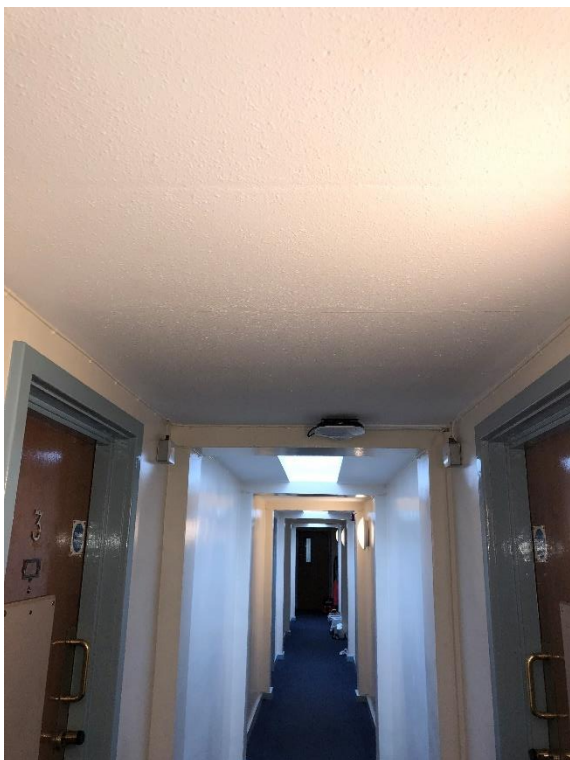
Photograph 3- RAAC Corridor Bay

The intermediate bays formed using RAAC panels have a textured painted finish. There is little evidence of cracking within panels. There is very slight to slight cracking along the joint between adjacent panels, see Photograph 4. Joints are filled with a cement based mortar or plaster. The cracking is not thought to be significant, although over time there is a risk the joint fill will de-bond and fail resulting in spalling. There is a slight vertical misalignment between some panels however it is not known if this has been present since installation. The stepping in itself is not of concern given the apparent reasonable condition of the panels. There is no evidence of insufficient bearing or movement at bearing positions.

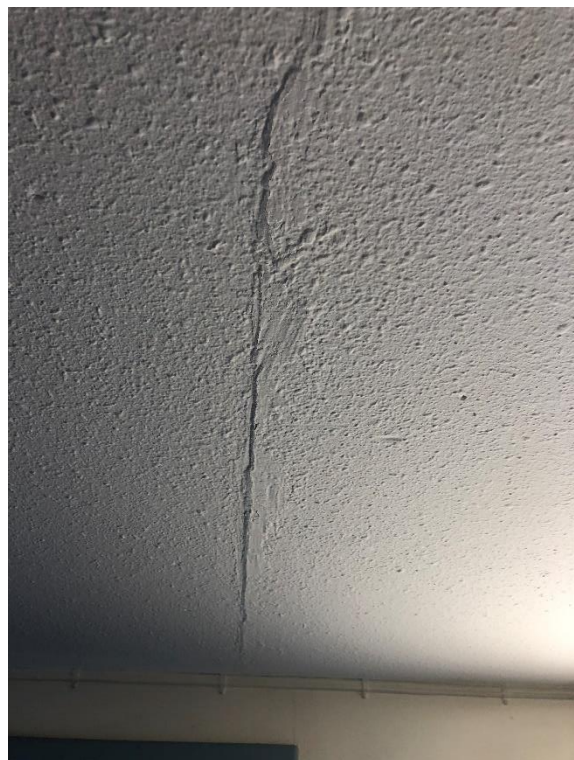
Photograph 4- Typical Joint Between RAAC Corridor Panels

The jointing between the RAAC panels is a concern and a regime of regular inspection and repair could be implemented to reduce risk of failure which may risk injury of occupants. Alternatively a boarded soffit could be installed to encapsulate the RAAC soffit. The disadvantage of this is the RAAC panels are no longer visible for inspection unless an easily demountable ceiling is installed.

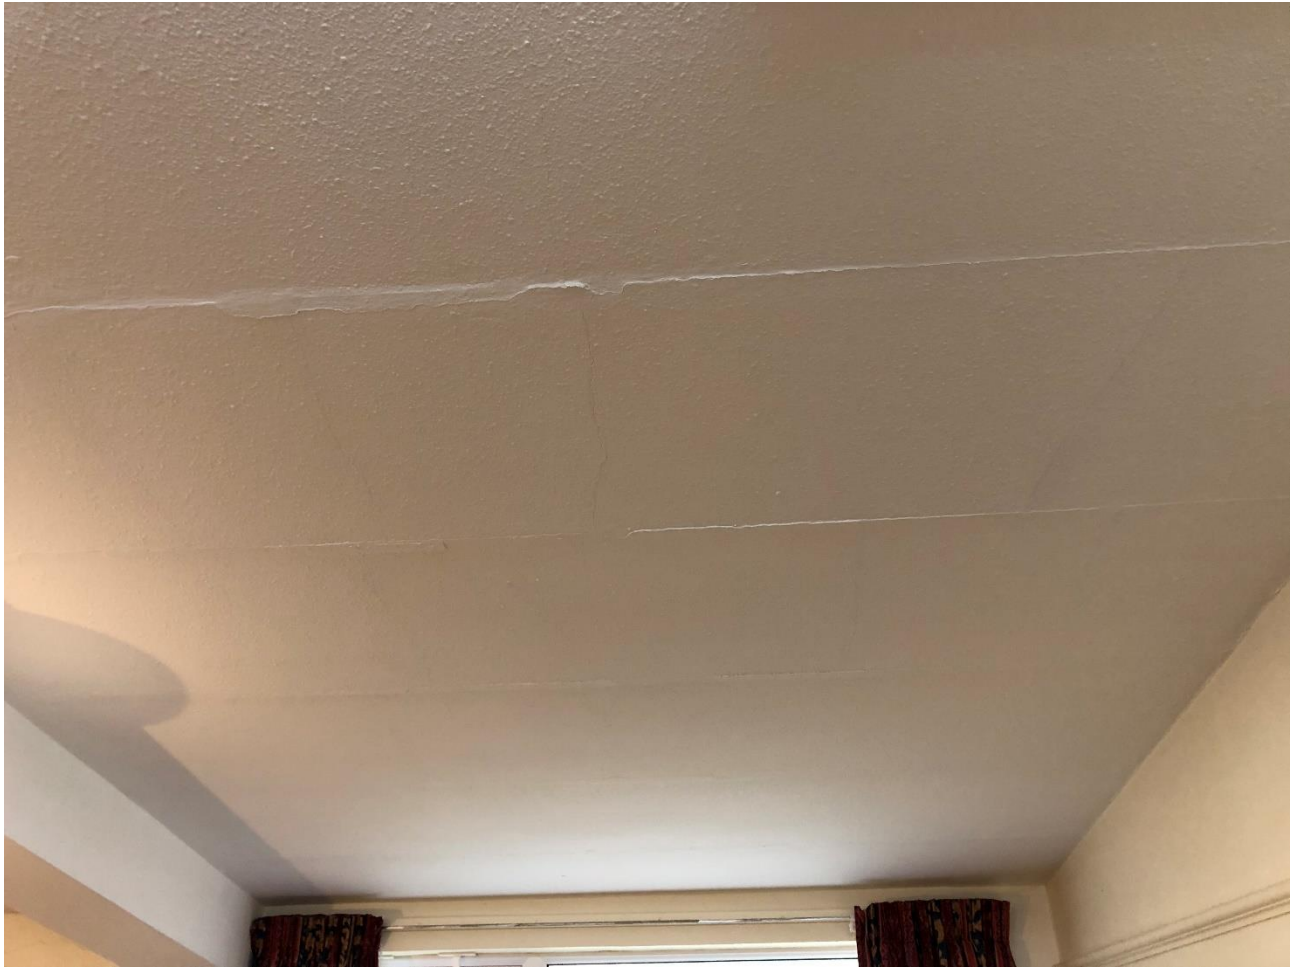
Many RAAC panels show fine cracks running perpendicular to span, these are usually reasonably well/evenly spaced along the panel's span, typically 4 to 6 cracks per panel. As the soffit of each panel is the tensile face of the panel it is unsurprising to see signs of this type of cracking, indeed most concrete beam and slab structures will crack in this way and it does not infer failure of the member.

The joints between panels have been filled with a plaster fillet. In many cases the joint is pronounced suggesting remedial repairs. In many cases there is a slight step between adjacent panels. The condition of these joints is variable, in some places the mortar is showing signs of de-bonding and in a few instances has failed

Photograph 5- Typical RAAC Bay Bedroom (Room 3)

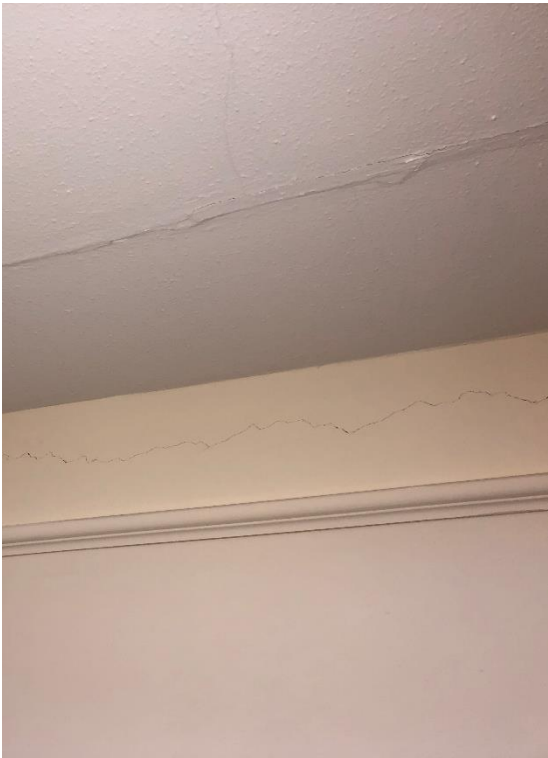
It is not clear whether walls between rooms and gable end walls are loadbearing, there is evidence in the form of horizontal cracking which suggests there is an RC beam along the top of each wall. This pattern is repeated in the external wall, see Photograph 6. This cracking is not of structural concern as it is expressing a joint between two elements. Whether intended or not the wall may be offering support to the beam, however given the age of the building loads appear to have reach equilibrium.

Photograph 6- Horizontal Crack to Perimeter Wall (Room 3)

Horizontal cracking to some walls indicative of a joint line between either masonry and studwork or masonry and a beam line could be cosmetically repaired. The joint may be strengthened with Expamet or similar to help prevent further cracking, however this cracking is not of concern structurally.

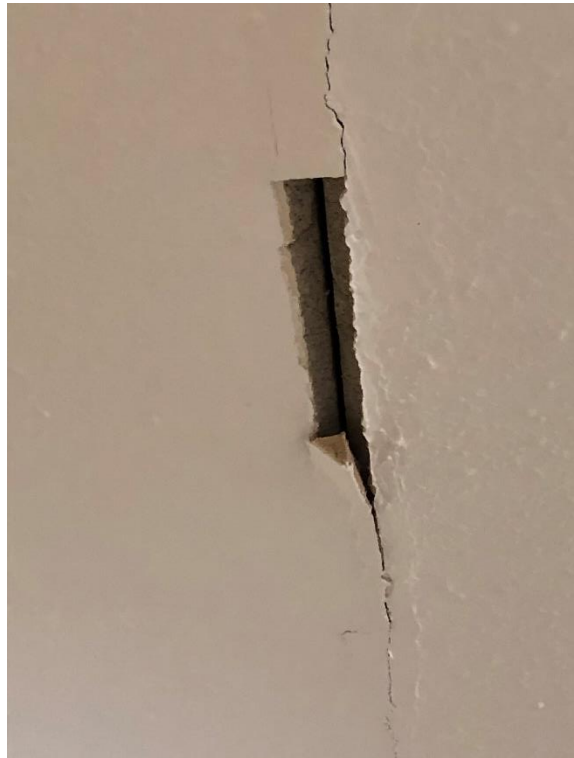
Room 3 – Failed joint between panels in bedroom, see Photograph 7.

Photograph 7- Failed Joint (Room 3)

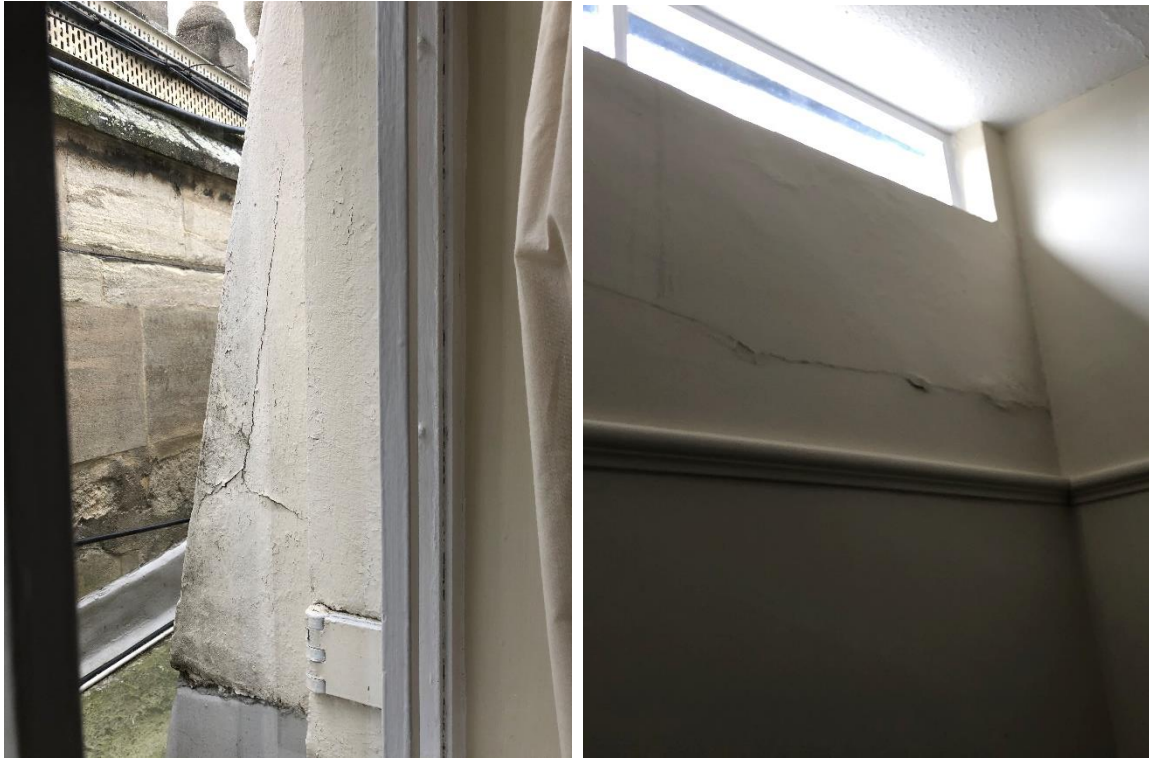
Room 5 – Vertical crack to external wall to right of right-hand window and adjacent buttress column showing cracking in finishes. Further investigation into the condition of the column recommended, see Photograph 8.

Room 7b- Horizontal crack below window this may be associated with leaking pipework as there appears to be a riser box out on the corridor side.

Photograph 8- Cracking to Rendered Finish to RC Column (Room 5) Photograph 9- Horizontal Crack to Perimeter Wall (Room 7b)

The render to a number of external buttress columns has failed, it is not possible without partial removal to determine if the column itself has corroded, we recommend localised removal of the failed render to allow closer inspection.

The damage to plasterwork in Room 7b, may be due to leaking pipework which should be investigated and rectified, although this is below the soffit level and so poses no risk to the RAAC panels.

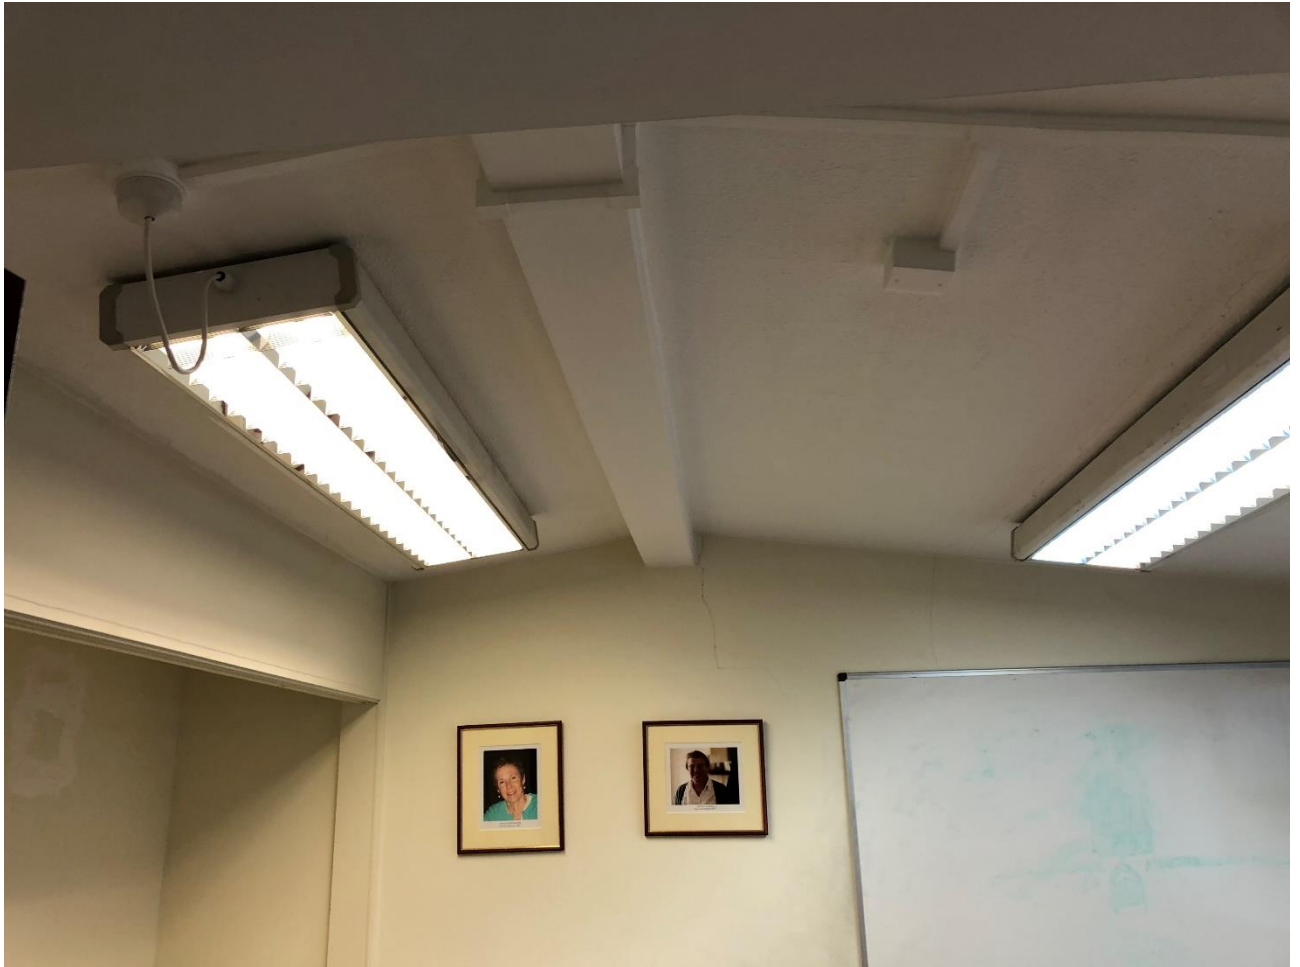
The configuration of the RAAC panels within the GCR/Computer Suite are similar to those in the bedrooms, spanning onto RC beams, however there is also a ridge beam forming an apex to the soffit running down the length of the room. The condition of the panels in this area are similar to those of the bedrooms. However the flank walls contain several cracks which is suggestive of local failure of the masonry, see Photograph 10.

Photograph 10- Cracking in Gable Wall Computer Suite

Cracking to the gable wall within the computer suite. Although the most severe crack is beneath the bearing to the ridge beam it is unlikely to be due to compressive failure as loads are relatively low. The cause of cracking is not

evident, localised removal of plasterwork may reveal the cause to be poorly bonded brickwork which could be re-pointed. Helical bar may be required to locally strengthen.

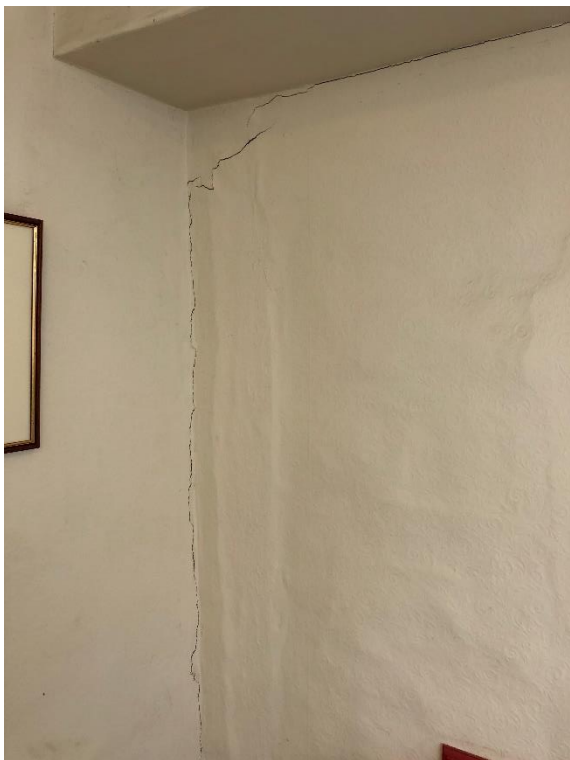
There is a severe crack in the corner of the wall adjacent the store off the half landing to the stairs, This may be a junction between the older and newer part of the building and it is not thought to be linked to the RAAC panels but may warrant further investigation, see Photograph 11.

Photograph 11- Cracking in Corner of Half Landing North Stair
