**Flat 2, 28 Glasgow Street, Glasgow G12 8JR**

We propose replacing the existing sash and case window with newly manufactured timber sash and case windows that will be manufactured in a like for like formation.

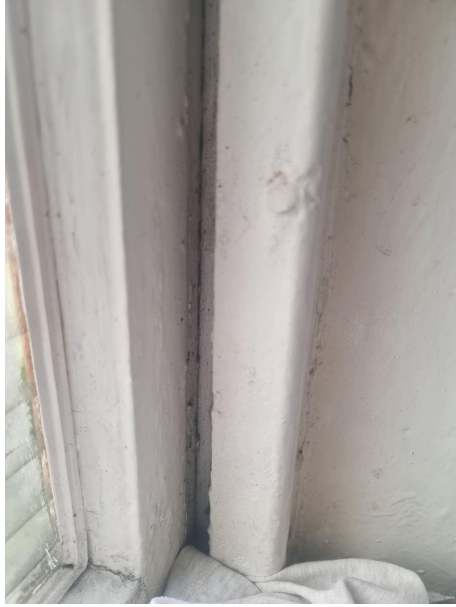
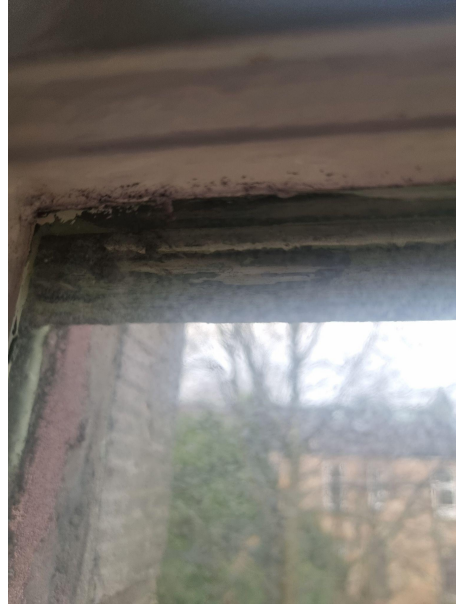
The bathroom window (Ref: B on the elevation drawings) is unopenable. There are large gaps around the window and rotting timber to the mid and bottom rails. The glass has also previously been replaced with perspex slatted glass.

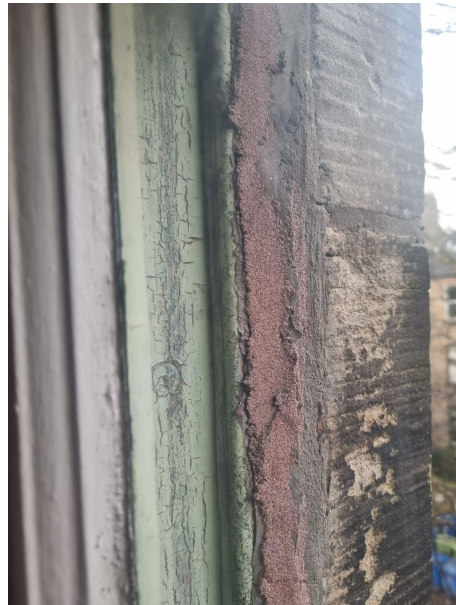
Casement woodwork is rotting externally and mastic has come away from the window which is allowing wind and water to enter.

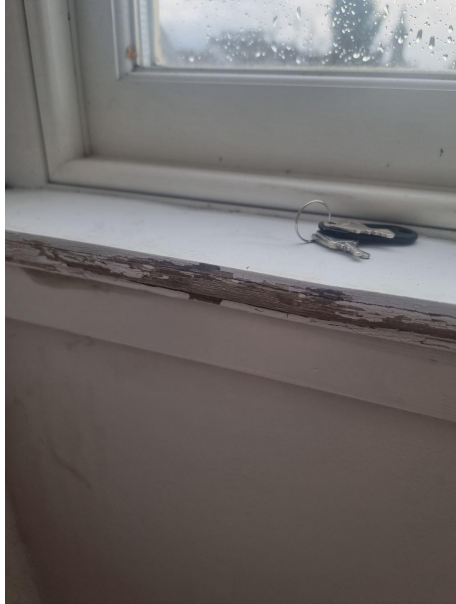
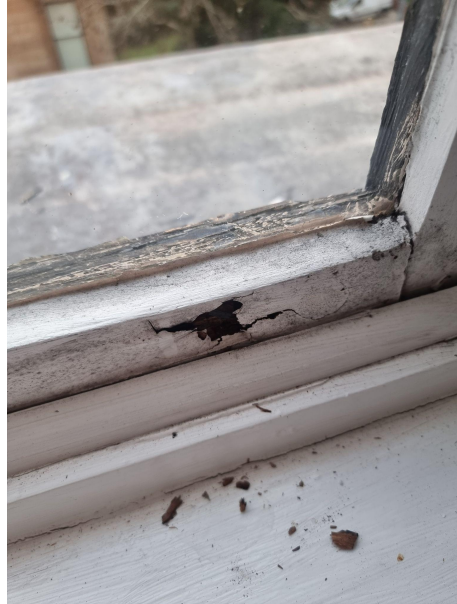
The internal sill to the arched window is rotting due to water ingress. The second photo shows the water damaged and rotting bottom rail. There is also a large seal which has been put in place temporarily to stop the wind and water entering.

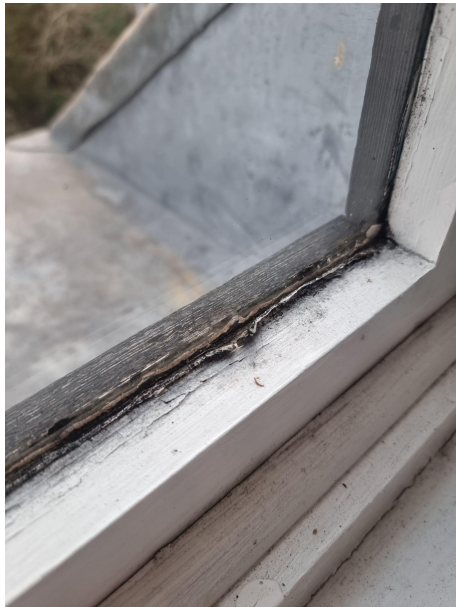
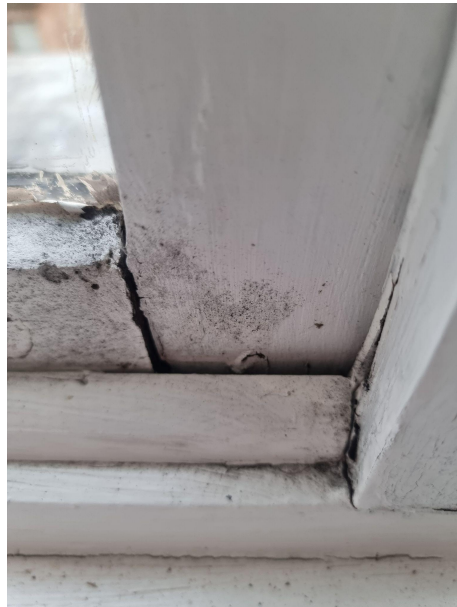
The first photo shows the seals to the glass are coming away and failing. The second photo again shows the large seal which has been installed as a temporary fix. It also shows that the window is becoming unattached at the joints.

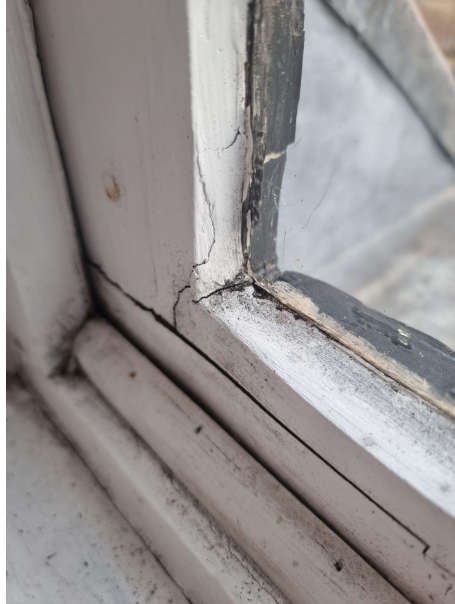
The wood to the bottom rail has now split due to the water damaged and rotting woodwork.

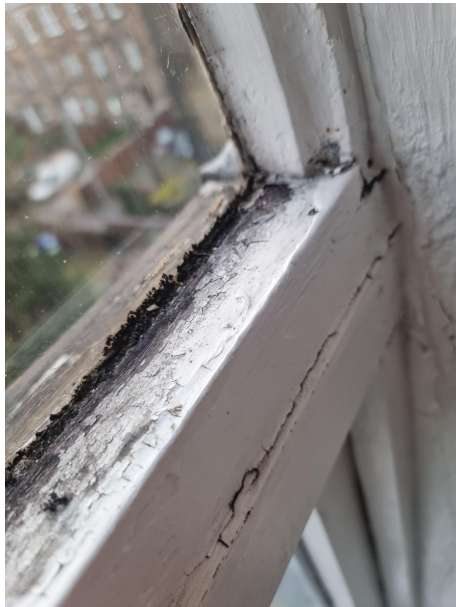
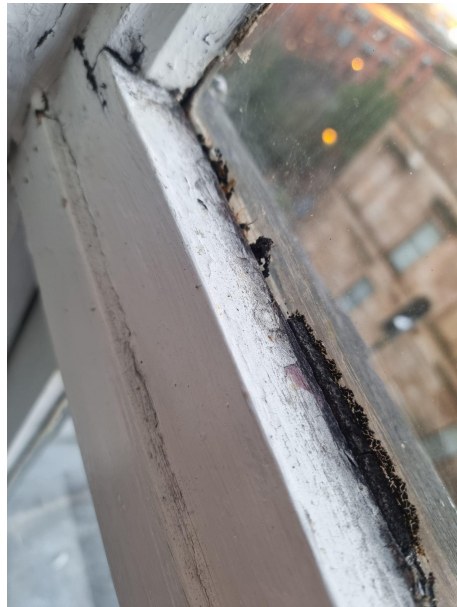
The seals to the internal of the window have failed which is allowing wind and water to enter. It is also allowing the build up of mold which is detrimental to the window woodwork.

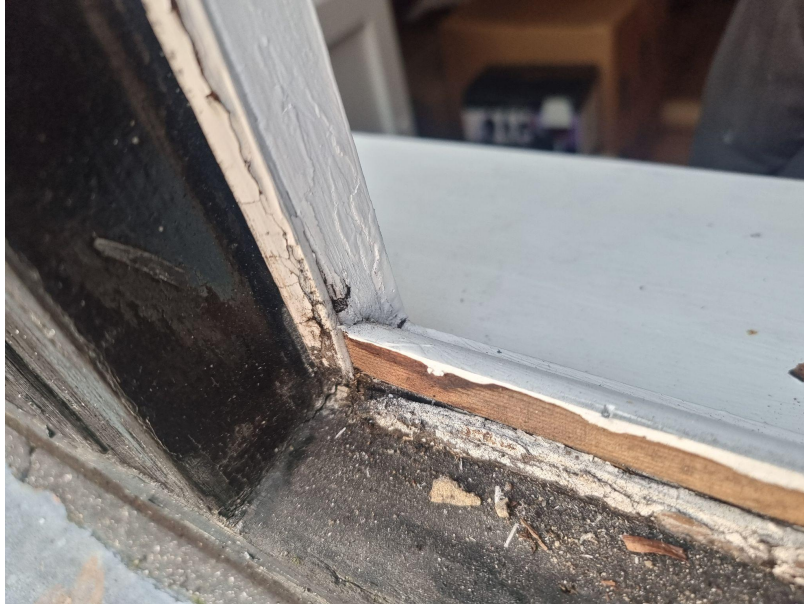
The external mastic is failing and coming away from the window which is allowing the water to enter the casement.

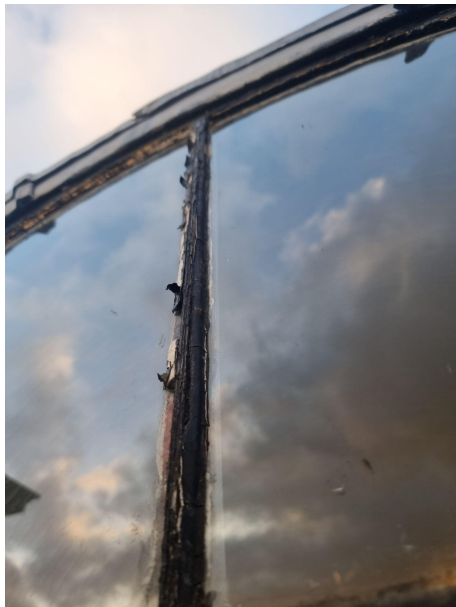
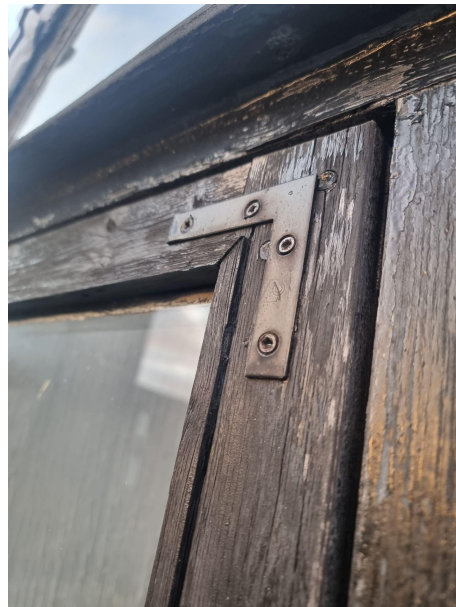
The astragal to the window is badly weathered and damaged. The second photos shows that the joint are currently being held together with brackets as the existing screws are unable to keep it securely together.

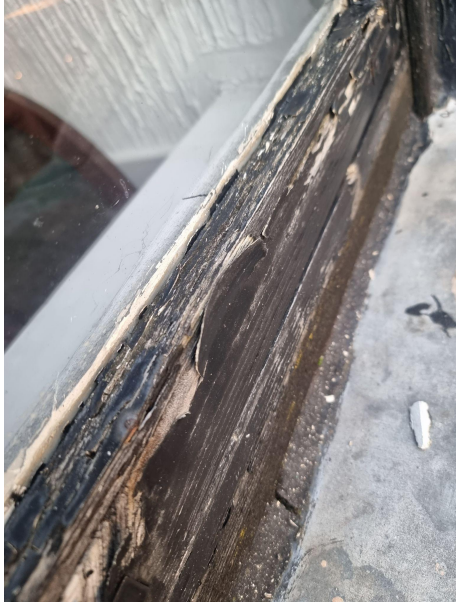
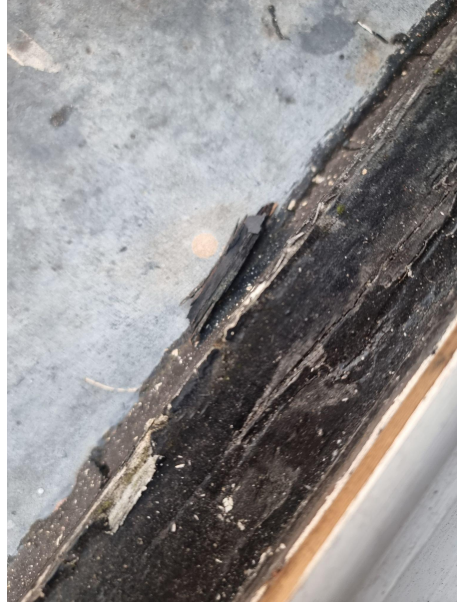
The bottom rail is severely water damaged and rotting externally and the mastic is broken in areas.
