Chestnut Cottage,  
Sheldons Lane,  
Hook,  
Hampshire,  
RG27 9LH

This report has been prepared along the guidance of B.S.5837:2012 the objective being to provide the case officer Miguel Martinez with information relating to the planning approval ref 21/00439/CON. Condition 7. This was issued in April 2021, With the main planning approval for the removal of the existing house and its replacement granted in February 2021.

Drawing  
 Tree Protection Plan (TPP)

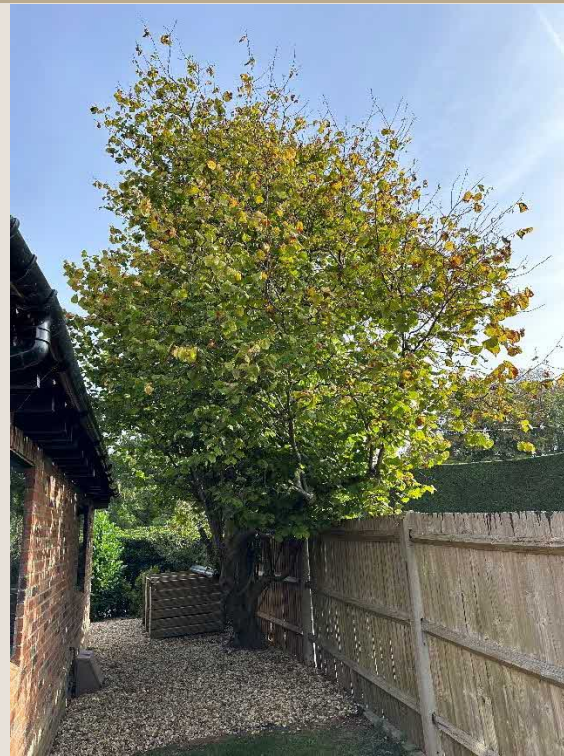
T2

T 2	No	Species: Common Hazel  Latin: Corylus avellana  Maturity: Mature	No	No	5	1s	6	165			2	1	3	2	2	Crown-Fair, Stem-Fair, Basal Area-Poor	C1	10 to 20 yrs.	Fair	Post construction	Recommended action: No action	09.10.23	Multi stemmed tree at 0.3m above ground level to the south of the Annex. Basal area is mainly shingle surfacing with a boundary fencing immediately to the south. Root buttress formation indicates no ground level alterations.	
T 3	No	Species: Whitebeam  Latin: Sorbus aria  Maturity: Mature	No	No	3.5	1n	1	320			2	2	2	2	2	Crown-Fair, Stem-Fair, Basal Area-Good	C1	10 to 20 yrs.	Fair	Post construction	Recommended action: No action	09.10.23	Tree is located in the rear garden which is of a large grassed area. Tree is multi stemmed at 1.2m and previously reduced. Root buttress formation indicates no ground level alterations have been conducted.	
T 4	No	Species: Purple Maple  Latin: Acer palmatum 'Atropurpureum'  Maturity: Mature	No	No	6	1.5w	1	340			3	2	3	3	2	Crown-Fair, Stem-Fair, Basal Area-Fair	C1	10 to 20 yrs.	Fair	Post construction	Recommended action: No action	09.10.23	Located on the south boundary where there is a established Laurel hedge of 2m in height. Crown has been repeatedly reduced. Root buttress formation indicates there have been no level changes during the construction.

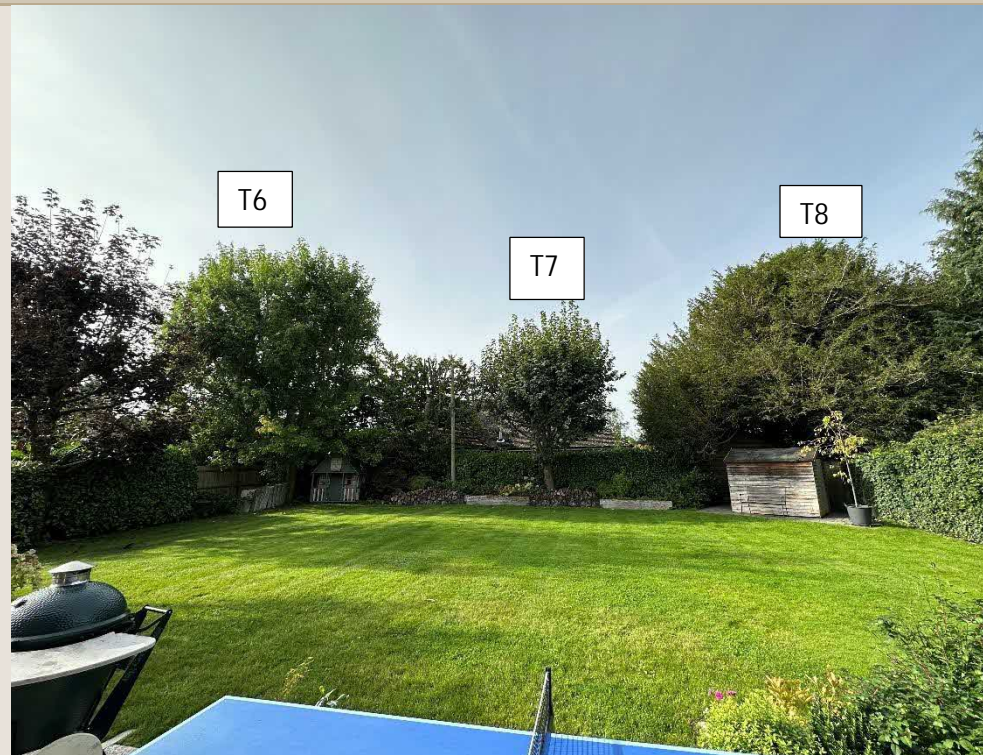
T6

T7

T8

View across the main lawn from the new house, which has a level aspect.

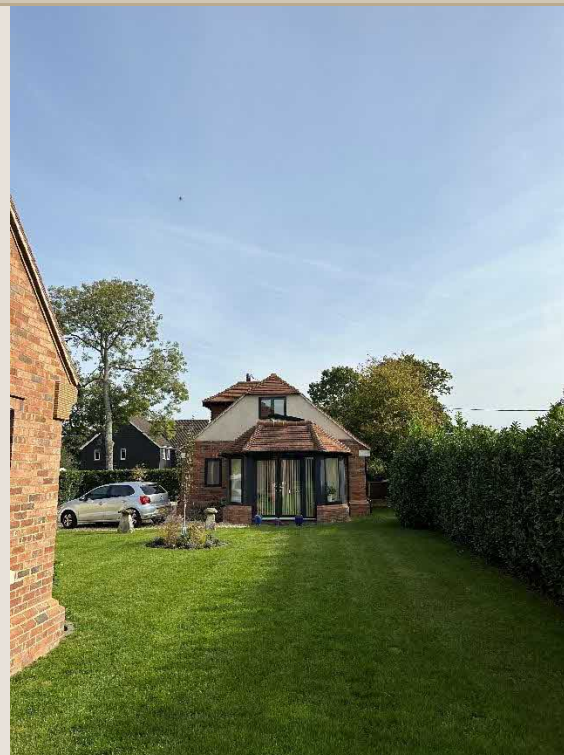
View from the main house towards 'The Annex' note the level ground area of the lawn

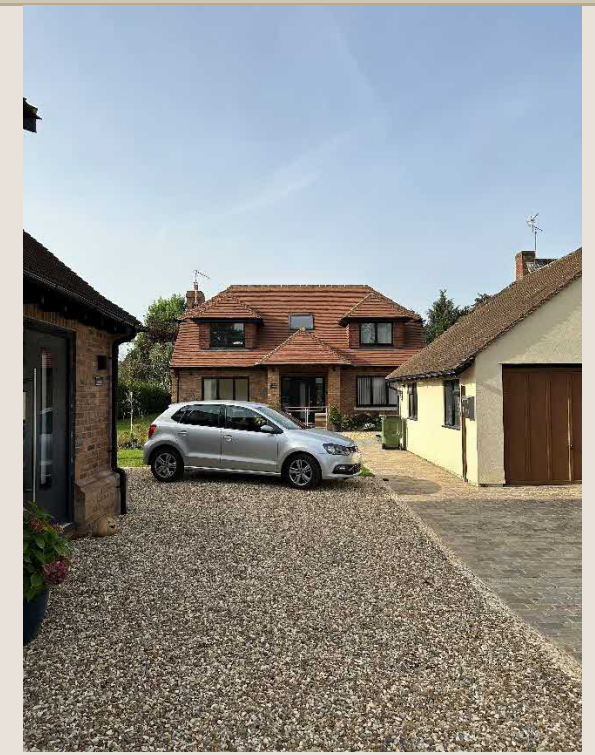
View from the entrance towards the main house

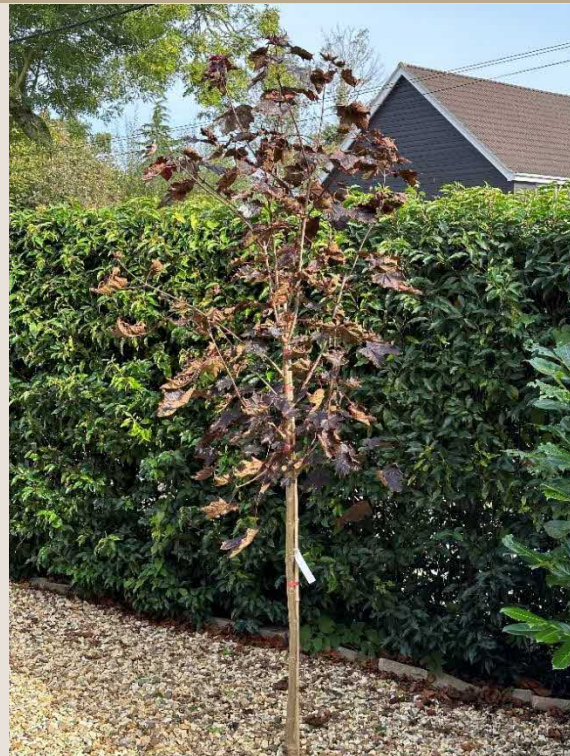
Replacement tree

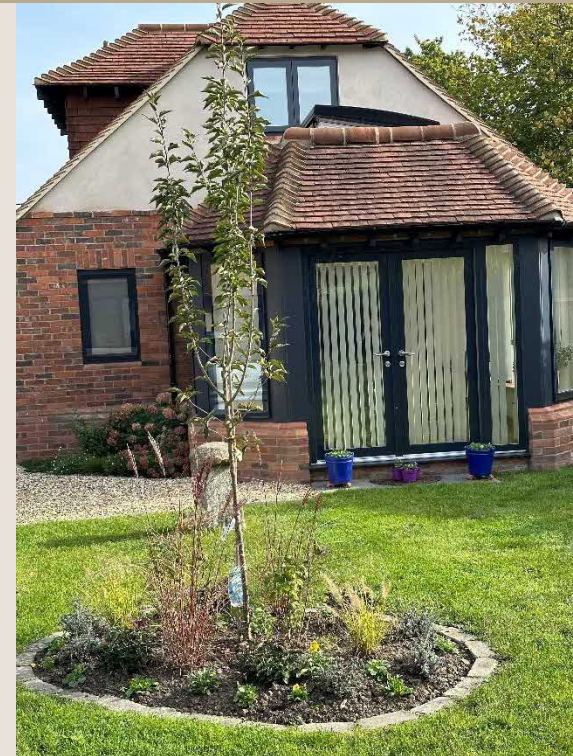
Replacement tree

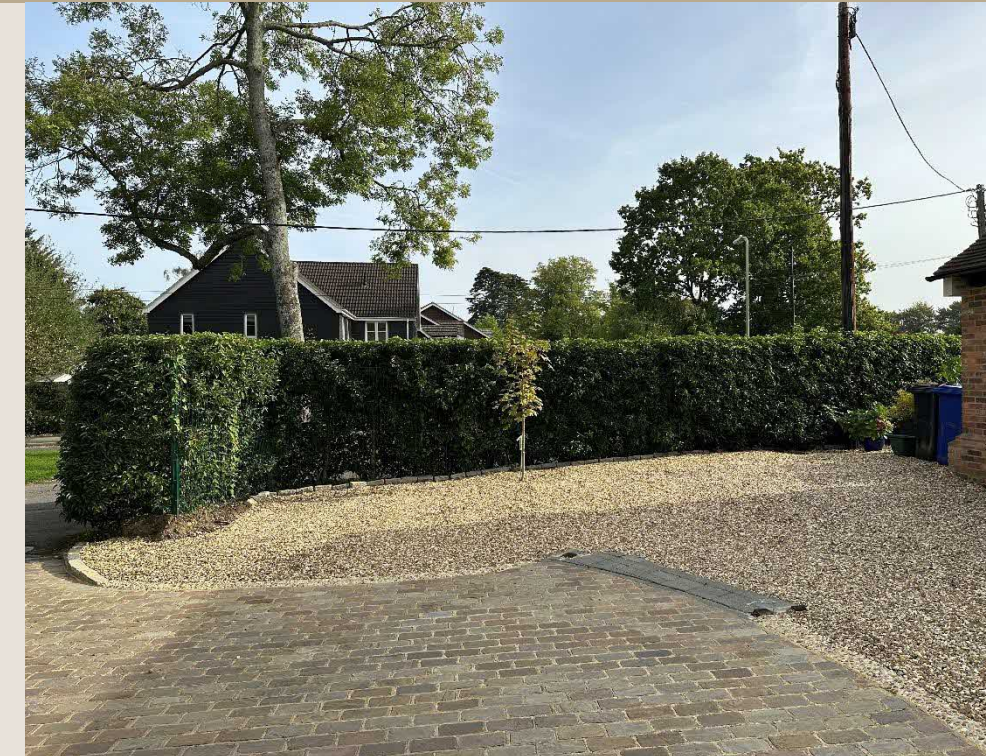
Replacement tree

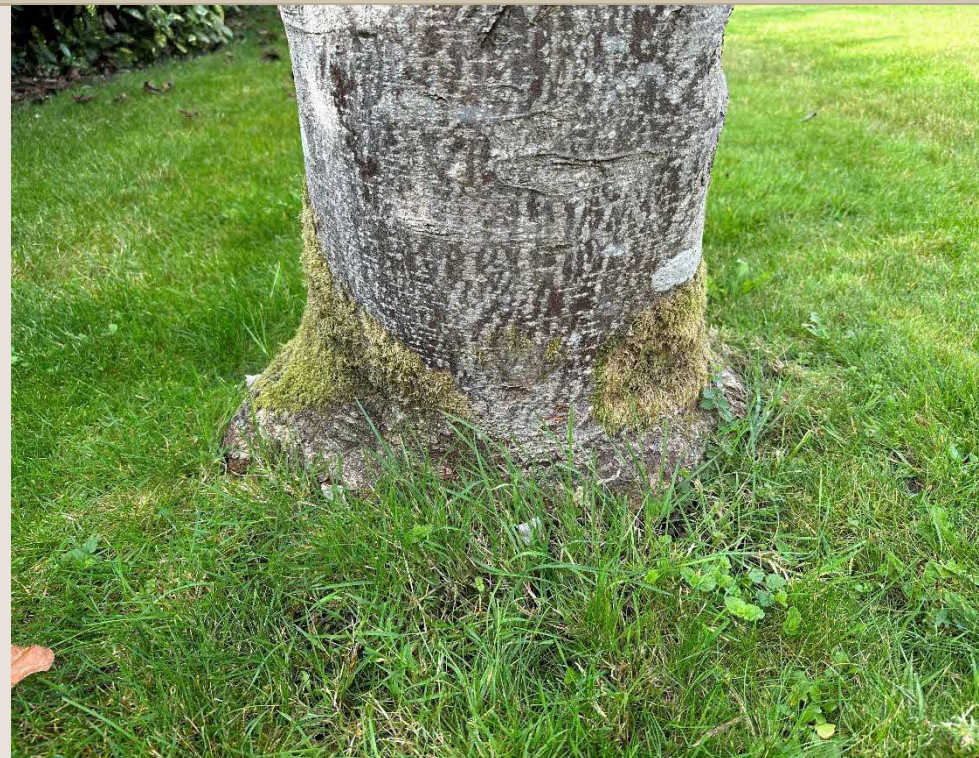
Basal area of T3

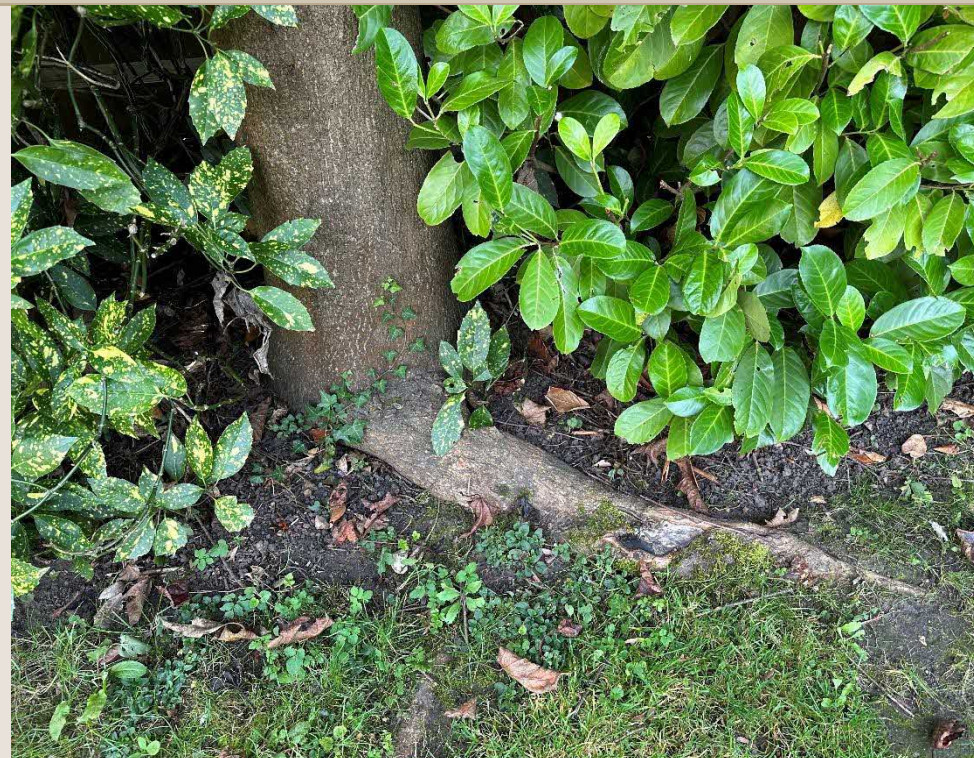
Basal area of T4 both of the closest proximity to the construction area and clearly indicating no ground level alterations have taken place.
