PROJECT DETAILS:
Monks Hall Refurbishment
Syleham
Eye, IP21 4LN

DRAWING REFERENCE:
Repair Details
Elevation 2 (North-East)

SCALE:	DATE:	DRAWN BY:	CHECKED BY:
As Noted A1	Oct 2023	DB	JF
PROJECT No:	DRAWING No:	REVISION:	
4289	R02	P1

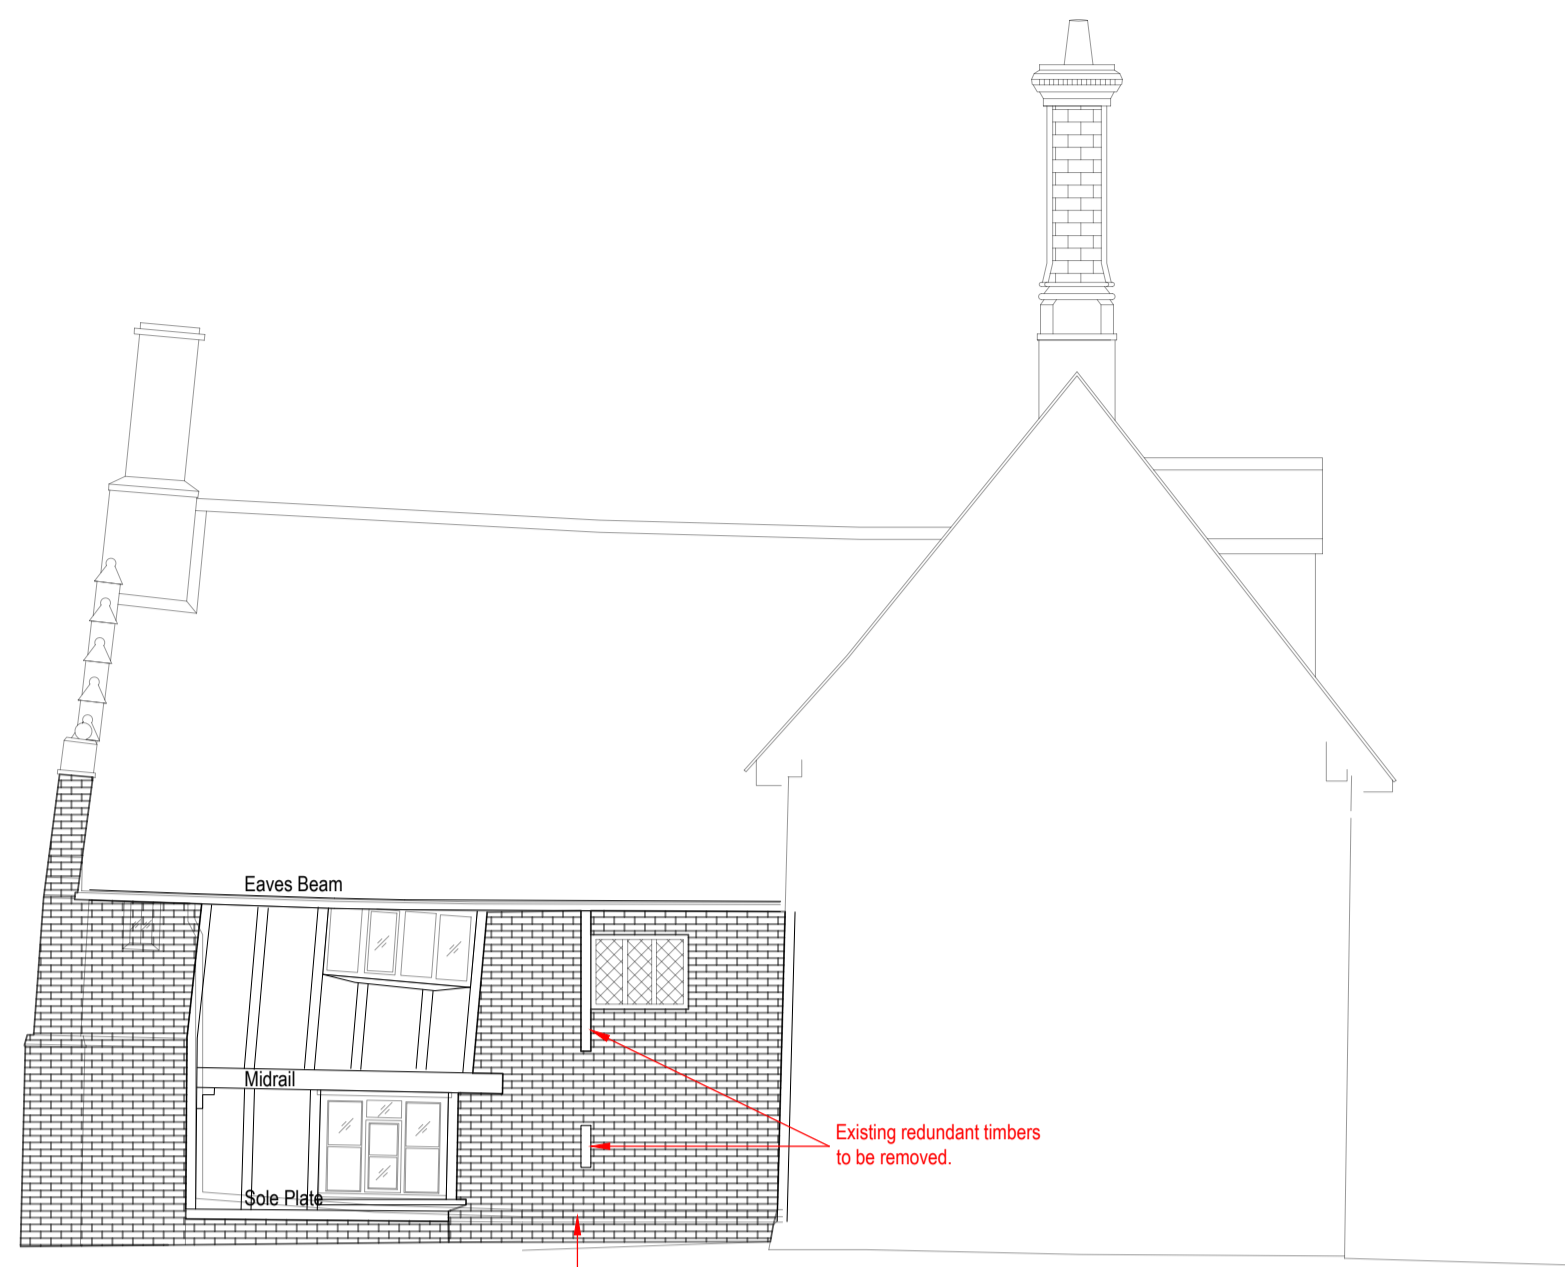
ELEVATION 2 - EXISTING
1:75

This drawing forms an appraisal of elements visible from ground floor level externally and internally. Additionally, internal finishes and stored materials covered other elements preventing a detailed inspection, particularly at low level. We can therefore not accept responsibility for items which were not seen at the time of the inspection, nor made aware of. Access at high level was not possible, nor were there any intrusive investigation works to determine the extent and condition of foundations or concealed structures.

The information presented is based on conditions which were apparent at the time of our inspection in October 2023. We cannot accept responsibility for conditions which may occur at other times. The appraisal is not intended to form a complete schedule of all required repairs, but to highlight the overall condition of principal structure and to serve as a record drawing for marking up by contractor to record repairs.
