PROJECT DETAILS:
Monks Hall Refurbishment
Syleham
Eye, IP21 4LN

DRAWING REFERENCE:
Repair Details
Elevation 1 (South-East)

SCALE:	DATE:	DRAWN BY:	CHECKED BY:
As Noted A1	Oct 2023	DB	JF
PROJECT No:	DRAWING No:	REVISION:	
4289	R01	P1

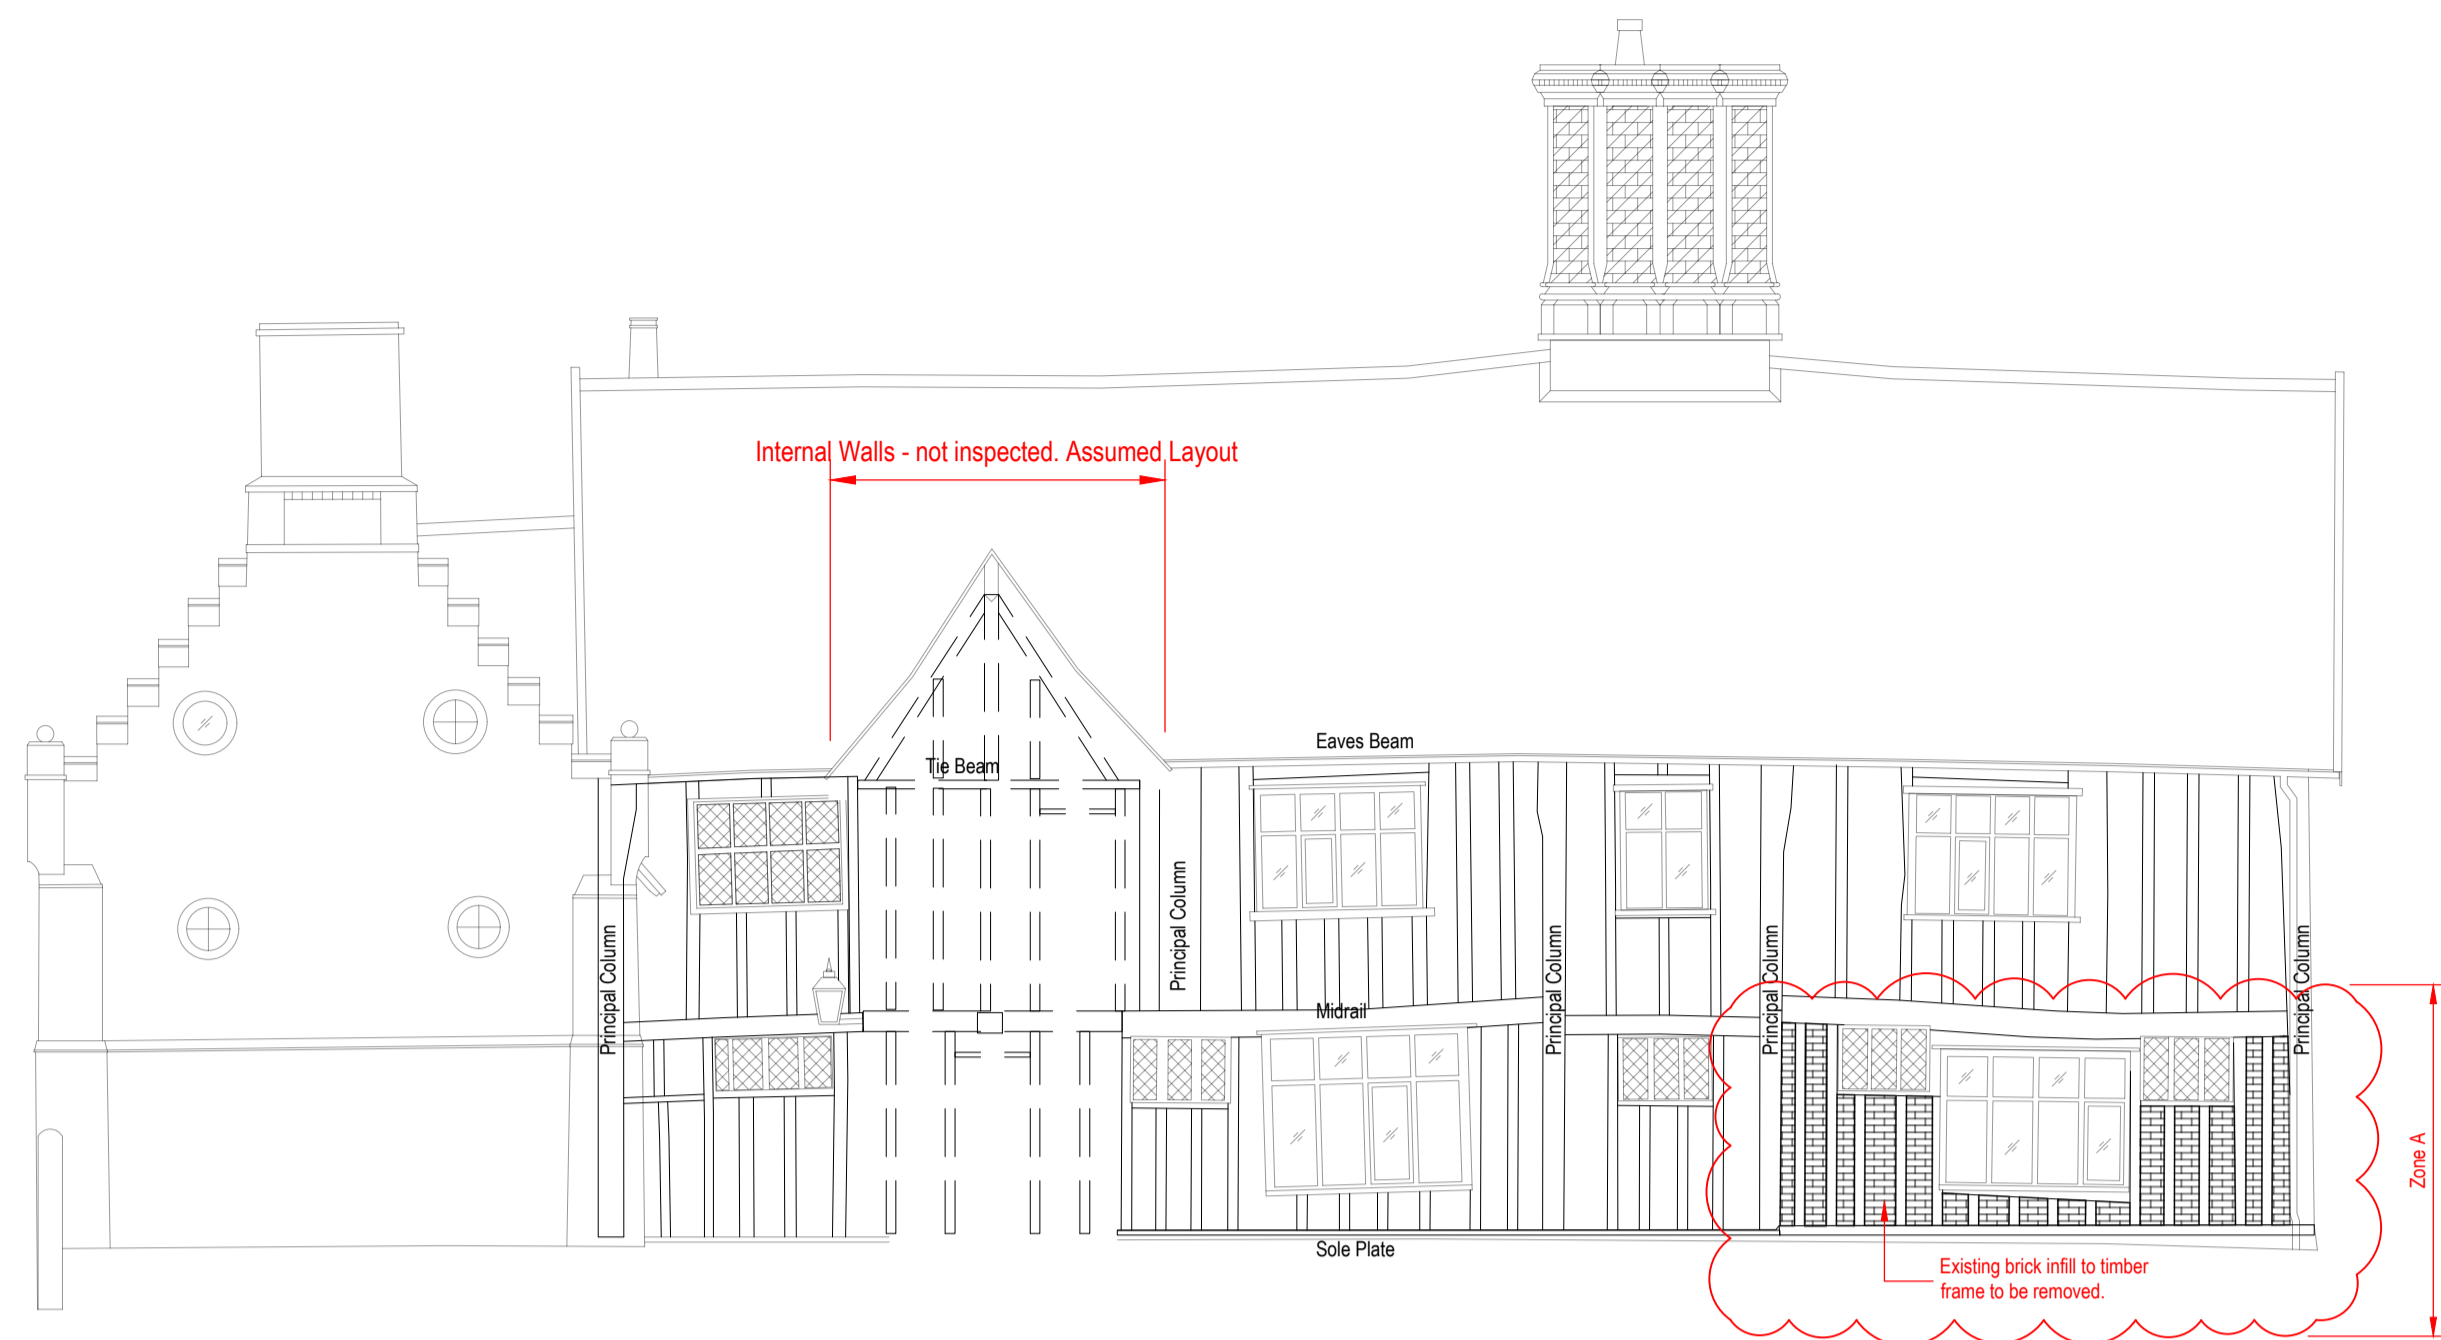
ELEVATION 1 - EXISTING
1:75

This drawing forms an appraisal of elements visible from ground floor level externally and internally. Additionally, internal finishes and stored materials covered other elements preventing a detailed inspection, particularly at low level. We can therefore not accept responsibility for items which were not seen at the time of the inspection, nor made aware of. Access at high level was not possible, nor were there any intrusive investigation works to determine the extent and condition of foundations or concealed structures.

The information presented is based on conditions which were apparent at the time of our inspection in October 2023. We cannot accept responsibility for conditions which may occur at other times. The appraisal is not intended to form a complete schedule of all required repairs, but to highlight the overall condition of principal structure and to serve as a record drawing for marking up by contractor to record repairs.
