FRITH:BLAKE CONSULTING LTD
STRUCTURAL-CIVIL-SUSTAINABILITY

PROJECT DETAILS:
Monks Hall Refurbishment
Syleham
Eye, IP21 4LN

DRAWING REFERENCE:
Repair Details
Elevation 4 (Side Elevation)

SCALE:	DATE:	DRAWN BY:	CHECKED BY:
As Noted A1	Oct 2023	DB	JF
PROJECT No:	DRAWING No:	REVISION:	
4289	R05	P1

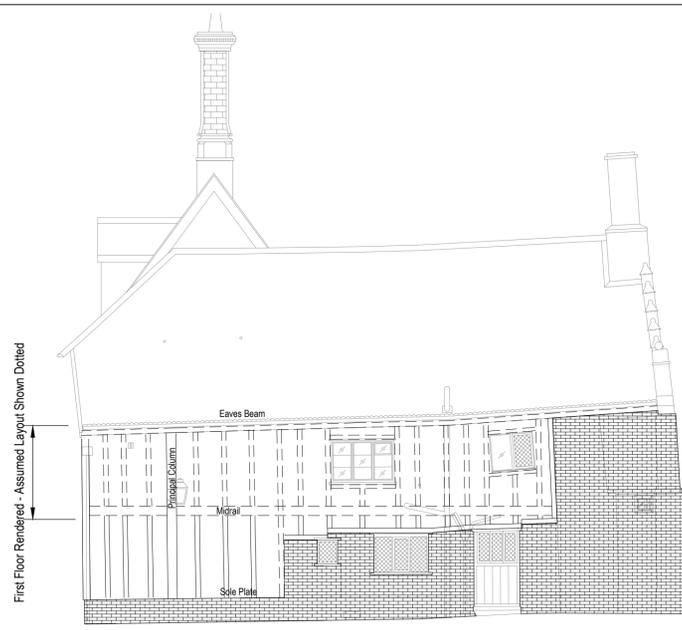
ELEVATION 4 - EXISTING
1:75

This drawing forms an appraisal of elements visible from ground floor level externally and internally. Additionally, internal finishes and stored materials covered other elements preventing a detailed inspection, particularly at low level. We can therefore not accept responsibility for items which were not seen at the time of the inspection, nor made aware of. Access at high level was not possible, nor were there any intrusive investigation works to determine the extent and condition of foundations or concealed structures.

The information presented is based on conditions which were apparent at the time of our inspection in October 2023. We cannot accept responsibility for conditions which may occur at other times. The appraisal is not intended to form a complete schedule of all required repairs, but to highlight the overall condition of principal structure and to serve as a record drawing for marking up by contractor to record repairs.
