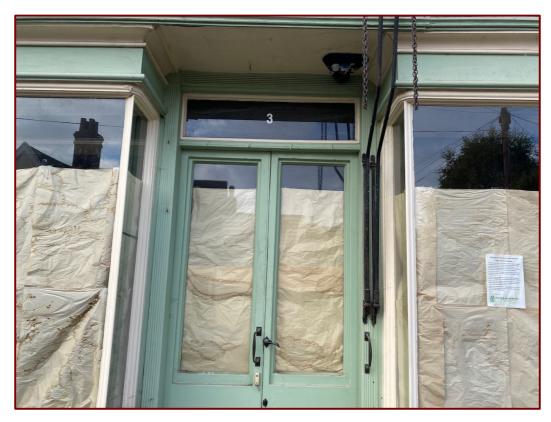
Existing pair of narrow double doors with rebated meeting stile, requires secondary leaf to be bolted for primary leaf to engage latch.

Clear opening width through one leaf restricted to approx. 700mm.

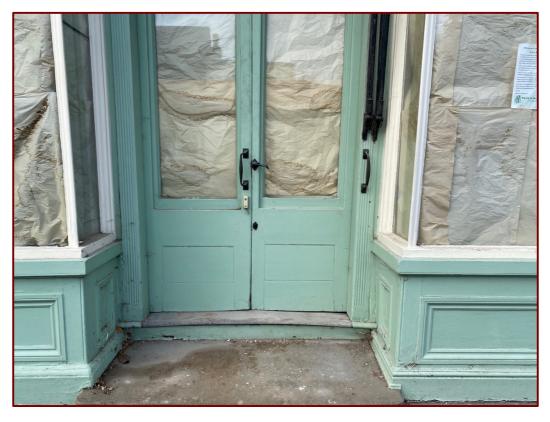
Raised door threshold bowing and riser piece decayed. Door threshold to be lowered down to original step level flush with new floor level.

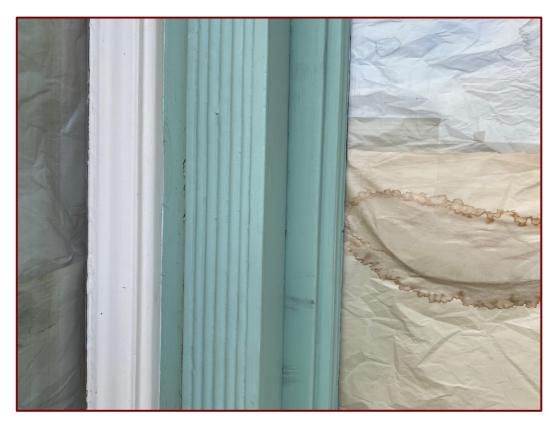
Existing fluted lining to reabted frame.

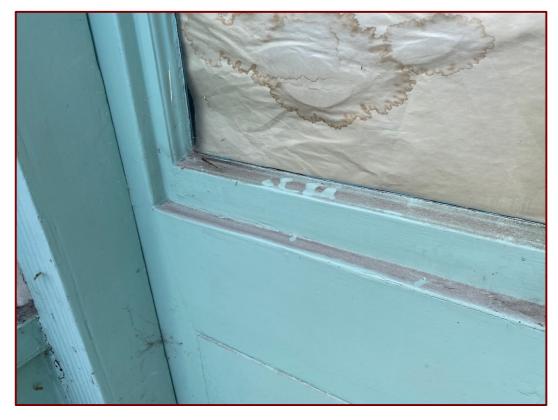
Original gunstock stile doors appear to have has glazed sashes inserted into the original glazing rebate.

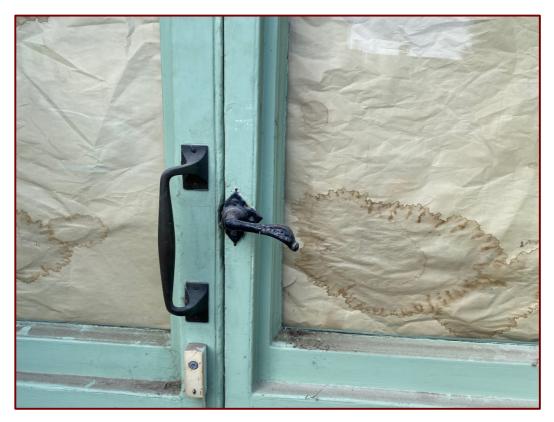
Mismatched and poorly adapted ironmongery.

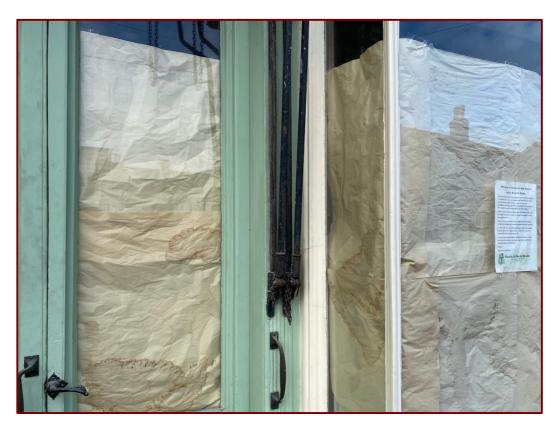
Redundant retractable canopy supports fixed to face of fluted column.

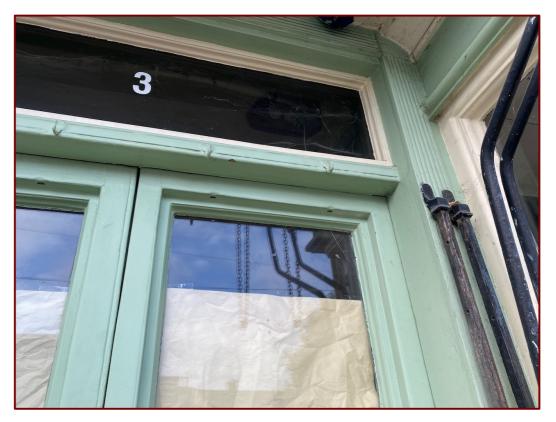
Top of redundant retractable canopy supports.

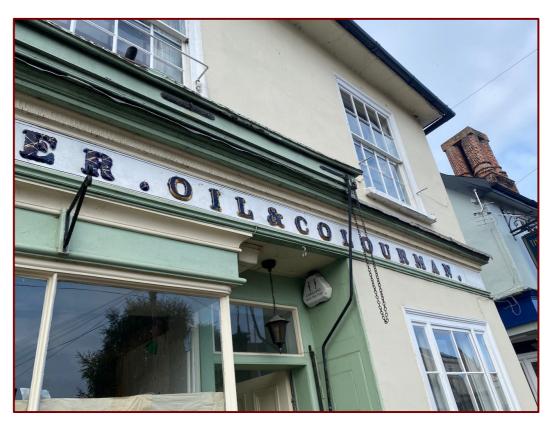
Original shop signage / fascia runs full width of Shop and adjacent residential frontage. Retractable canopy extends to the width of the shop fraontage and includes the recessed entrance to the residential unit.
