Arboricultural Appraisal Report

Subsidence Damage Investigation at:

The Cottage
 Nocton Hall
 Nocton
 LN4 2BA

CLIENT:	Crawford & Company
CLIENT REF:	SU2205588
MWA REF:	SUB221205-11608
MWA CONSULTANT:	John Graham B.Sc. Hons PhD
REPORT DATE:	10/07/2023

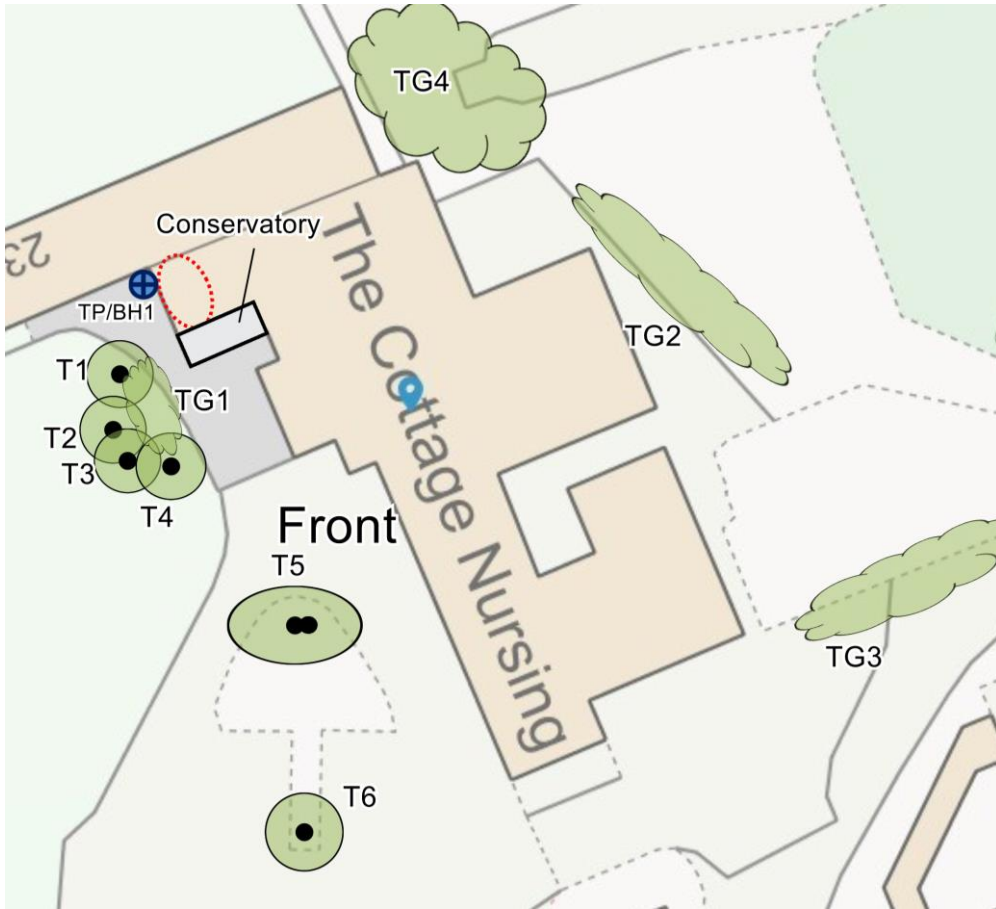
Site Plan

Approximate areas of damage

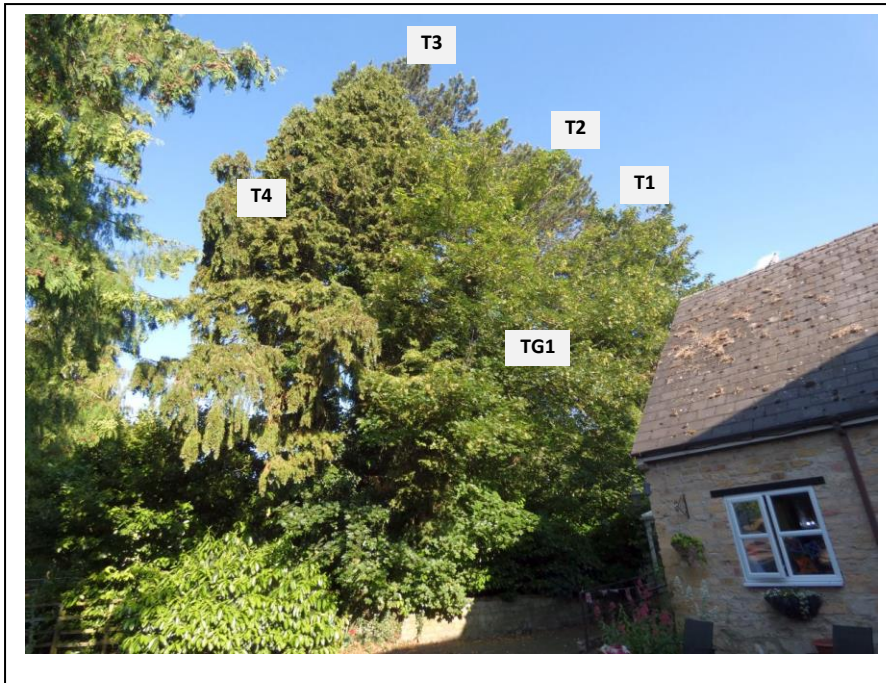
The current damage affects the front left and was first noticed in summer 2022. For a more detailed synopsis of the damage please refer to the building surveyor's technical report.

View of front left.

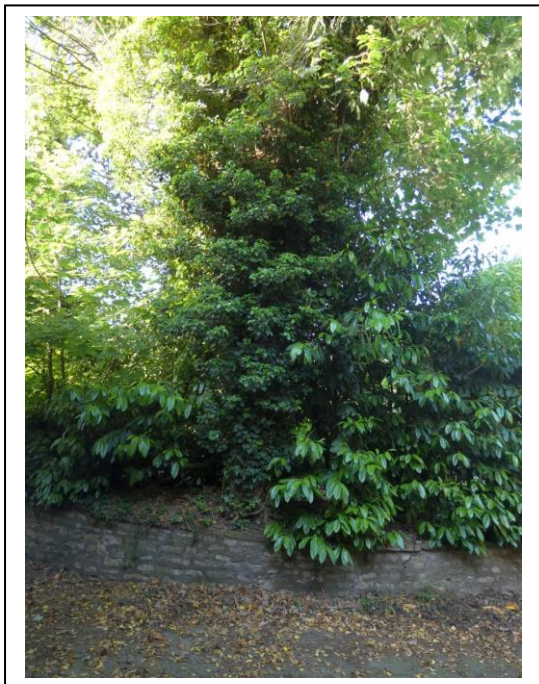
Roots were observed to a depth of 1,100mm bgl in TP/BH1 and recovered samples have been positively identified (using anatomical analysis) as sycamore, the origin of which will be T1 and/or TG1 confirming their influence on the soils below the foundations. Irrespective of the identification of recovered root samples, the roots of T2 and T3 (pines) are also likely to be present below foundation level in proximity to the area of movement/damage and influencing soil moisture and volumes.

Tree No.	Species	Ht (m)	Dia (mm)	Crown Spread (m)	Dist. to building (m)	Age Classification	Ownership
T1	Sycamore	15 *	550 Ms *	10 *	5	Older than extension(s)	Third Party Coachmans Cottage LN4 2BA
Management history		No significant recent management noted. Trees covered in ivy and partially obscured by scrub.					
Recommendation		Remove (fell) to near ground level and treat stump to inhibit regrowth.					
T2	Pine	15 *	600 *	12 *	8	Older than extension(s)	Third Party Coachmans Cottage LN4 2BA
Management history		No significant recent management noted. Trees covered in ivy and partially obscured by scrub.					
Recommendation		Remove (fell) to near ground level.					
T3	Pine	15 *	600 *	10 *	9 *	Older than extension(s)	Third Party Coachmans Cottage LN4 2BA
Management history		No significant recent management noted. Trees covered in ivy and partially obscured by scrub.					
Recommendation		Remove (fell) to near ground level.

View of stem of T1.

If an arboricultural solution is to be implemented to mitigate the influence of the implicated trees/vegetation we recommend that T1, T2, T3 and TG1 are removed. Other vegetation recorded presents a potential future risk to building stability and management is therefore recommended.

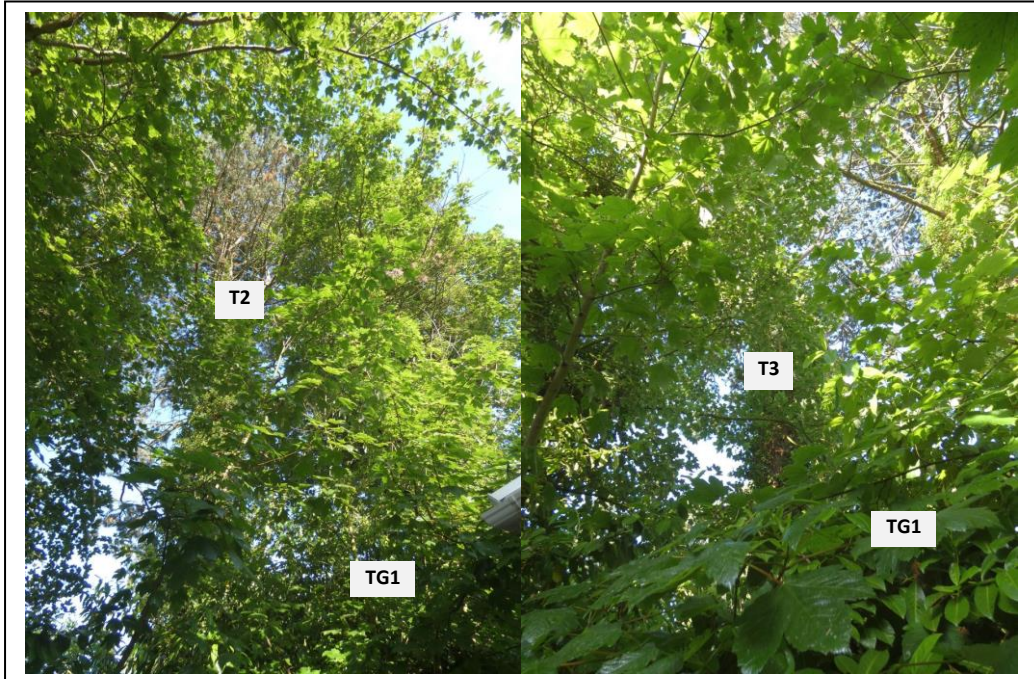
View of stems of T2 and T3 behind TG1.

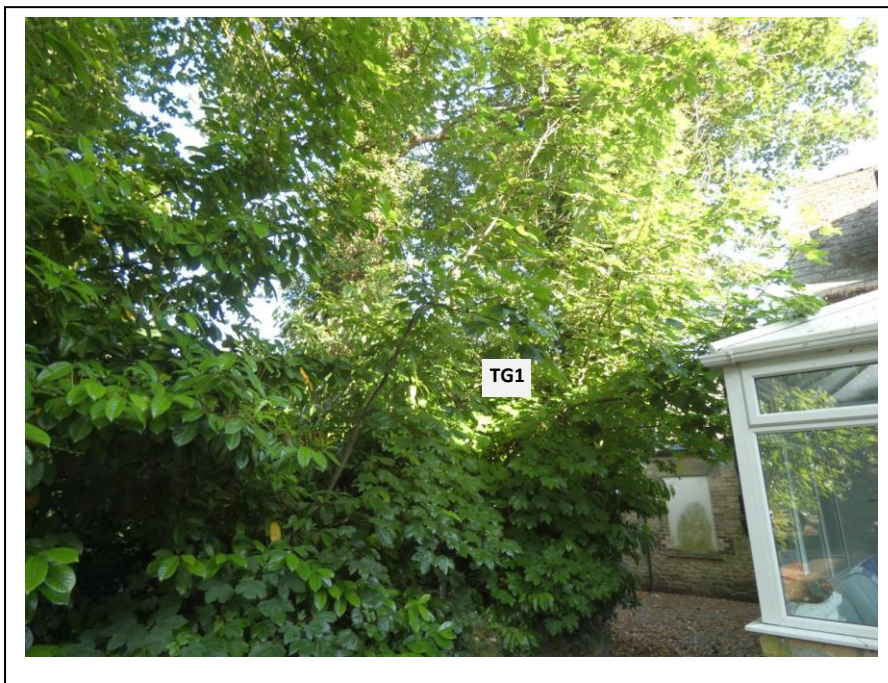
TG1	Sycamore	12 *	150 Ms *	4 *	5.5	Younger than Property	Third Party Coachmans Cottage LN4 2BA
Management history		No significant recent management noted.					
Recommendation		Remove (fell) to near ground level and treat stump to inhibit regrowth.

View of TG1.
