Site Investigation Report

145660.1.USI

Brief	Auger were commissioned by Crawford & Co to undertake a site investigation and CCTV inspection of the underground drainage within the area of concern (AOC) at the property.
-------	--

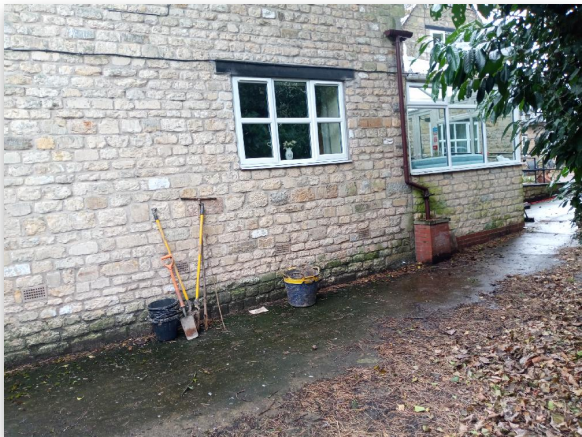
Fig 1.1: Trial Hole 1 Location

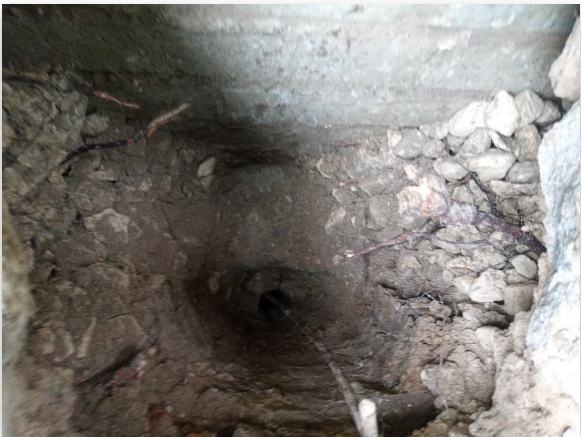
Trial Hole Findings	TH1 was completed in the proposed location revealing the footing and taking soil and root samples.
Drain Survey	No CCTV survey of the underground drainage was undertaken whilst on site because the only drainage in the are of concern was a disused rainwater gully. This gully had an unusual raised design however had no guttering.

Fig 1.2: Trial Hole 1 Footing

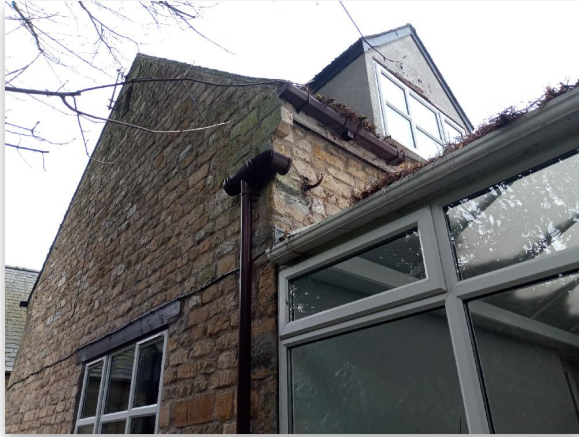
Fig 2.1: No guttering for gully

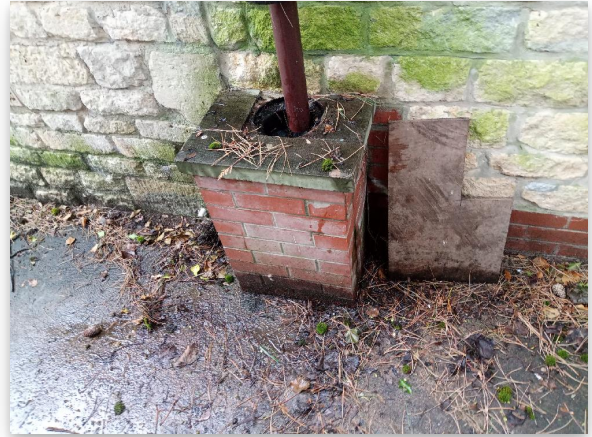
Fig 2.2: Raised RWG

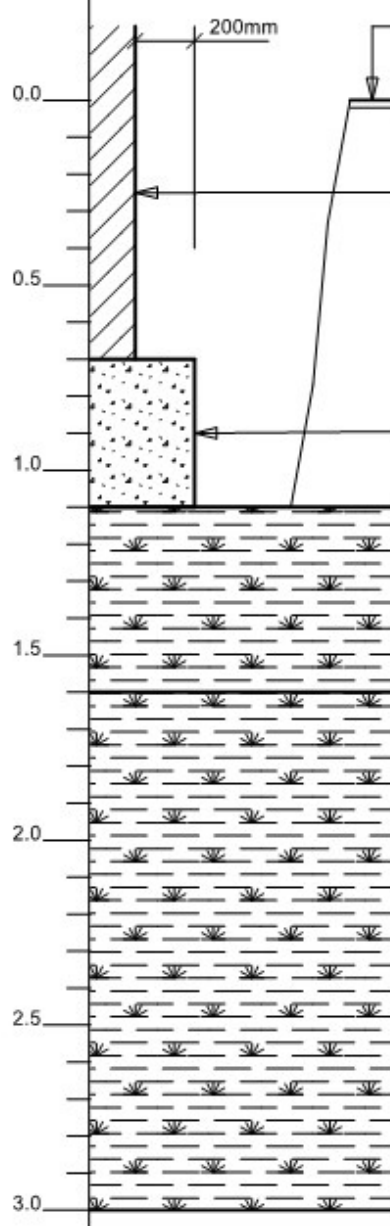
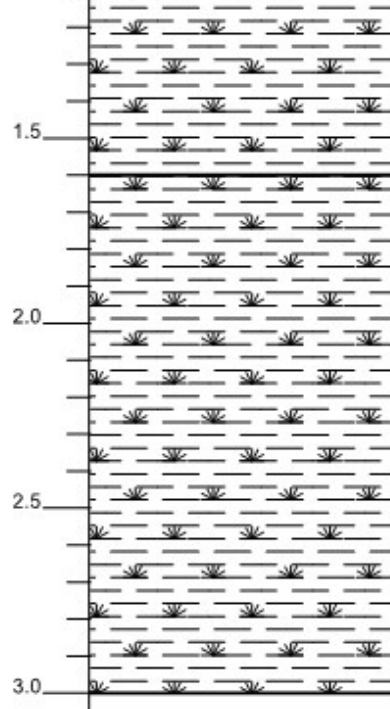
Trial Hole Log No.1

Location: Front left hand side next to the conservatory

Ground Level				
		Concrete				
0.5		Blockwork				
1.0		Concrete				
		Moist very stiff Brown fine to medium gravelly clayey SILT	88kpa		Soil @ 1.1m	Root @ 1.1m
1.5

Moist Very Stiff Brown fine to medium gravelly silty CLAY	94kpa		Soil @ 1.6m	
2.0			96kpa		Soil @ 2.1m	
2.5			98kpa		Soil @ 2.6m	
3.0		TRIAL HOLE TERMINATED	98kpa
