MacIntyre Trees
Arboricultural Consultancy

Arboricultural Impact Assessment Report.

In Relation to Demolition and
Construction at Hill Farm, Akeley Road,
Lillingstone Lovell.

Date	January 2024
Report Ver.	23113_Fv1

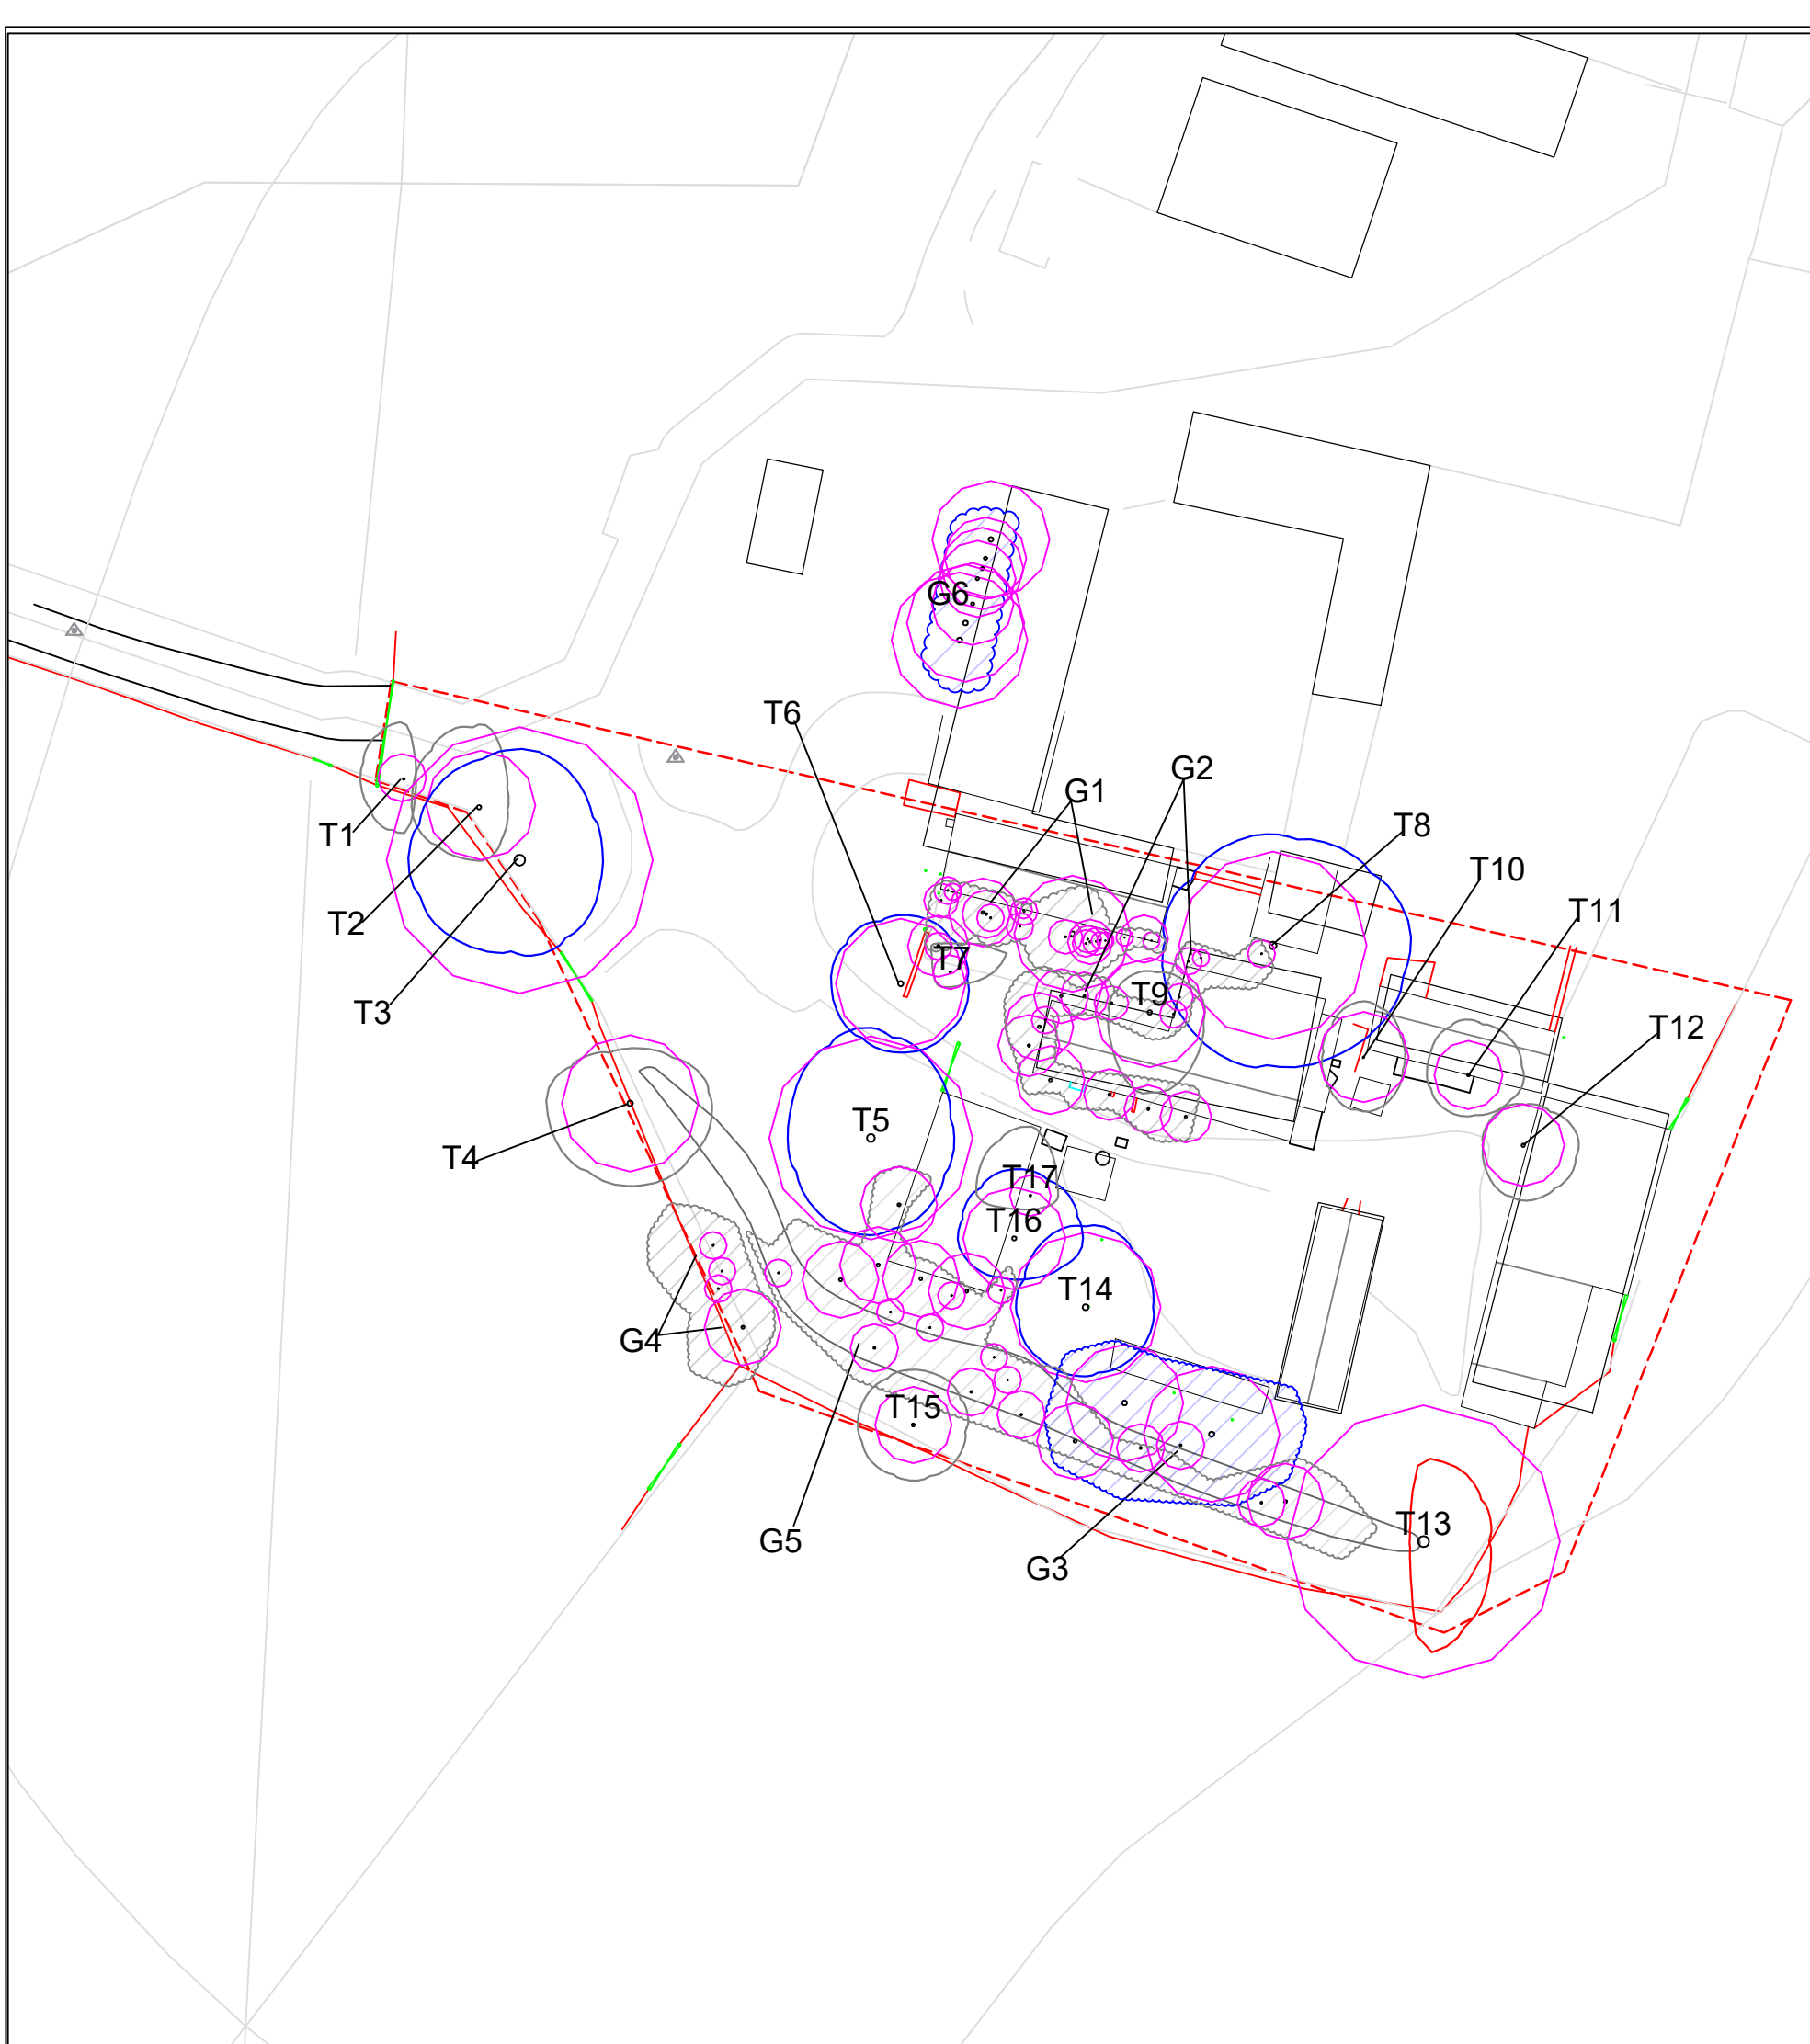
Drawing Title: **TREE_CONSTRAINTS_PLAN (EXISTING_LAYOUT)**

Ref No.	Species	Ht (m)	Dia (mm)	N	S	E	W	Lc H (m)	SC	PC	Age Class	Comments	Cat	Sub Cat	ULE (years)	Root Protection Radius (m)
T1	Wild cherry	5	140	4	4	1	3	1.5	Good	Good	Y	Small self seeded cherry. Average form. Some branch stubs. Suppressed by adjacent crown.	C	1	40+	1.7
T2	Wild cherry	7	320	6	4	2	5	2	Fair	Fair	EM	Twin stem from near base with bark inclusion present at union. East side of crown part dead, suppressed also by larger willow. Ground disturbance and root damage likely near stem base, with levels lowered and road plannings scraped to stem base.	C	1	20-40	3.8
T3	Weeping willow	12	780	8	7	6	8	5	Fair	Good	M	Numerous storm damaged limbs and some bark damage on north east side of main stem. Ground levels appear to have been lowered and gravel piled around base. Maiden form, with some long and end-weighted limbs which will be more prone to failure as tree becomes larger. Reduction to pollard form a suitable long term management option. Some dieback on north side. Wound at base on west side, possible decay buried beneath deposited gravel. Small cherry sapling to south.	B	1	20-40	9.4

T4	Crack willow	6	400	4	6	6	6	1.8	Fair	Fair	EM	Tree growing at base of large spoil pile containing variety of (waste) material. Multi-stemmed from around 1.8 metres some bark inclusions.	C	1	20-40	4.8
T5	Walnut	12	590	8	7	6	6	6	Fair	Good	SM	Twin stem from around 1 metre with east stem having very large tear wound on south side at around 1.5 metres, additional wound on large secondary limb at around 3 metres on west side. No advanced decay present, but longevity reduced because of the wounds. Apical growth slightly thin. Made ground directly to north of stem.	B	1	20-40	7.1

Ref No.	Species	Ht (m)	Dia (mm)	N	S	E	W	Lc H (m)	SC	PC	Age Class	Comments	Cat	Sub Cat	ULE (years)	Root Protection Radius (m)
T6	Common ash	14	380	5	5	5	5	3	Poor	Good	EM	Tree grows from base of stone wall, ground levels have been altered in the past. Large piles of road plannings also directly at base of stem.	B	1	20-40	4.6
T7	Pear variety	7	80	0.2	3	5	1	2	Fair	Fair	M	Regrowth growing from base of decaying stem. Very asymmetric crown. Congested and twisted stems. Pruning to achieve good aesthetic form not feasible and current state.	C	1	20-40	1.0
T8	Common ash	15	550	8	9	10	8	4	Fair	Fair	SM	Large ash growing directly from base of brick barn and displacing block work. Ivy covered stem which obscures twin stem union. Some deadwood in crown, but does not appear to be ash dieback disease related. Overhangs both buildings. Retention unfeasible in context of maintaining buildings in usable state.	B	1	20-40	6.6

T9	Goat willow	11	320	3	6	4	3	3	Fair	Good	SM	Triple stemmed from base with bark inclusion on south side. Tree grows within 1 metre of building line and overhangs roof significantly. Clothed in ivy and limited long-term	C	1	'10-20	3.8
T10	Common ash	10	260	4	4	3	3	2	Fair	Poor	EM	Multi stemmed from base and growing from base of stone barn. Some fire damage on south side. Limited amenity value or potential.	C	1	20-40	3.1
T11	Common ash	10	200	4	3	4	3	7	Fair	Fair	EM	Similar to previous, growing from base of stone barn. Clothed in ivy. Some fire damage on southwest side. Limited potential.	C	1	'10-20	2.4
T12	Common ash	10	240	3	4	4	3	4	Fair	Fair	EM	Self seeded, as previous but growing from base of agricultural barn shed. Numerous wounds up stem. Fire damage.	C	1	'10-20	2.9

Ref No.	Species	Ht (m)	Dia (mm)	N	S	E	W	Lc H (m)	SC	PC	Age Class	Comments	Cat	Sub Cat	ULE (years)	Root Protection Radius (m)
T13	Crack willow	7	800	6	8	5	1	0	Poor	Poor	M	Very poor condition Willow with numerous failed limbs and sparse crown. Pollard form with decay at regrowth points and into main lower trunk. Growing from large pile of spoil.	U		<10	9.6
T14	Common ash	14	440	6	5	5	5	6	Good	Fair	SM	Tree has been high pruned to give clear stem to around 9 metres height. Low growth rates and somewhat sparse crown form. Some deadwood present.	B	1	20-40	5.3
T15	Common ash	6	220	4	4	4	4	1	Fair	Good	Y	Small self seeded tree on south side of man-made bank next to grazing field. Twin stemmed from base. Small feature of average form. Some tip dieback.	C	1	20-40	2.6
T16	Apple variety	6	300	5	3	5	4	2	Fair	Fair	M	Apple tree growing in area of scrub and next to base of shed. Not shown on topo so position estimated. Appears in relatively good health.	B	1	20-40	3.6

T17	Common ash	8	120	5	1	2	4	3	Fair	Fair	Y	No access to base due to dense vegetation. Self-seeded Ash growing from the base of shed and water tank. Average form.	C	1	20-40	1.4
G1	Common ash	7	100	3				0	Good	Fair	Y	Line of self-seeded Ash all growing from base of old stone barn. One larger (parent) tree within, also growing directly from base of barn. Some die back within - probable ash dieback disease (ADB) as epicormic flush and pattern of dieback indicative of this, ADB also present in area in numerous other trees. Some positive wildlife and screening value but in context of maintaining space as usable area trees are entirely inappropriate in their current positions.	C	2	20-40	1.2

Ref No.	Species	Ht (m)	Dia (mm)	N	S	E	W	Lc H (m)	SC	PC	Age Class	Comments	Cat	Sub Cat	ULE (years)	Root Protection Radius (m)
G2	Common ash, Goat willow	7	100	3				0	Good	Good	EM	Self-seeded ash and goat willow around building. All growing through or from base of the building such that unfeasible to retain an interest of maintaining building in any usable state. Some ash dieback disease noted. Limited wider landscape value or potential.	C	1,2	20-40	1.2
G3	Common ash, Horse chestnut,	6	100	2				0	Fair	Fair	EM	Two early mature horse chestnut on east portion of waste filled man made bund. forming dominant canopy cover of group of trees along bund. Below average growth rates. Some screening value provided, but largely unremarkable in terms of amenity and form.	B	2	20-40	1.2
G4	Elder	3	50	2				0	Fair	Fair	EM	Small patch of elder scrub on southside of bank toe and next to grazing field. No stems on topo so plotted inicatively.	C	2	'10-20	0.6

G5	Ash, Hawthorn, Goat willow, Elm, Walnut	6	150	1				0	Fair	Fair	EM	Group of trees growing through man-made bank which contains spoil and variety of (waste) materials including brick, metal, tyres, and other building materials. Predominantly ash self-set, with some elm becoming prevalent, particularly at west end. One failed stem on shipping container barn.	C	2	20-40	1.8
G6	Lawson cypress	16	300	2				4	Fair	Good	SM	Line of cypress next to barn, Numerous bark inclusion- typical for species but often results in failures as trees get larger. Prominent but limited long term potential. Not on ytopo so pltted inidcatively.	B	2	20-40	3.6

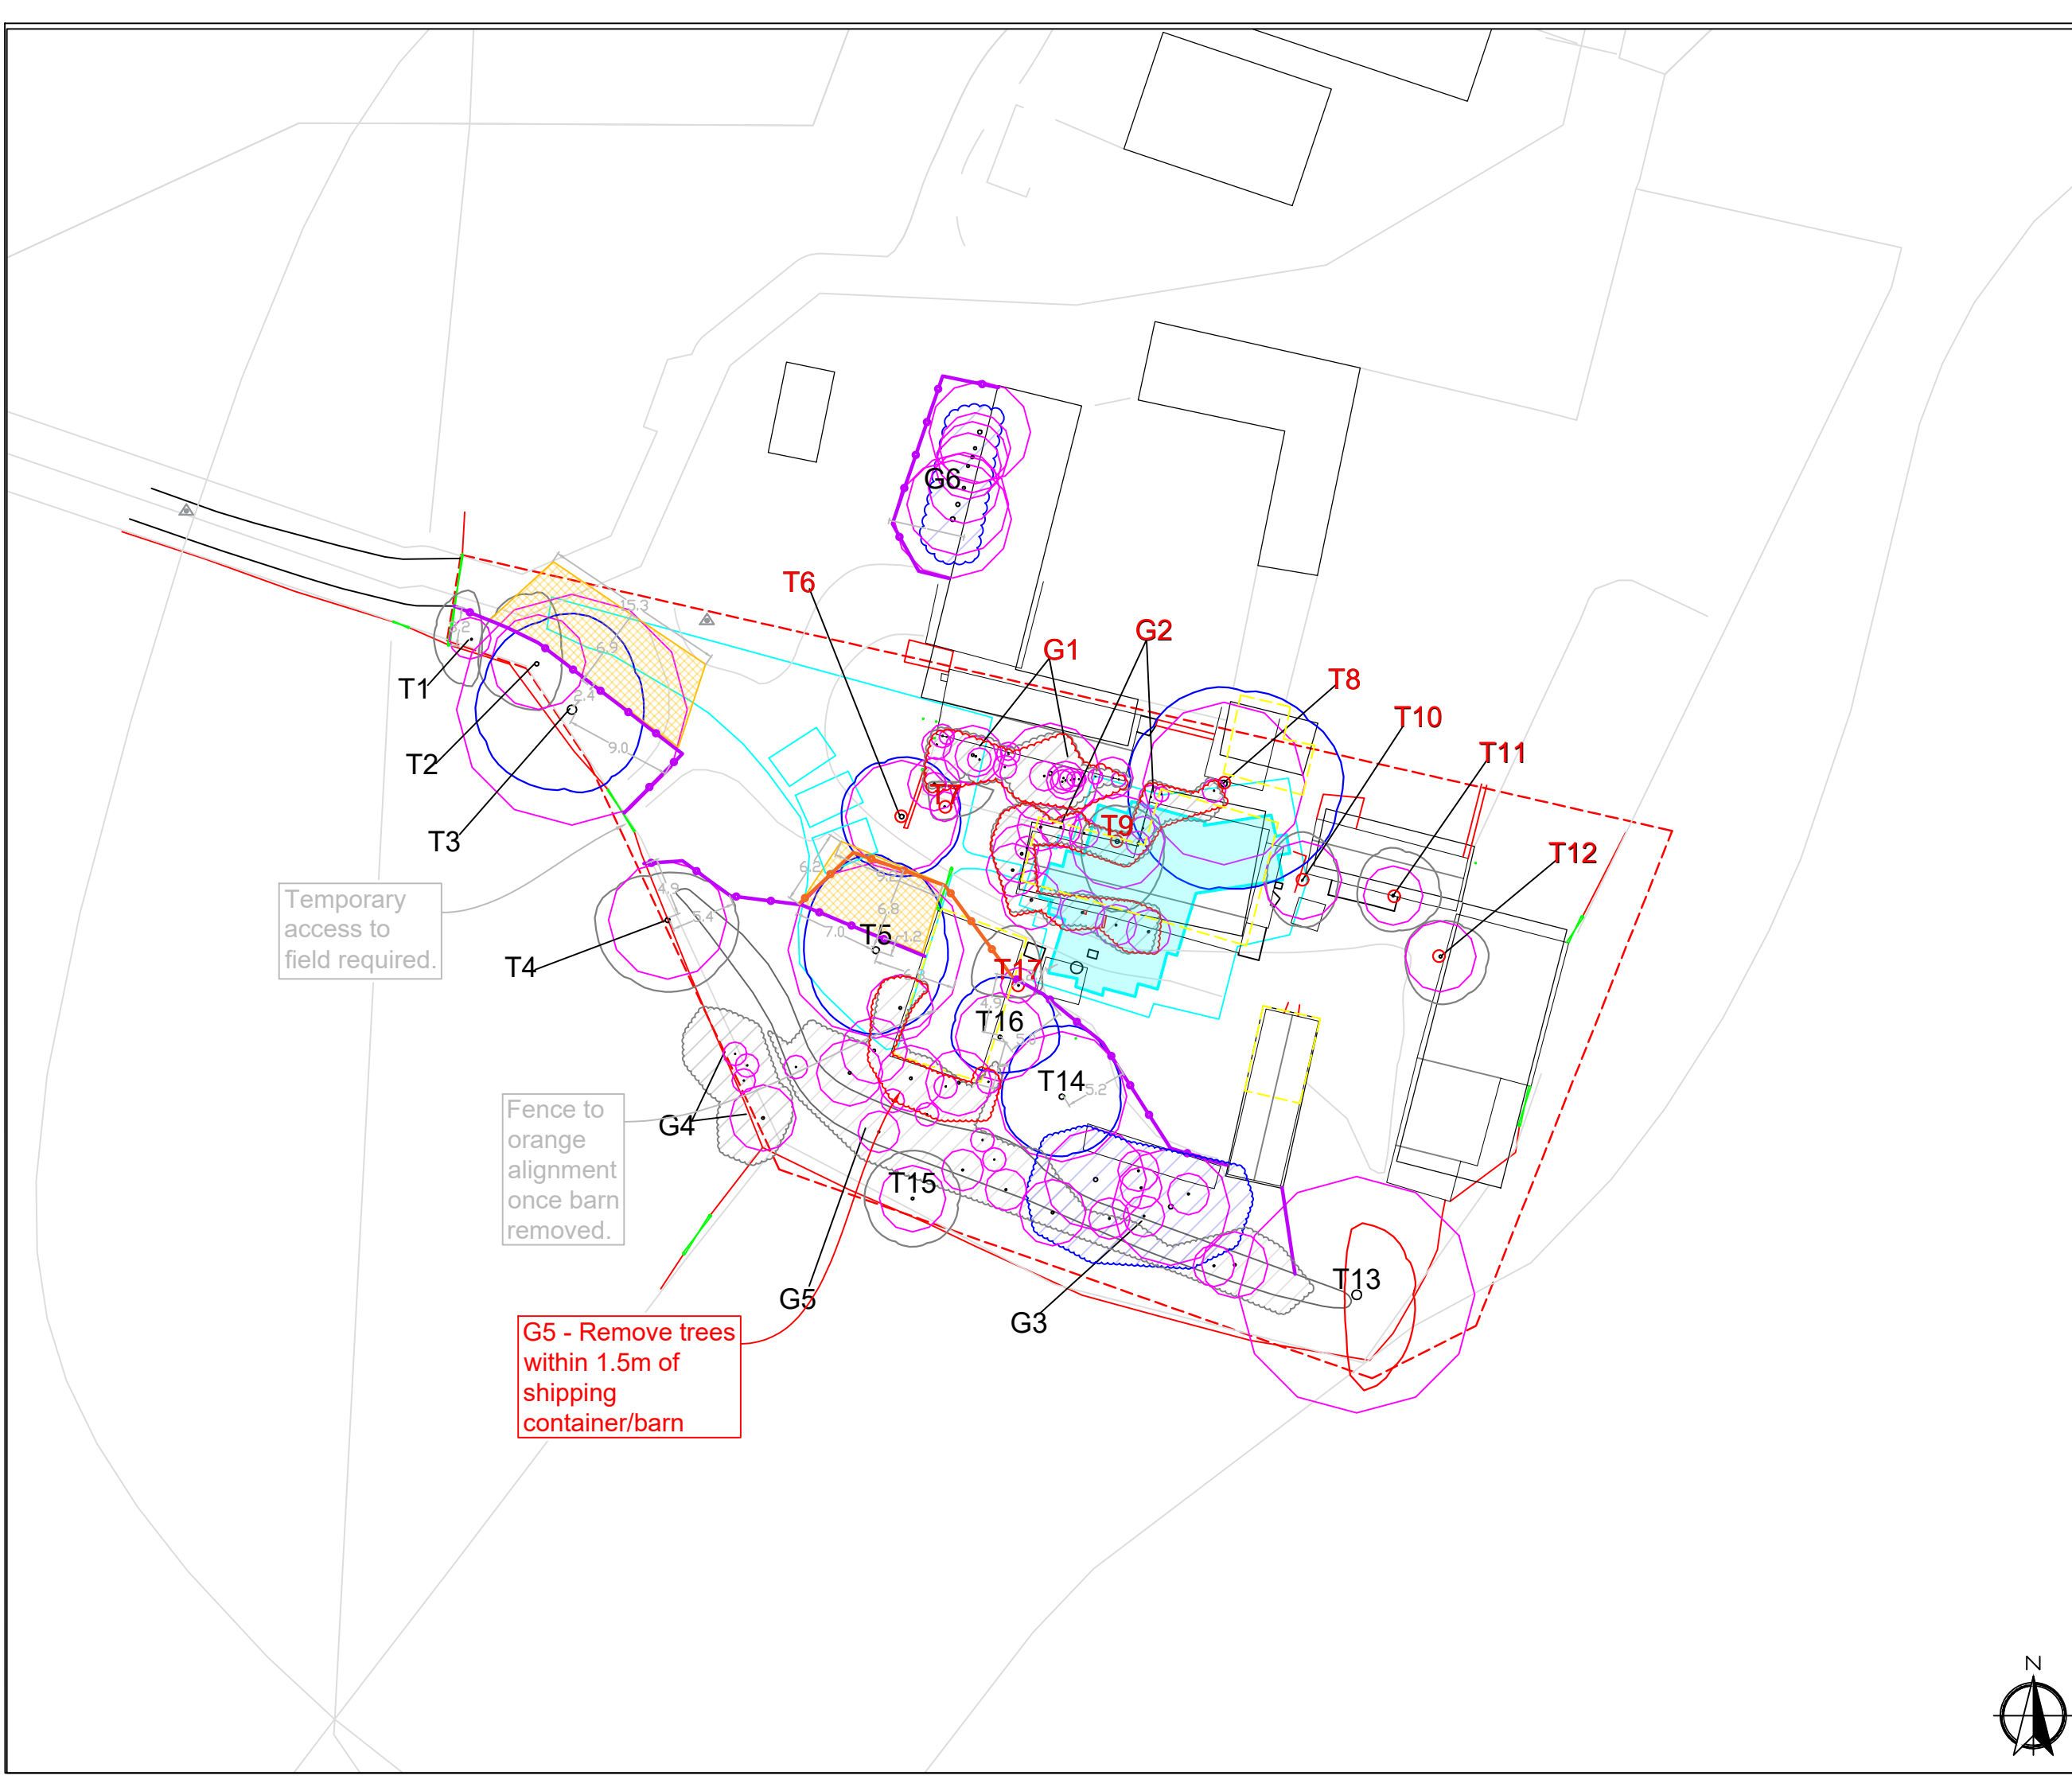
Ref No.	Species	Survey Notes	Cat	Impacts of Proposals	Details	Suggested Mitigation/Protection
T6	Common ash	Tree grows from base of stone wall, ground levels have been altered in the past. Large piles of road plannings also directly at base of stem.	B	Remove	To enable safe working space, access for demolition/construction and to favour adjacent Walnut.	New planting to be provided as part of landscape scheme.
T7	Pear variety	Regrowth growing from base of decaying stem. Very asymmetric crown. Congested and twisted stems. Pruning to achieve good aesthetic form not feasible and current state.	C	Remove	To enable safe working space, access for demolition.	New planting to be provided as part of landscape scheme.
T8	Common ash	Large ash growing directly from base of brick barn and displacing block work. Ivy covered stem which obscures twin stem union. Some deadwood in crown, but does not appear to be ash dieback disease related. Overhangs both buildings. Retention unfeasible in context of maintaining buildings in usable state.	B	Remove	To allow demolition and construction.	New planting to be provided as part of landscape scheme.

T9	Goat willow	Triple stemmed from base with bark inclusion on south side. Tree grows within 1 metre of building line and overhangs roof significantly. Clothed in ivy and limited long-term	C	Remove	To allow demolition and construction.	None
T10	Common ash	Multi stemmed from base and growing from base of stone barn. Some fire damage on south side. Limited amenity value or potential.	C	Remove	Inappropriate to retain in position due to closeness to barn.	None
T11	Common ash	Similar to previous, growing from base of stone barn. Clothed in ivy. Some fire damage on southwest side. Limited potential.	C	Remove	Inappropriate to retain in position due to closeness to barn.	None
T12	Common ash	Self seeded, as previous but growing from base of agricultural barn shed. Numerous wounds up stem. Fire damage.	C	Remove	Inappropriate to retain in position due to closeness to barn.	None

G5	Ash, Hawthorn, Goat willow, Elm, Walnut	Group of trees growing through man-made bank which contains spoil and variety of (waste) materials including brick, metal, tyres, and other building materials. Predominantly ash self-set, with some elm becoming prevalent, particularly at west end. One failed stem on shipping container barn.	C	Part Remove	Small area to be removed to enable removal of shipping container barn which is sunk into bund at southern end. Remove stems closest (within 1.5m) of shipping container/barn at southern end.	None

- 4.3. The proximity of the walnut tree (T5) and apple tree (T16) are such that there is potential for direct damage during the removal of the shipping container/barn. Some minor pruning would alleviate this aspect. Providing this pruning is carried out by suitably qualified and competent arboricultural contractors, and (in the case of the walnut) in the summer preceding works, then impacts will be minimised, and the overall appearance of the walnut tree will not be unduly compromised.

- 4.5. Whilst not directly required to enable construction or demolition, the re-pollarding of tree T13 (willow) is also recommended as the tree is currently in particularly poor form with numerous failed limbs hanging into garden space. The stem condition of the tree is also poor, but some regrowth is likely which will be of benefit to wildlife. Because of the condition of this tree and its position on a raised bund and away from main construction, no additional protective fencing is felt necessary.

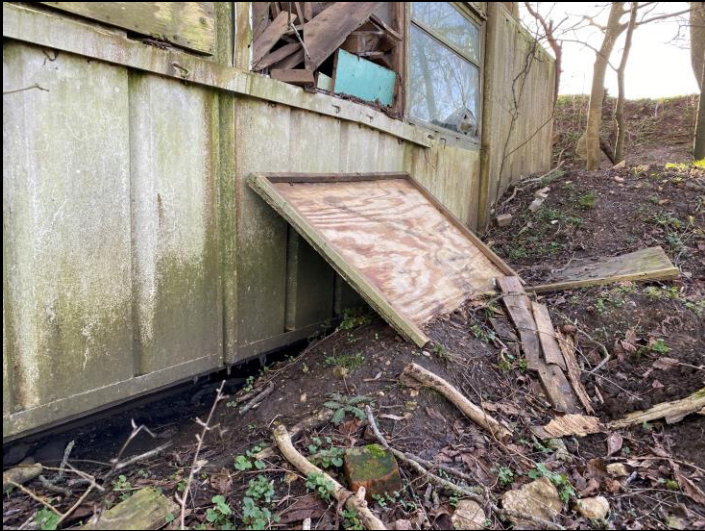
Close up of area near G5, Shipping container/lean-to barn buried

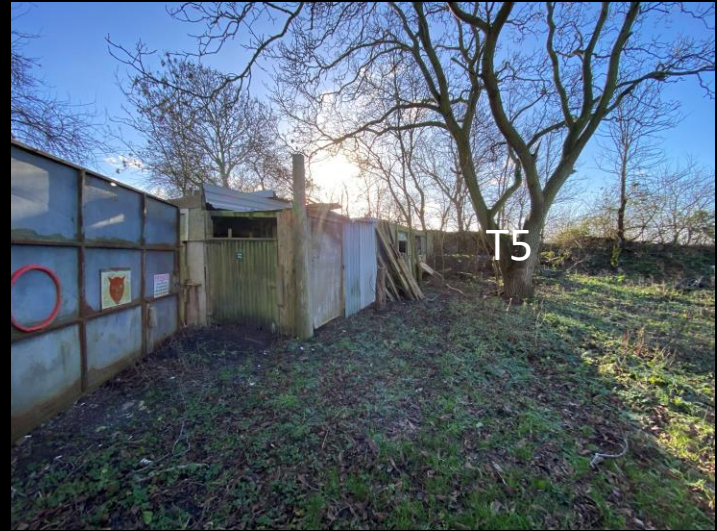
Container and lean-to forming 'barn' area near T5

- 4.7. Similar impacts also likely to occur around the base of tree T5 (walnut) which currently comprises compacted road plantings and loose stone. The area is to continue to be utilised as driveway and access will also be required over the area to remove the shipping container and lean to barn. The removal of much of the existing lean-to structure can be carried out by hand and with minimal impacts to the trees, however the removal of the larger shipping container element will require plant machinery. Ground compaction impacts as a result of this can be greatly reduced by ensuring ground protection is installed prior to its removal and an alignment of protective fencing can be erected to the full extent of the RPA once the shipping container/barn has been removed to avoid further ground compaction or direct damage impacts.

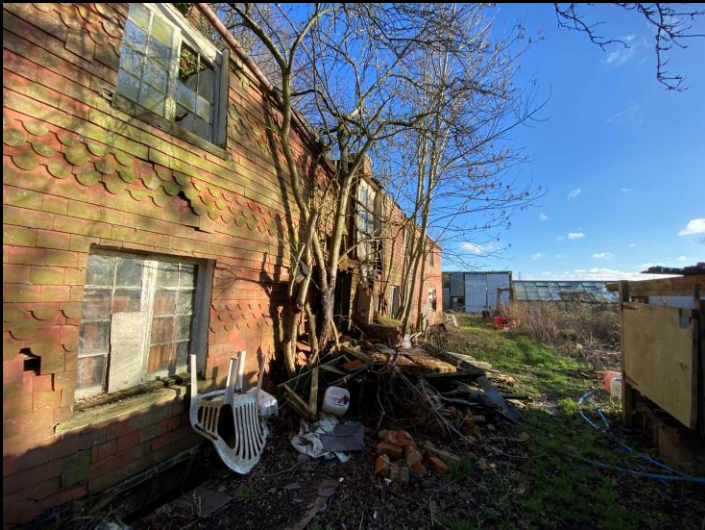
Typical cover around building – south side

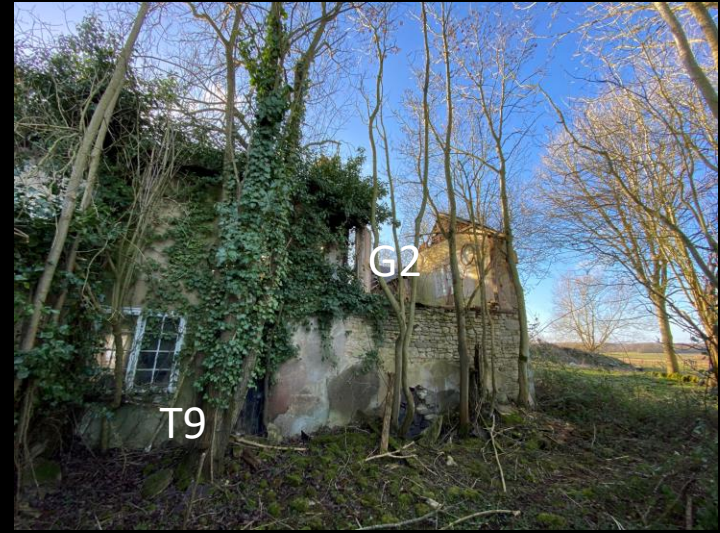
Typical cover around building, north side

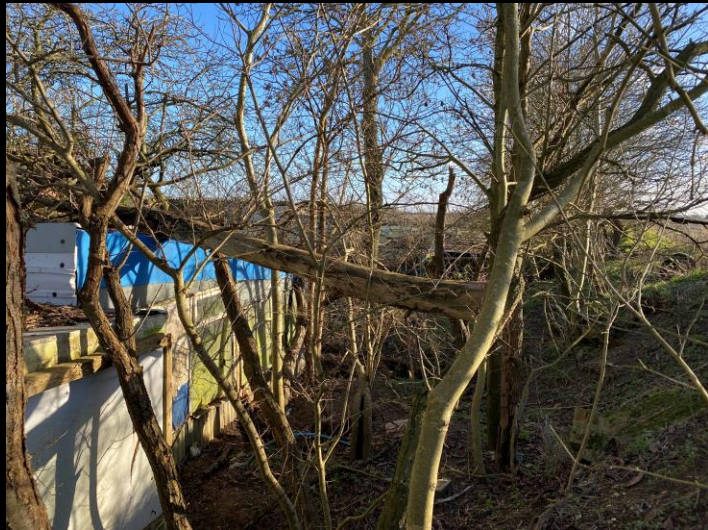
Collapsed tree over container – G5
