Bat Risk Assessment of:

Lark House
Cornsay
Durham
DH7 9EP

Report Ref: Wakefields_LarkHouse_Bat1.1

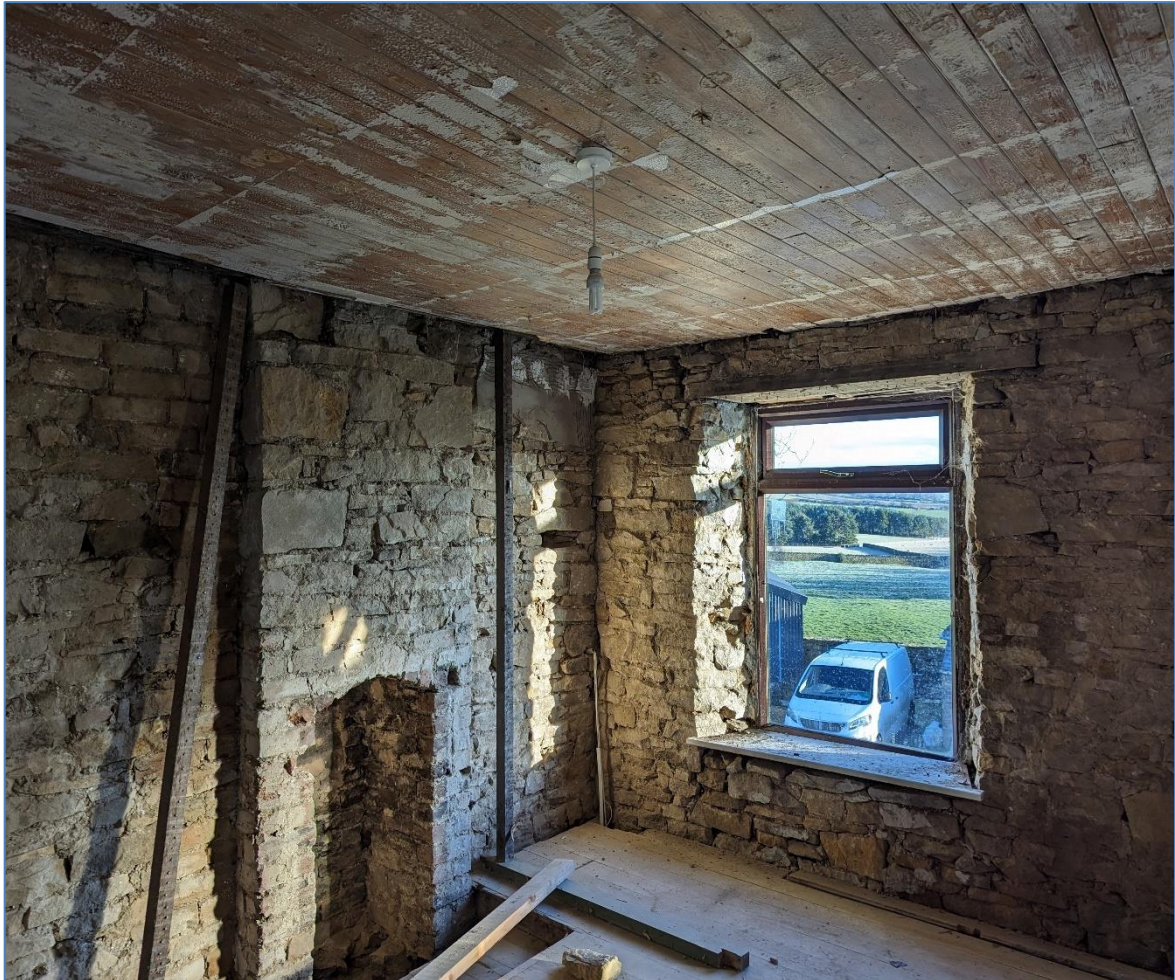
3.4.1 Lark House is a detached, two-storey building. The building is a former residential property and is currently being soft stripped and dismantled in preparation for demolition (Photograph 1).

Photograph 1 – Soft stripping and dismantling inside Lark House.

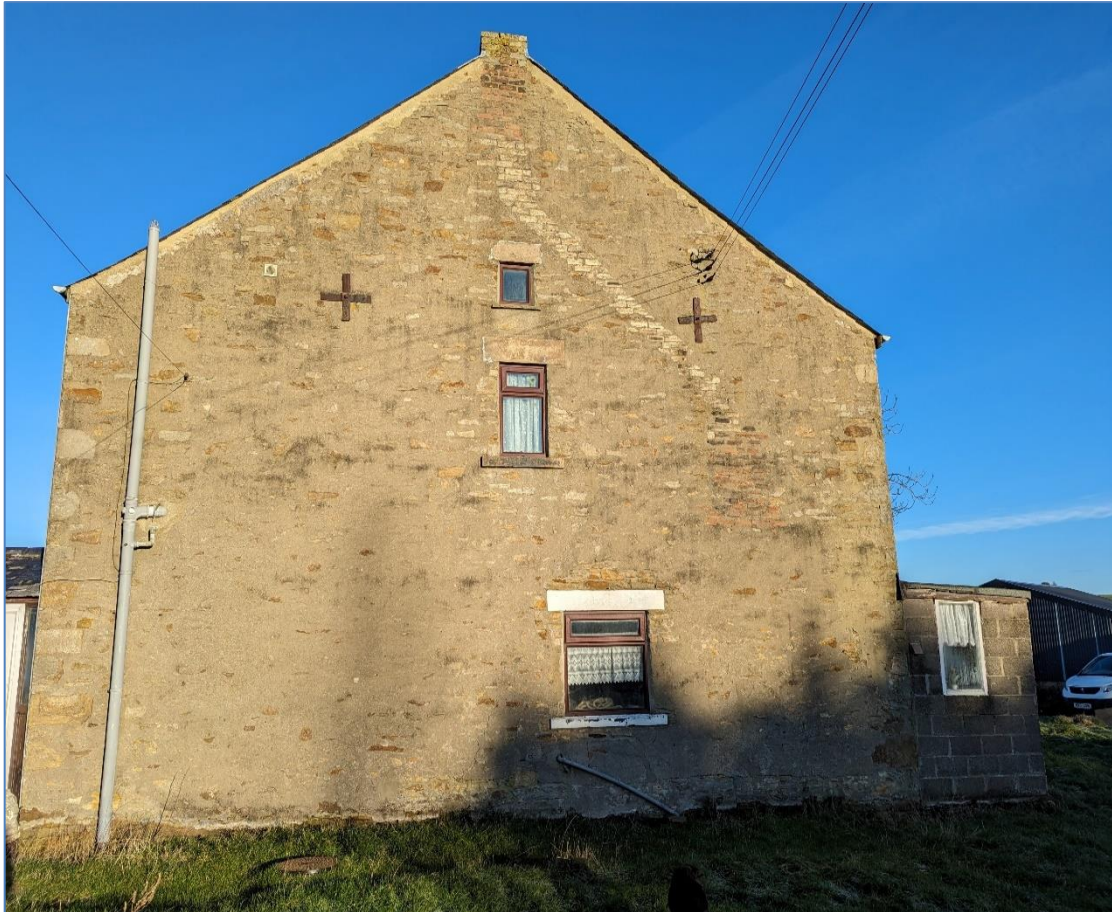
Photograph 3 – South gable mostly rendered and good pointing underneath roof slates.

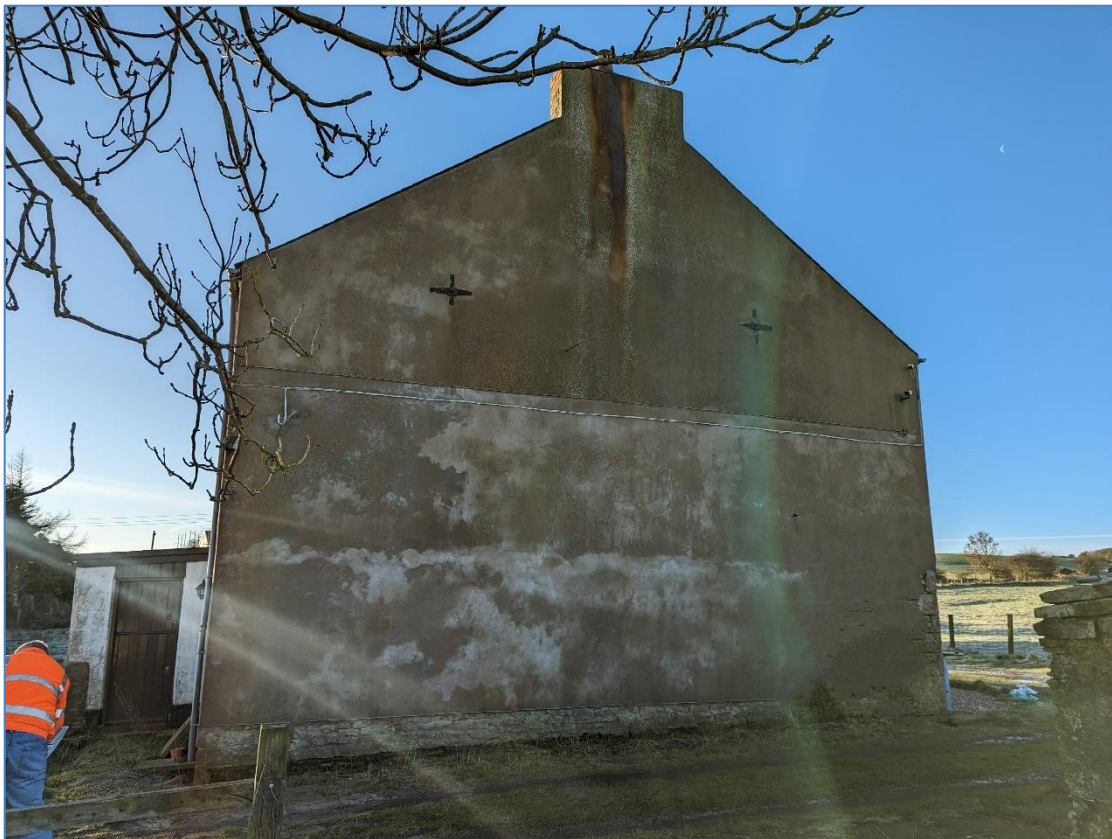
Photograph 4 – North gable rendering.

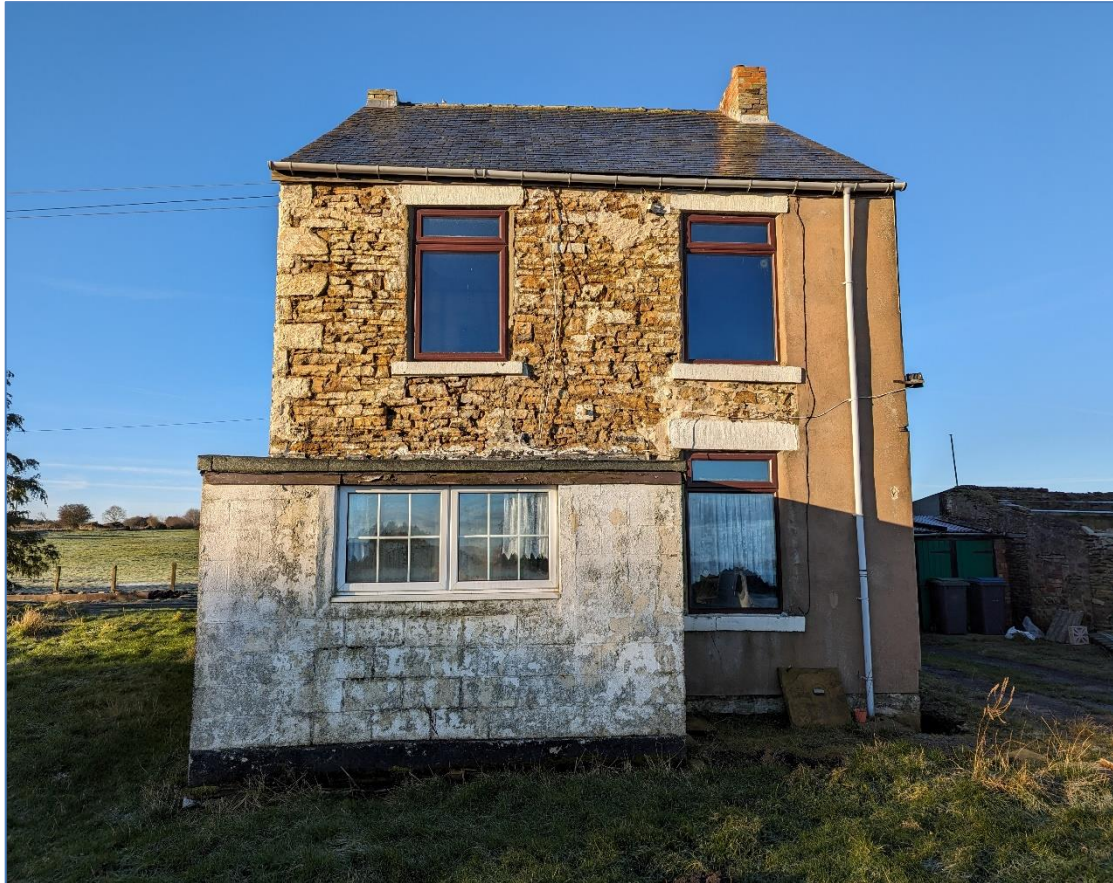
Photograph 5 – East elevation with single-storey extension.

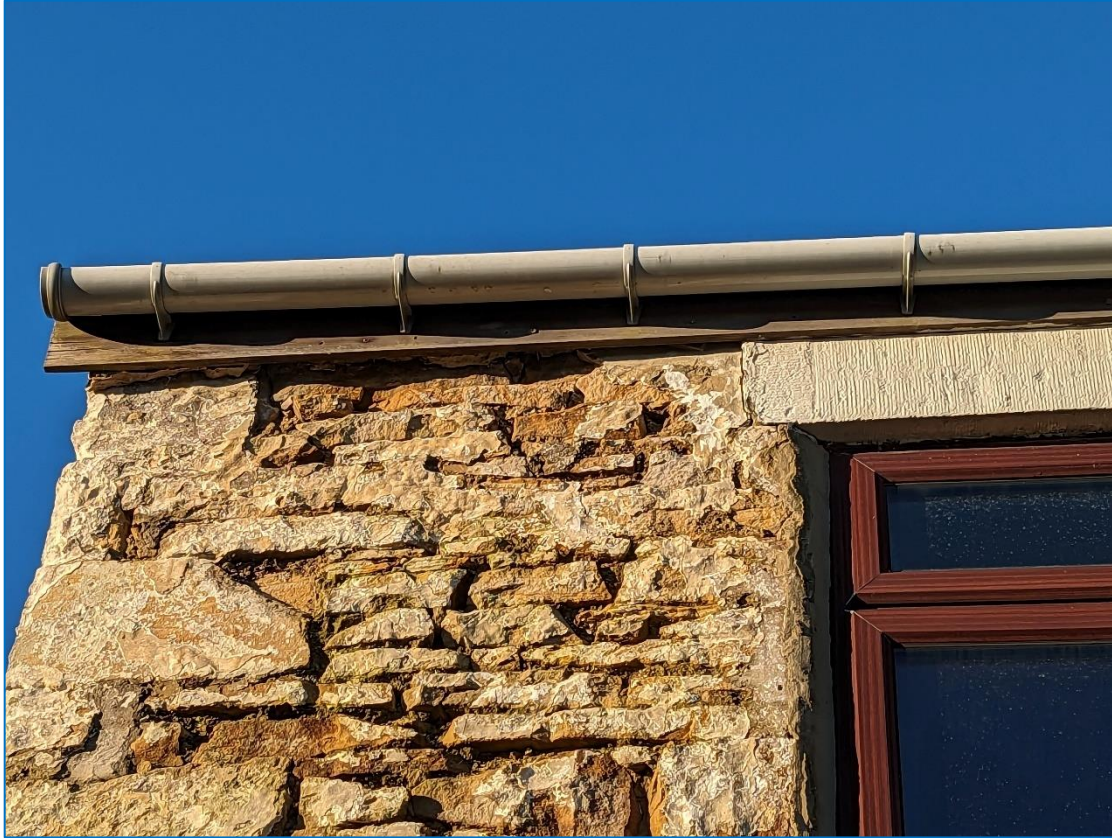
Photograph 6 – Gaps under east elevation fascia boards.

4.2.2 The building roof was well sealed in terms of exterior gable end pointing but not well sealed around the east and west elevation guttering fascia boards. There were also gaps present among the roof void stone work on the north gable. The gaps behind the east and west elevation fascia boards could provide access to the gaps present among the roof void stone work. There was no evidence, internally or externally, that bats were using the buildings as a roost.

5.0.1 The works to demolish the building will not be undertaken during the hibernation period of November to March inclusive.

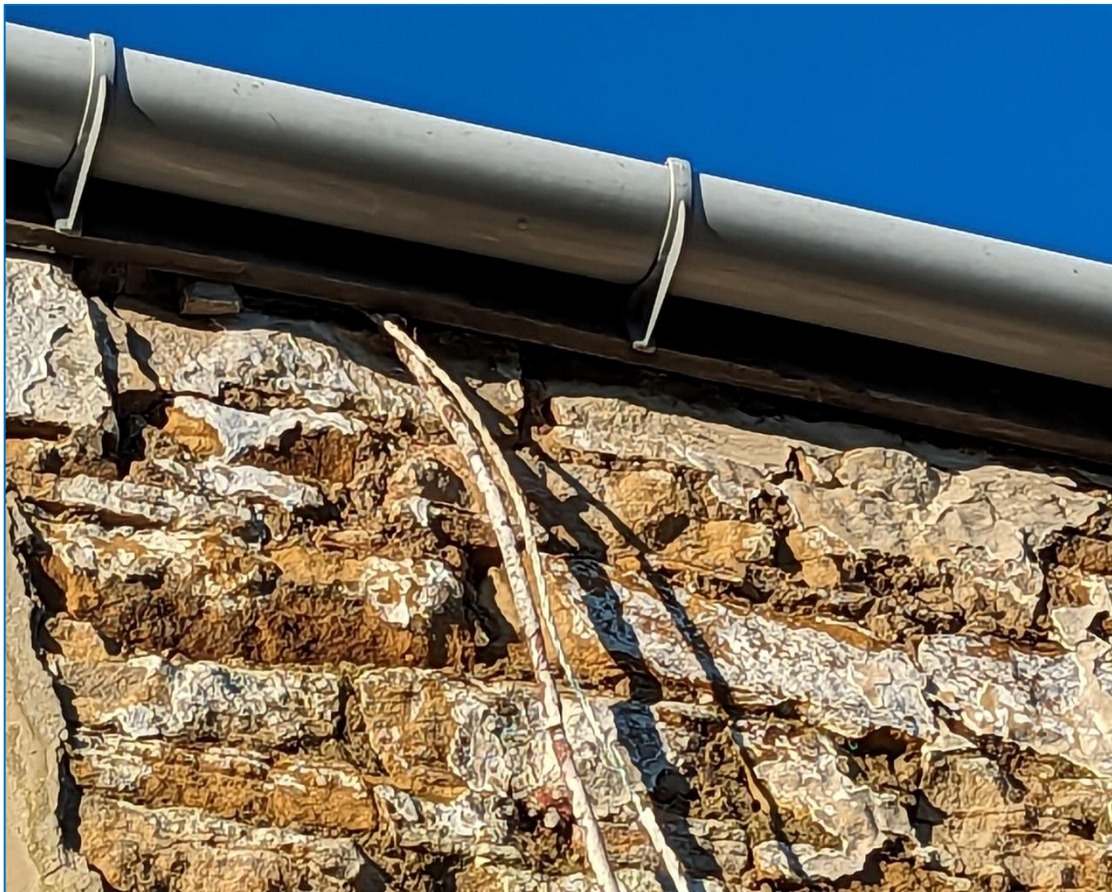
Photograph 7 – More gaps under east elevation fascia boards.

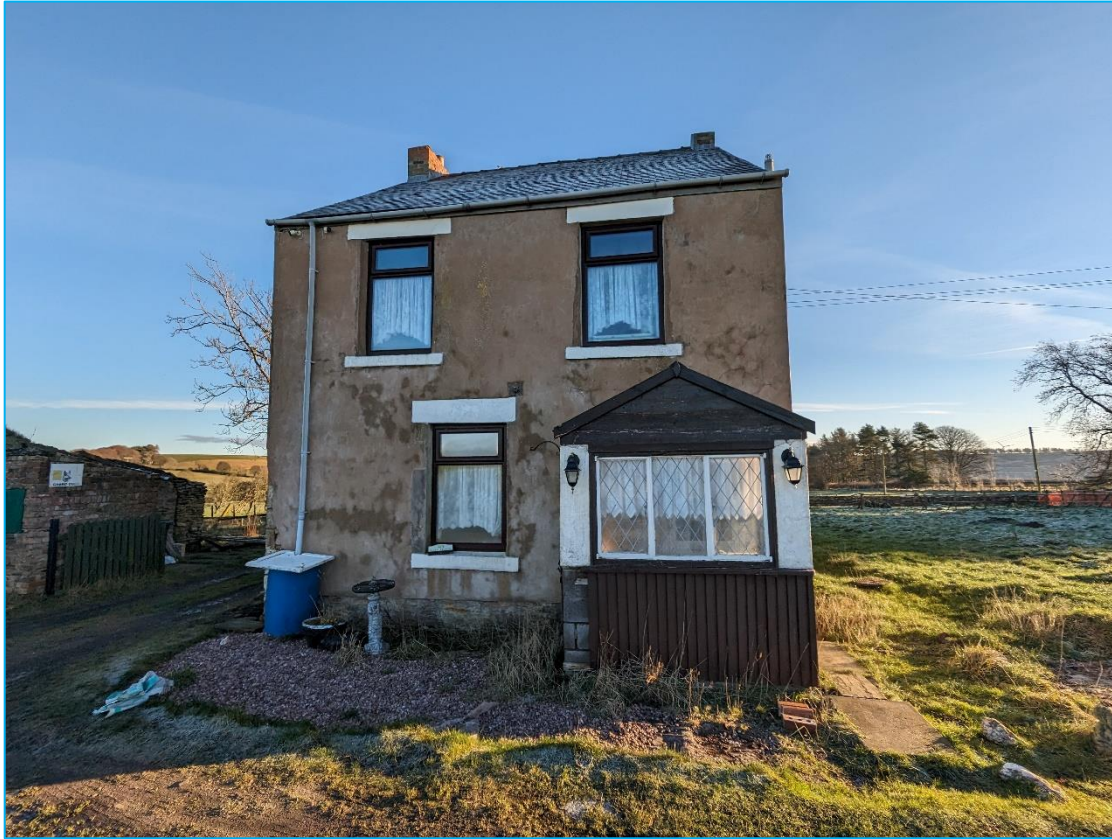
Photograph 8 – West elevation with single-storey, pitched roof extension.

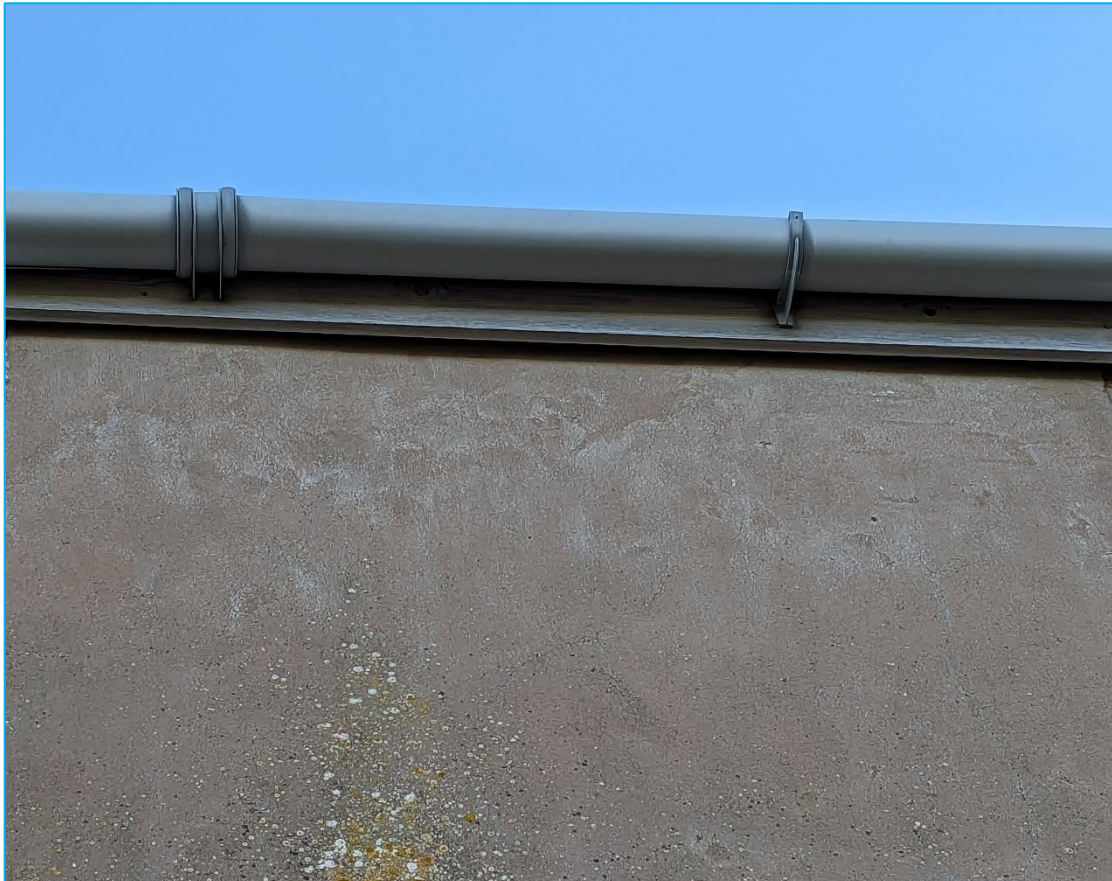
Photograph 9 – Gaps under west elevation fascia boards.

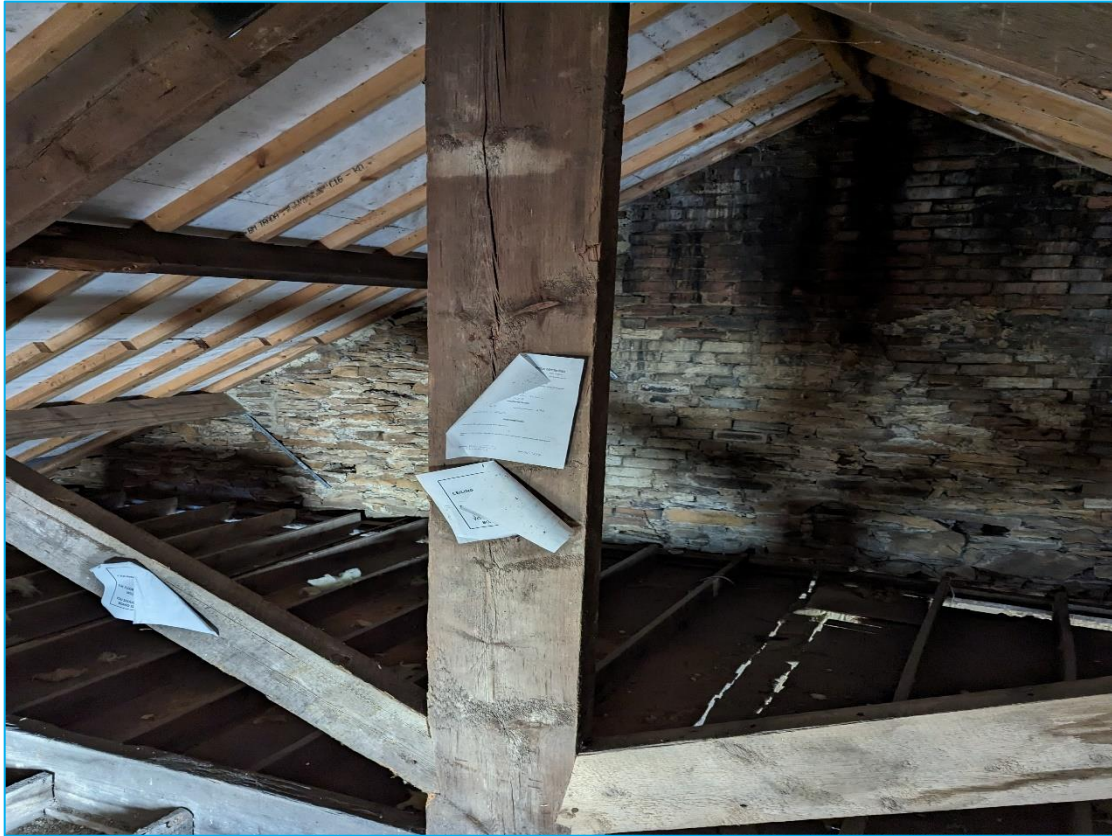
3.4.4 Internally, the building is not currently being used as a residential property and is partially dismantled (Photograph 1). The roof void has a king post, purlin and rafter construction and the gable ends are well sealed on the inside (Photograph 10). The back of the slate roof was well covered by a breathable membrane and lots of cobwebs were visible on the purlins and rafters (Photograph 11). Gaps were visible inside the roof void on the inside of the

Photograph 10 – King post roof void and inside of south gable.

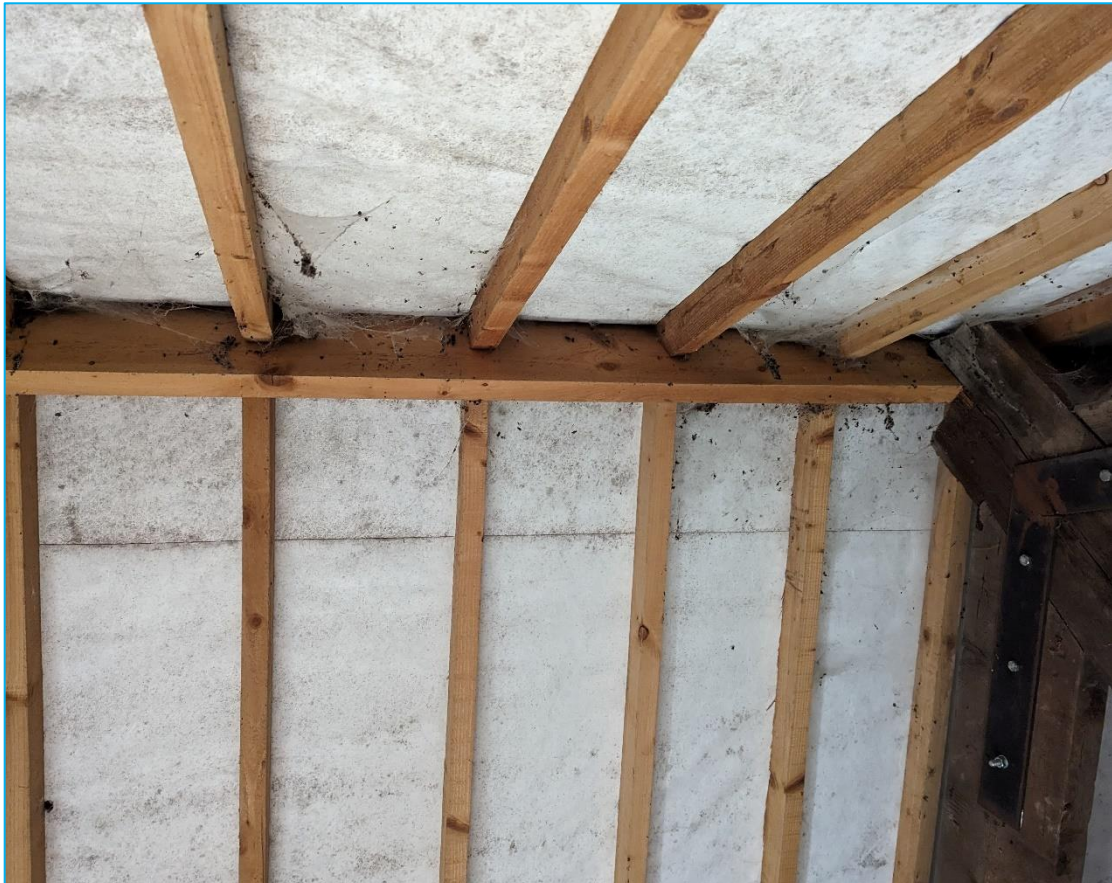
Photograph 11 – Breathable slate roof lining and cobwebs in roof void.

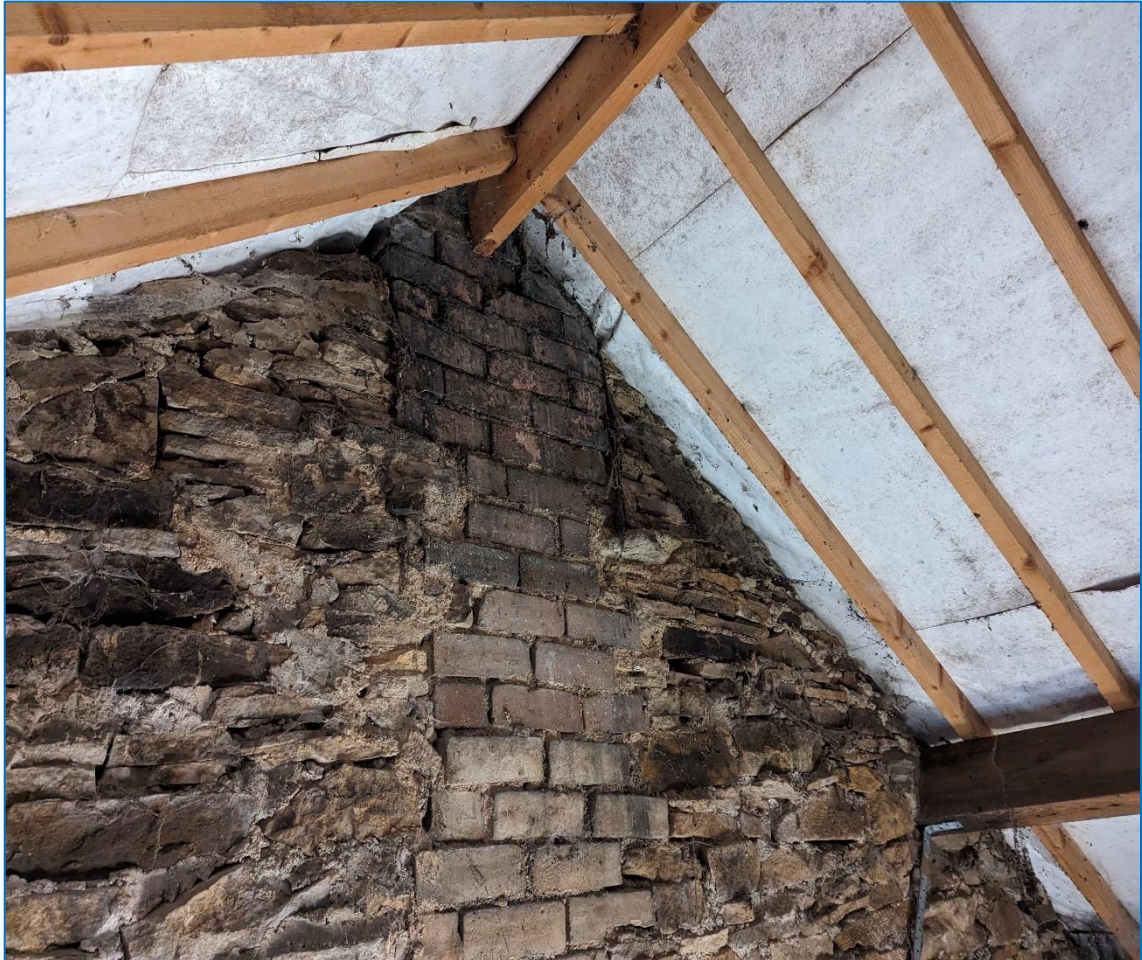
north gable stone work (Photograph 12). There was no evidence of use by bats, such as droppings, fur-oil staining, scratch marks, squeaking, feeding remains or live or dead bats.

Photograph 12 – Gaps on inside of north gable stone work.

5.0.2 The works to remove and demolish the stone work at the upper level, the roof void, will be done by hand and with extreme care in the event that non-hibernating bats are roosting in the gaps. Stones around gaps will be carefully removed and checked for bats before being discarded. New exposed surfaces will be checked carefully for bats as the works progress. If bats are found at any time during the works, the emergency procedures below (para 5.0.3) will be followed.
