**STRUCTURE ONLY
BUILDING SURVEY REPORT**

**LARK HOUSE
CORNSAY
DH7 9EP**

Our Ref: H/K/S2208062-report

7 October 2022

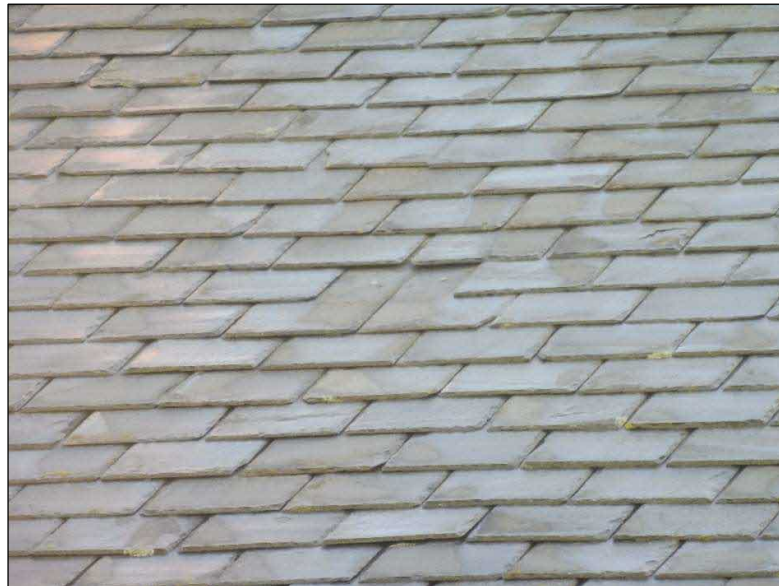
Photograph 2

B1.2 In an exposed location, ridge tiles should be mechanically fixed into position to help resist wind damage, along with the verge slates. An isolated slate was missing to the front slope, most likely a result of wind damage.

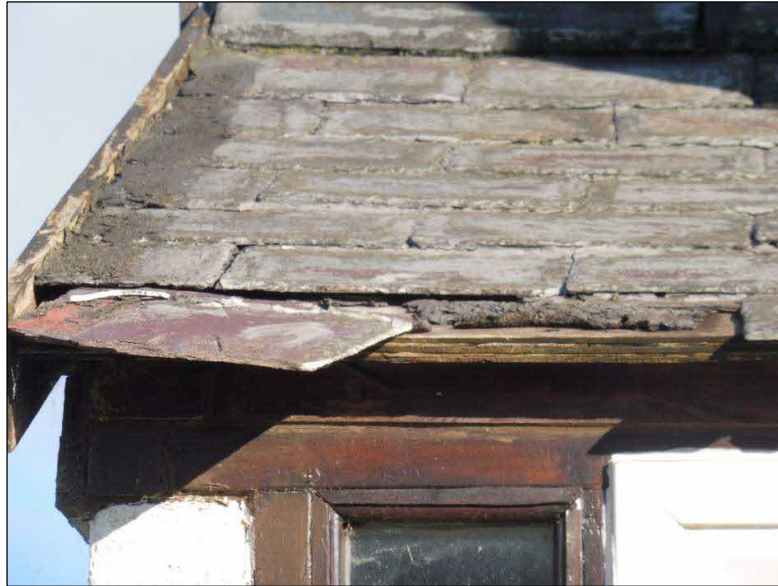
Photograph 3

B1.4 The front porch incorporates a small dual pitched roof covered in natural slate. This is in very poor condition. Evidence suggests the slates are held in place in part with bitumen applied over plywood. This is an unusual very poor form of fixing and will have a limited effective life.
