# SOAKAWAY TEST REPORT

## SURFACE WATER

**Fursdon House, Blunts Lane,  
Plymouth, Devon, PL6 8BE**

<b>Recipient:</b>	Mr Angus Fraser
<b>Project:</b>	Fursdon House, Blunts Lane, Plymouth, Devon, PL6 8BE
<b>Report Title:</b>	Soakaway Test Report - Surface Water
<b>Report Number:</b>	STG1413 – STR – 01
<b>Report Author:</b>	Simon Tyrrell
<b>Report Status:</b>	FINAL
<b>Date:</b>	10 <sup>th</sup> November 2023

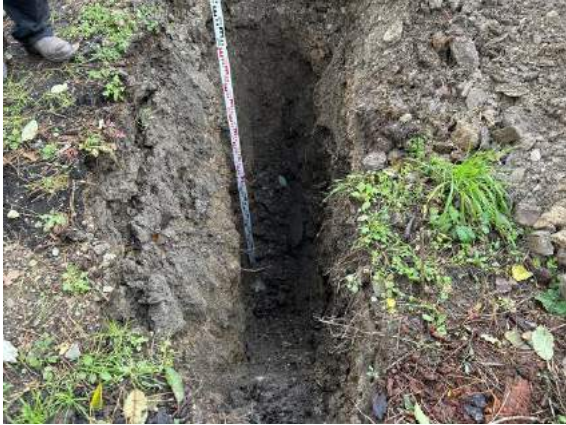
Photo 1: Completed TP01 from Face B looking 095 E

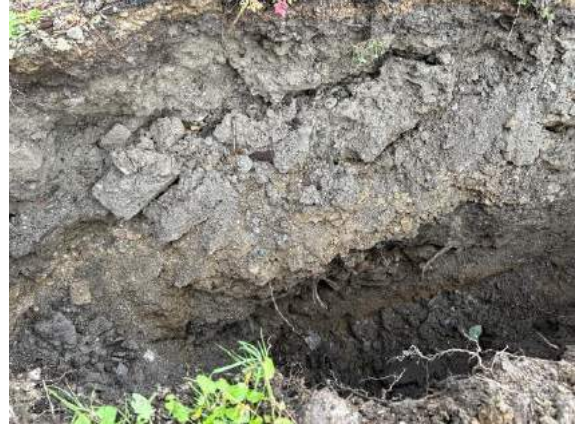
Photo 2: Completed TP01 from Face A looking 005 N

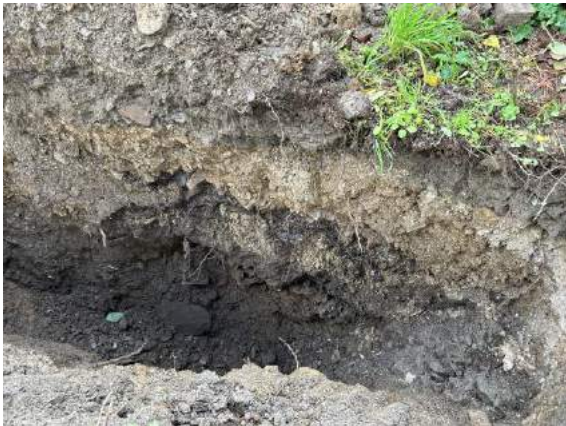
Photo 3: Completed TP01 from Face C looking 185 S

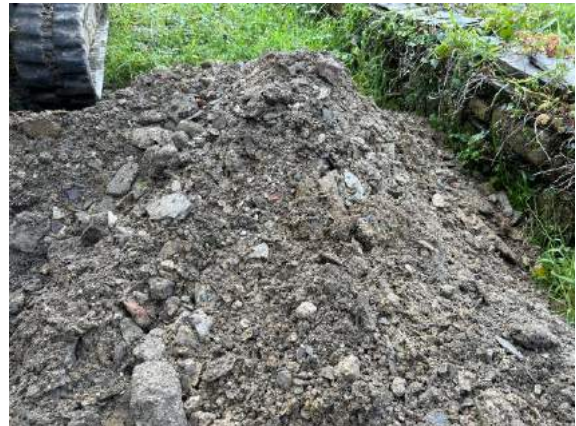
Photo 4: Spoil of TP01 (0 – 0.45m) looking 090 E

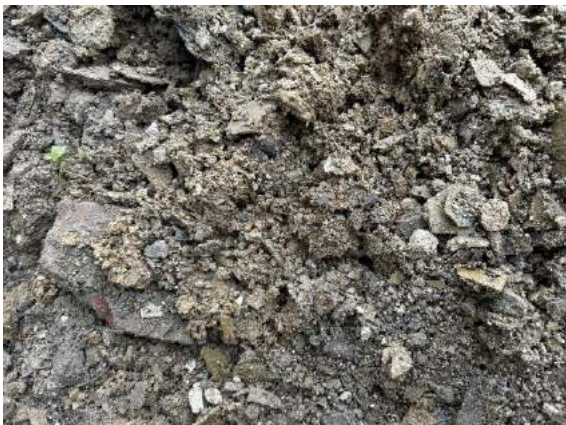
Photo 5: Spoil of TP01 (0.45 – 1.30m) looking 090 E

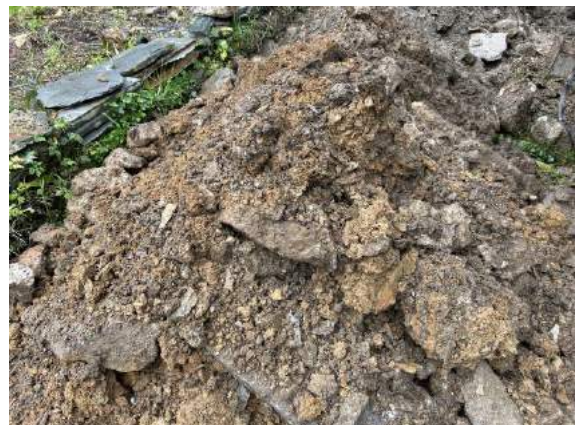
Photo 6: Spoil of TP01 (1.30 – 1.90m) looking 200 S

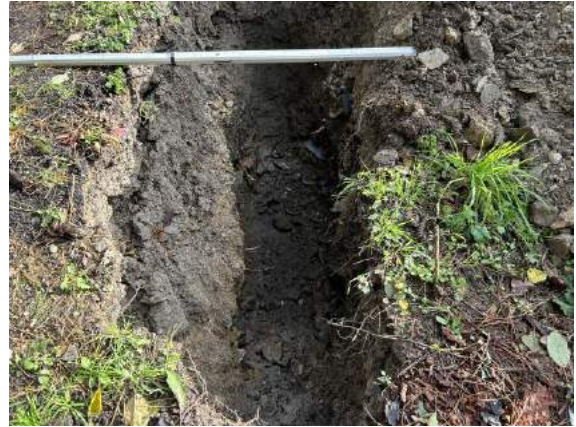
Photo 8: TP01 Test 1 completed (8 mins 15 secs) from Face B looking 095 E

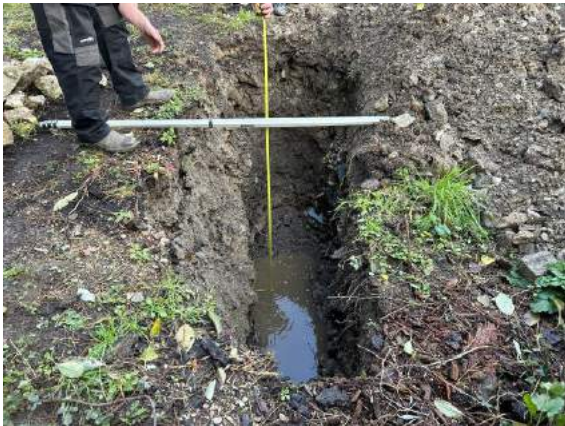
Photo 9: TP01 Test 2 in-progress (4 mins 30 secs) from Face B looking 095 E

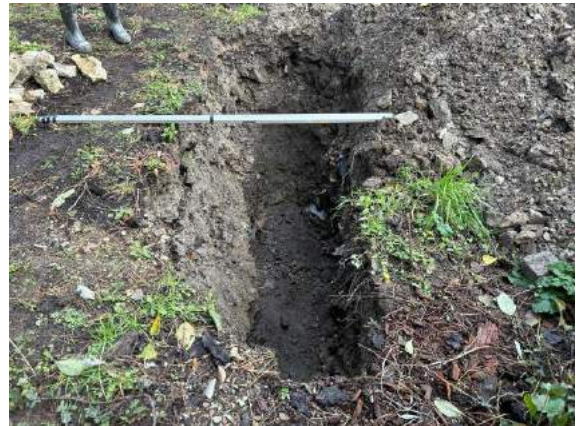
Photo 10: TP01 Test 2 completed (9 mins 42 secs) from Face B looking 250 W

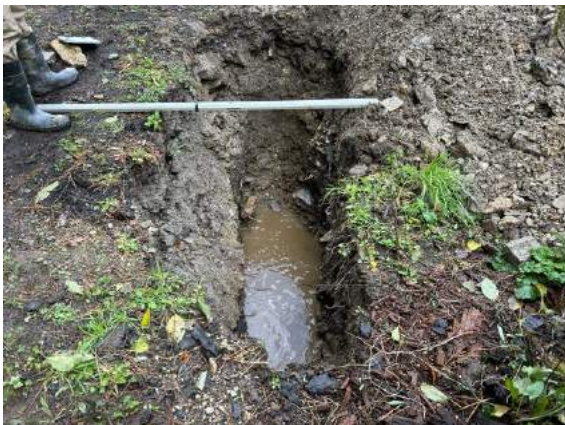
Photo 10: TP01 Test 3 in-progress (3 mins) from Face B looking 095 E

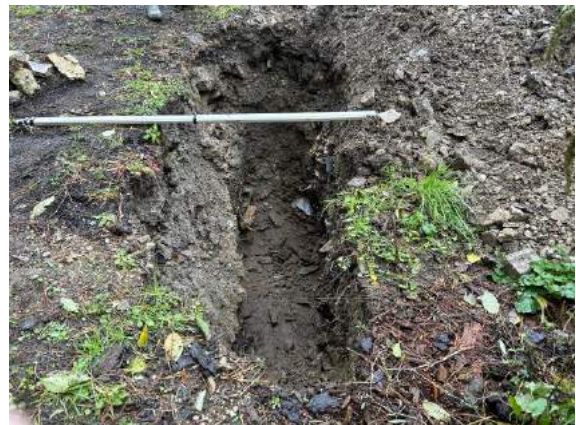
Lowest soil infiltration rate to be used for design is: **4.42 x 10<sup>-4</sup> m/s** and corresponds to Test 3.

Photo 11: TP01 Test 3 completed (12 mins) from Face B looking 095 E

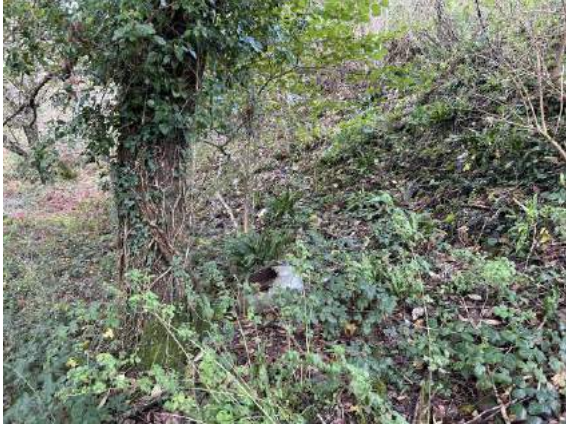
The site gradient falls  $\sim 15^\circ$  to the west corresponding to a N-S trending V-shaped valley. Consequently, to facilitate the original dwelling a prior cut and fill exercise has taken place; >2m cut in the east with material deposited in the western region creating a level lawned/garden area and a subsequent envelope of Made Ground which has steeper slope angle ( $\sim 45^\circ$ ) as shown in additional photos in Appendix C.

Photo 12: Vegetated Made Ground envelope deposited upon natural ground looking N

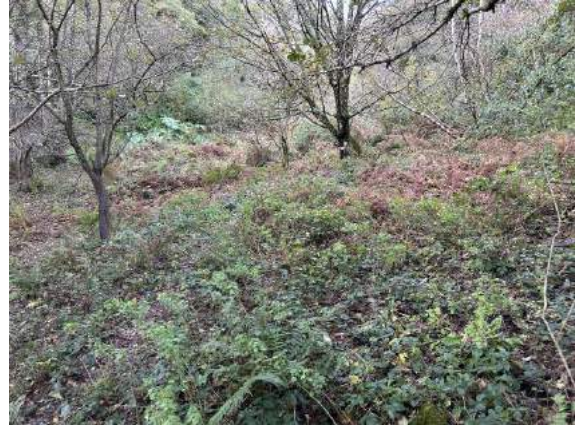
Photo 14: Natural vegetated slope/ground beyond Made Ground looking N

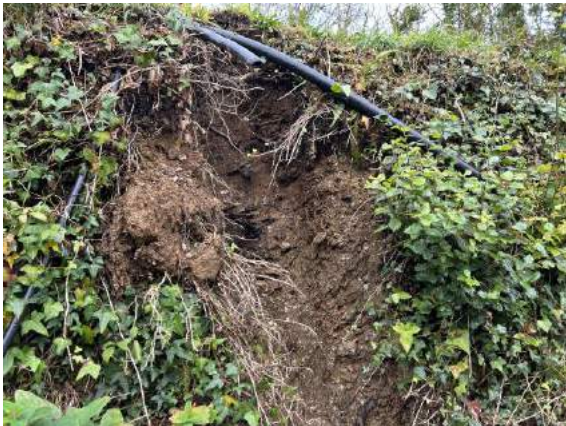
The presence of the Residual Soil was supported by an examination of the prior cut in the eastern region of the site by STG Engineering Ltd. Topsoil over orangish brown Residual Soil over weathered bedrock over bedrock was identified as shown in the additional photos in Appendix C.

Photo 13: Prior cut to the east showing Topsoil over Residual Soil looking E

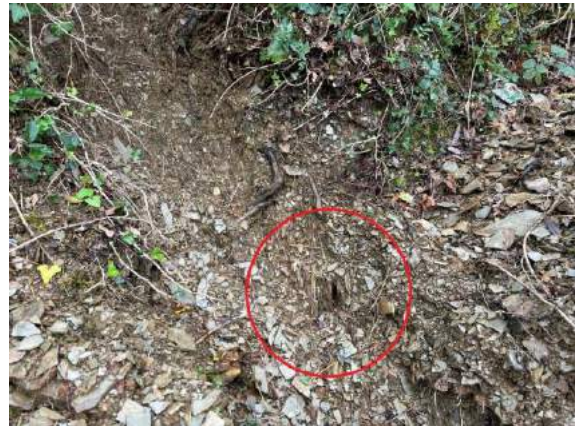
It is worth noting that a dominant fabric (bedding) was evident within the bedrock which dipped steeply (80-90°) to the NE (annotated in Photo 14) which would promote downward movement of water.

Photo 14: Prior cut to the east showing underlying weathered Bedrock over Bedrock

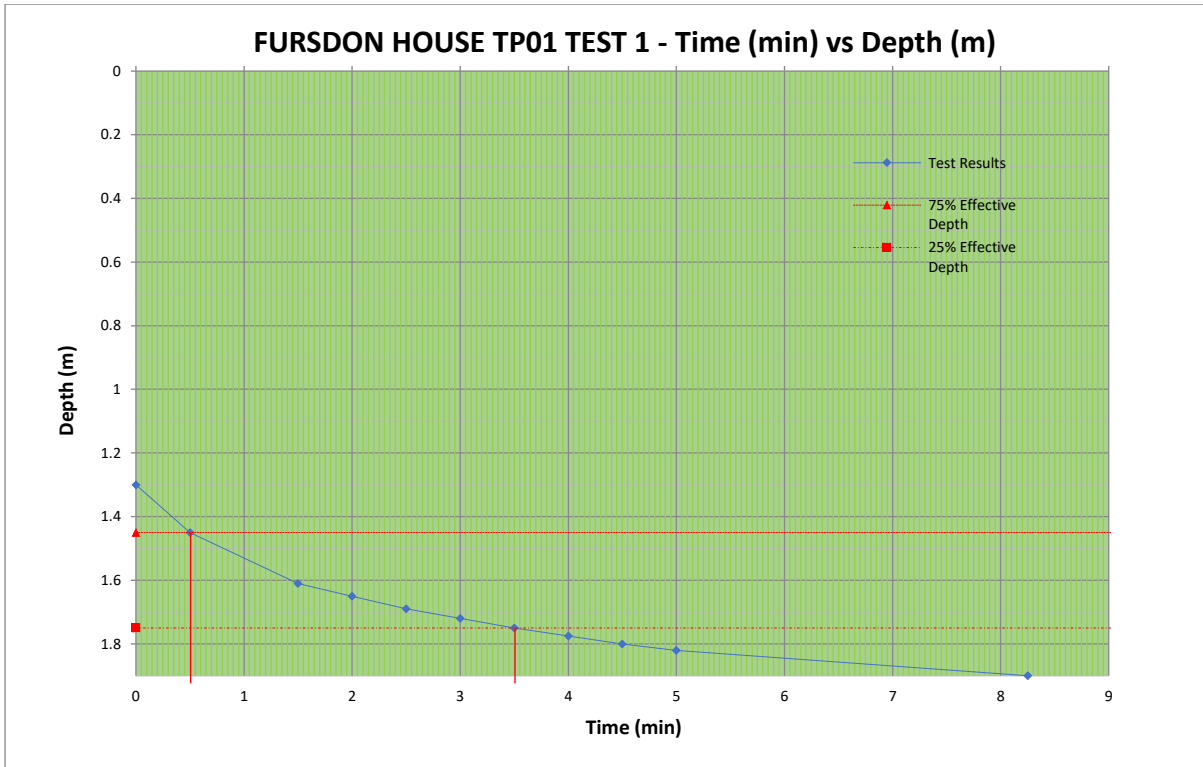
TEST 1: 75% Effective Depth Time = 0.50 mins, 25% Effective Depth Time = 3.50 mins.  $T_{p75-25}$ : 3.50 – 0.50 = 3.00 mins

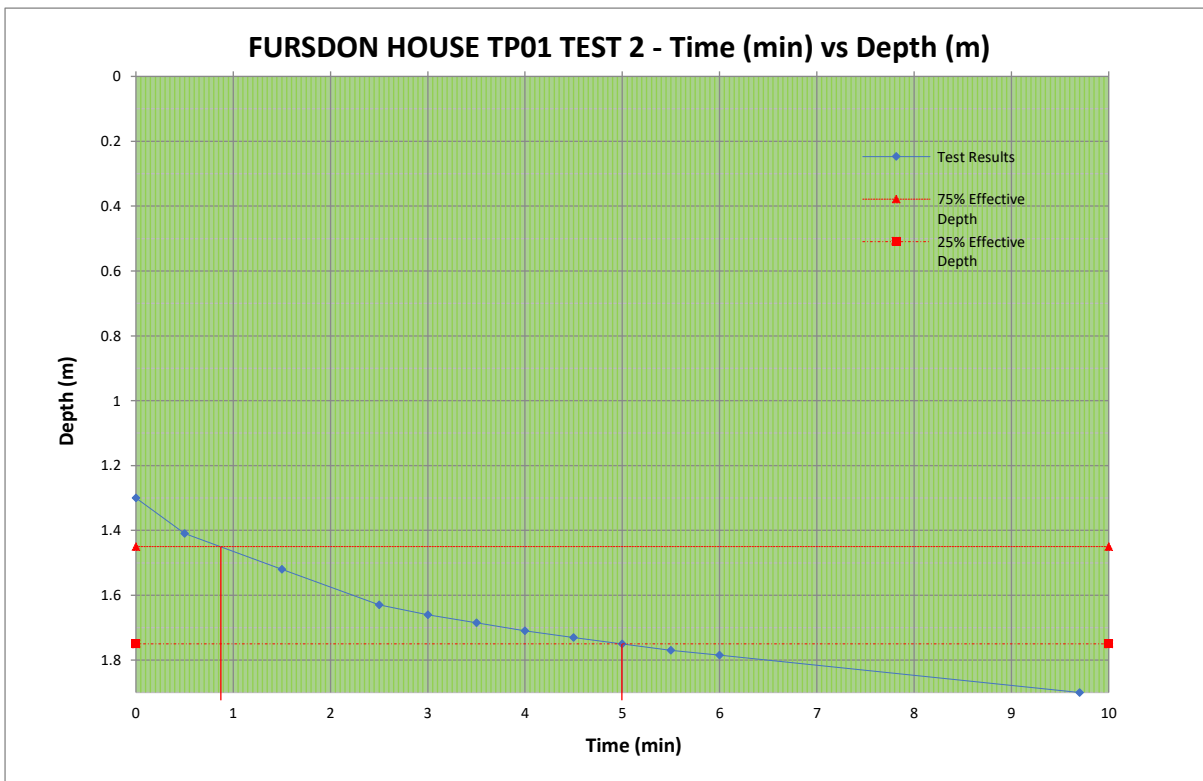
TEST 2: 75% Effective Depth Time = 0.875 mins, 25% Effective Depth Time = 5.00 mins.  $T_{p75-25}$ : 5.00 – 0.875 = 4.125 mins

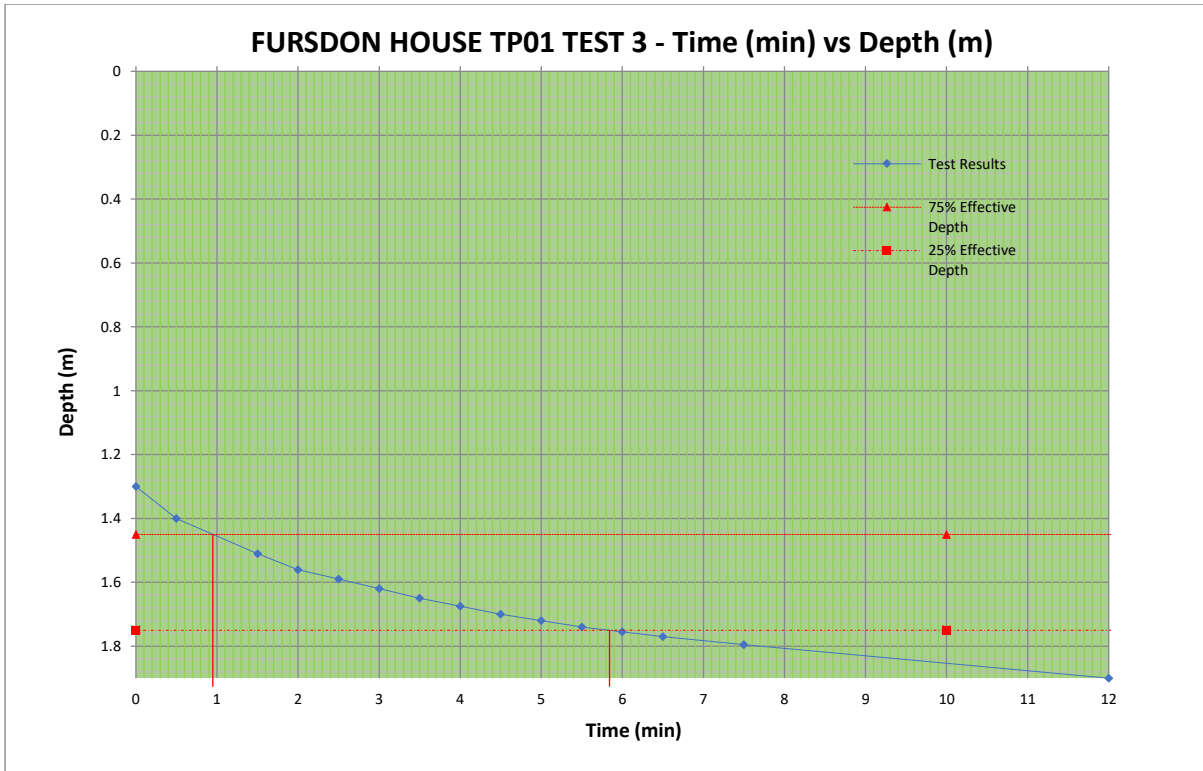
TEST 3: 75% Effective Depth Time = 0.95 mins, 25% Effective Depth Time = 5.83 mins.  $T_{0.75-25}$ : 5.83 - 0.95 = 4.88 mins
