STRUCTURAL REPORT IN RESPECT OF:

**SILVER BIRCHES
HERONSGATE
RICKMANSWORTH
WD3 5DN**

MARKS HEELEY LTD

APRIL 2023

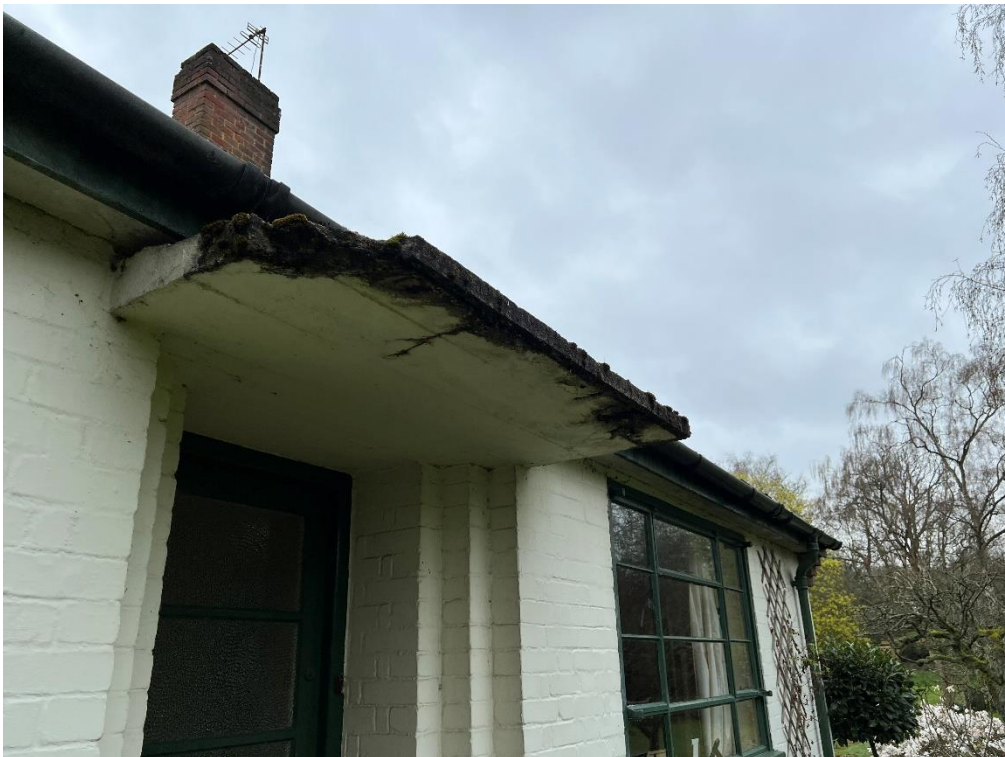
3.3.8. Remove dangerous concrete canopy, see photograph 4.

4 – DEFECTIVE CANOPY

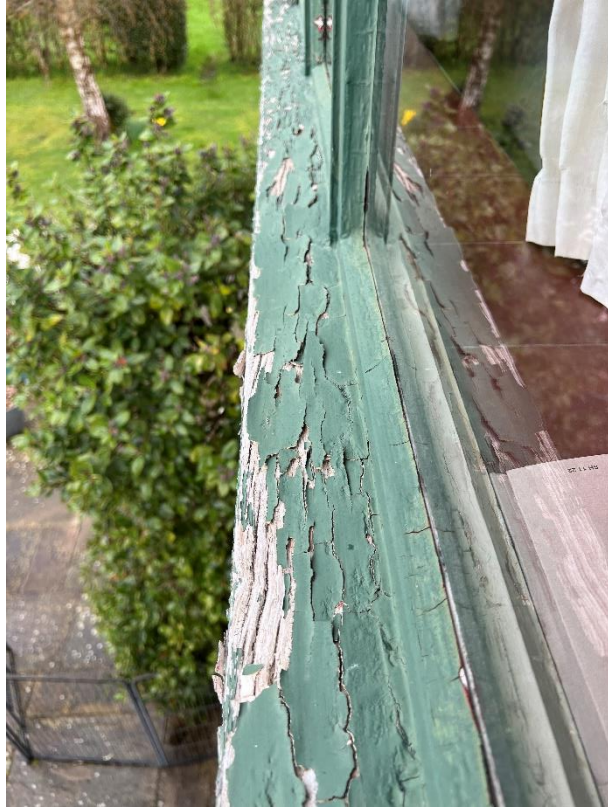
3.3.1. Extensive decay to all timber elements, see photographs 5, 6 and 9.

5 – DEFECTIVE TIMBER

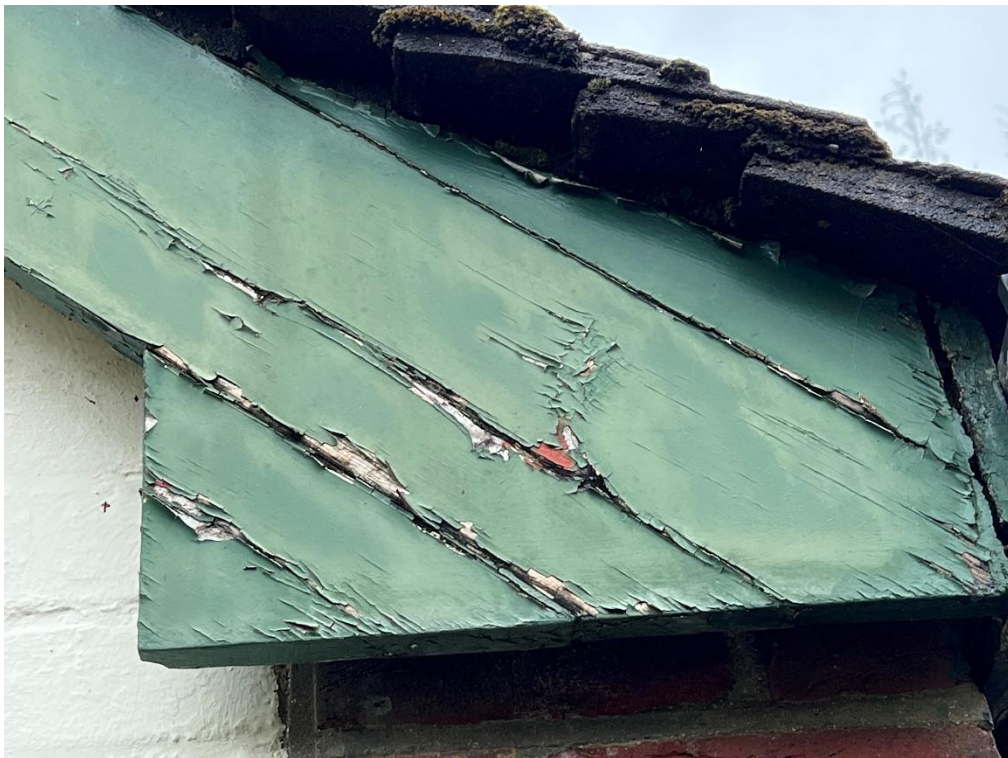
6 – DEFECTIVE TIMBER

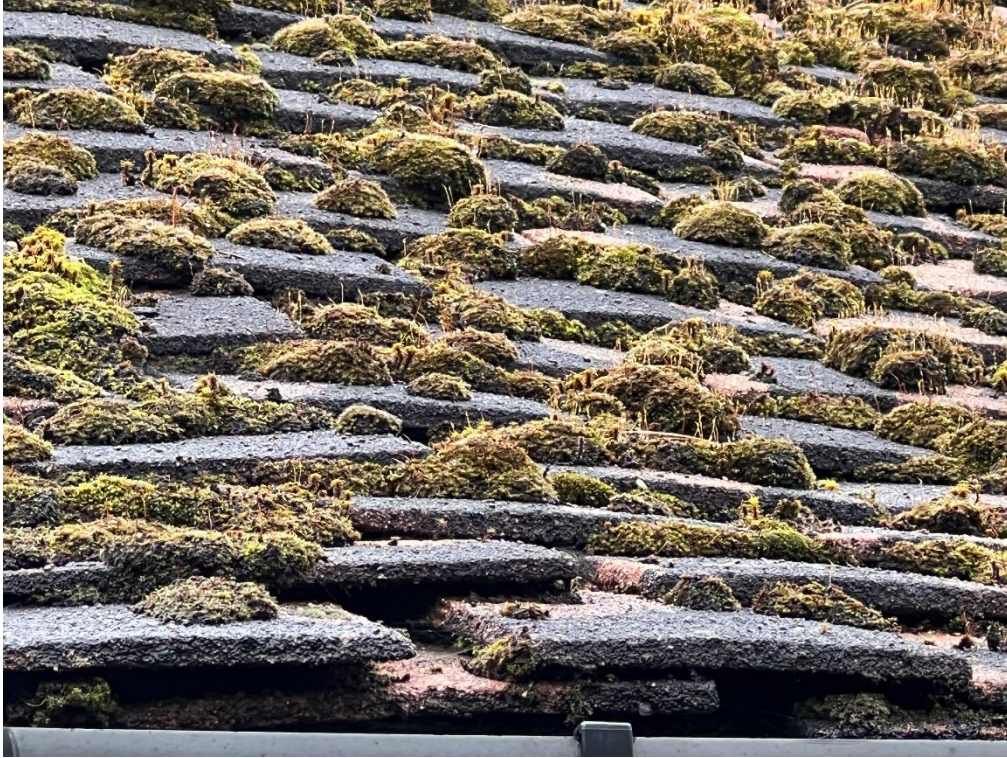
3.3.2. Eroded/broken roof tiling, see photographs 7 and 8.

7 – BROKEN/ERODED TILES

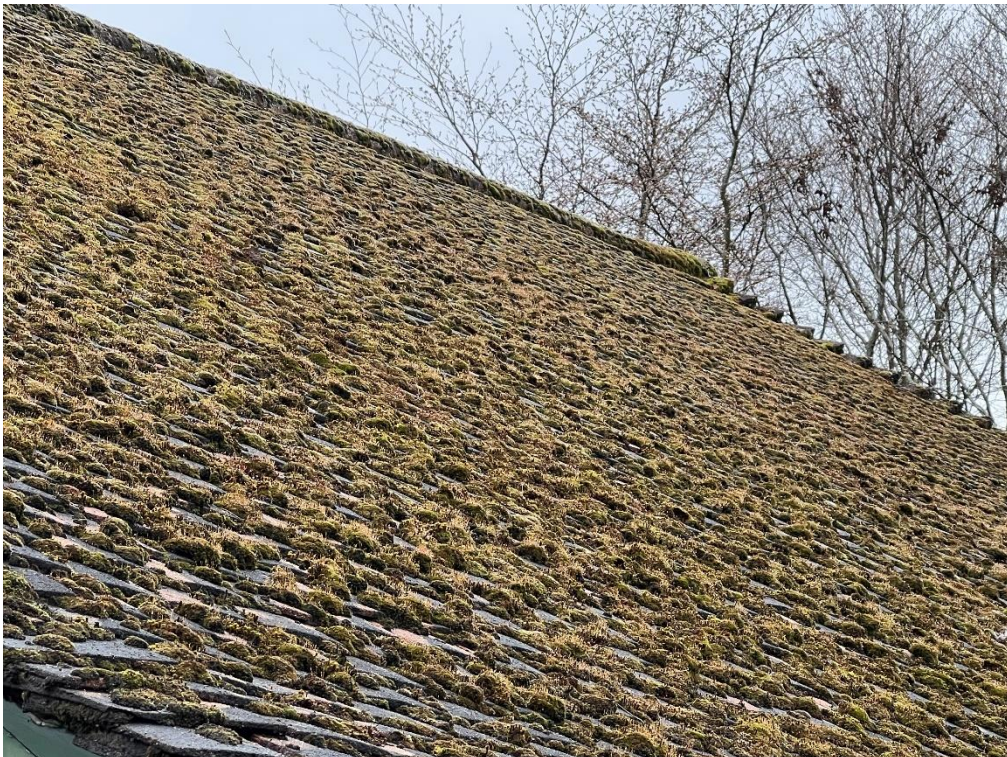
8 – ROOF DEFECTIVE

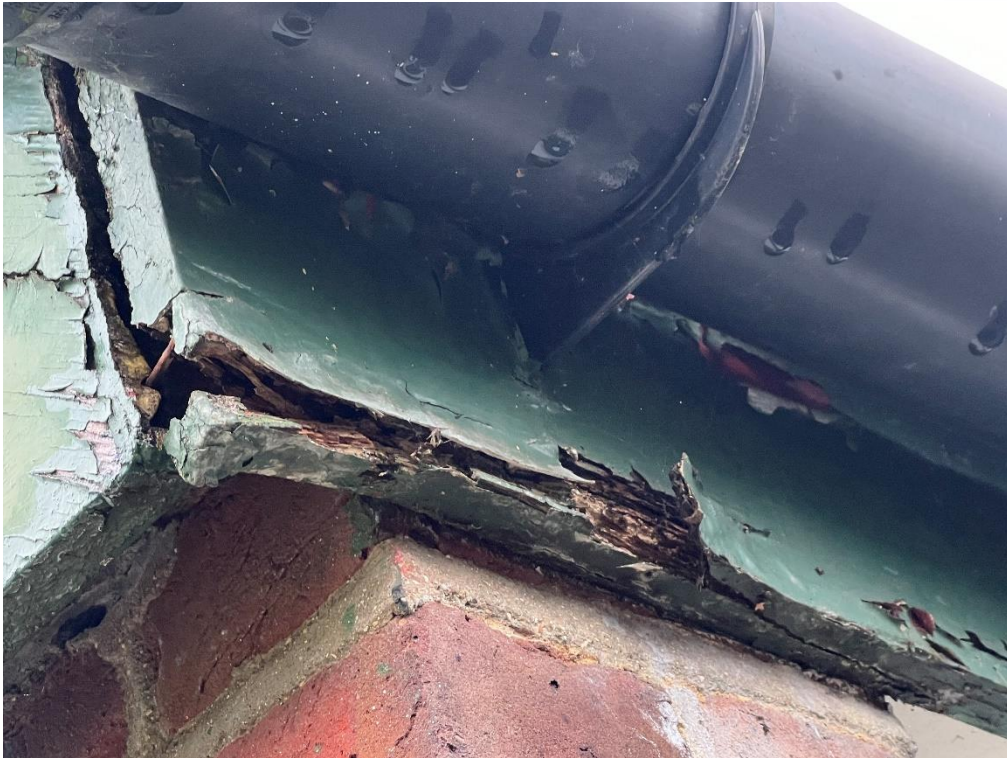
9 – DECAYED TIMBER

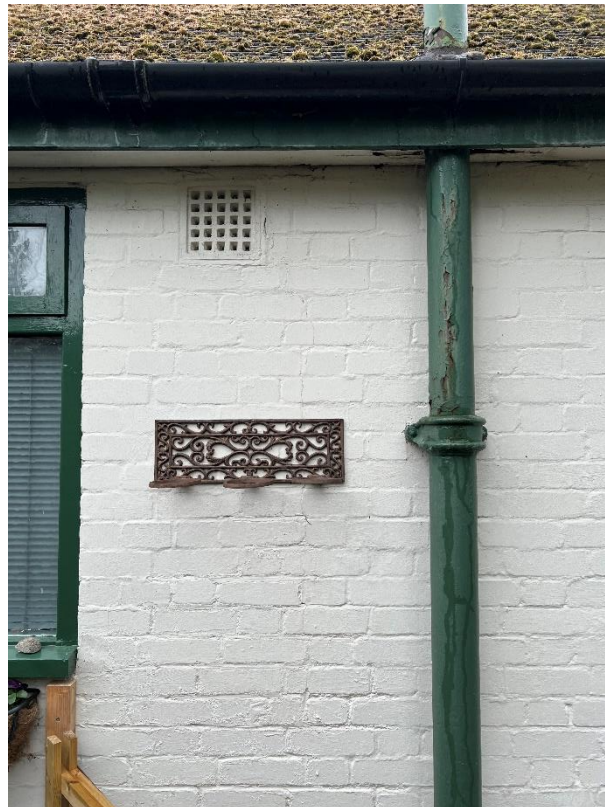
3.3.3. Corroded/defective soil stacks, see photograph 10.

10 – CORRODED SOIL STACKS

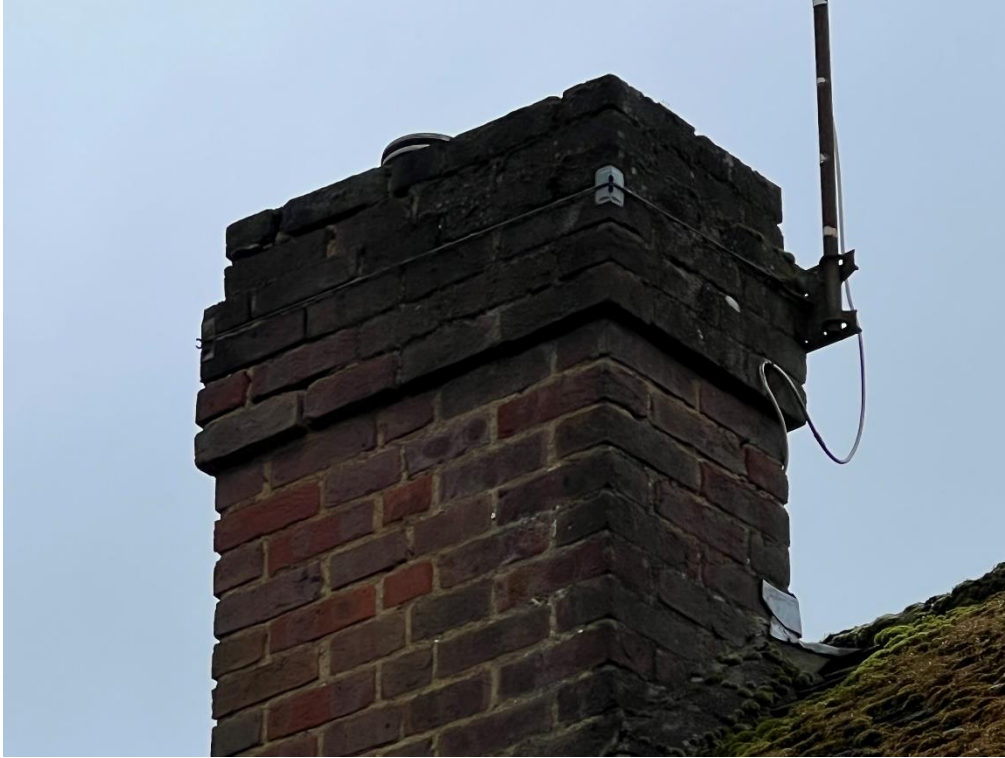
3.3.7. Chimney stack, open mortar joints, see photograph 11.

11 – ERODED BRICK JOINTS

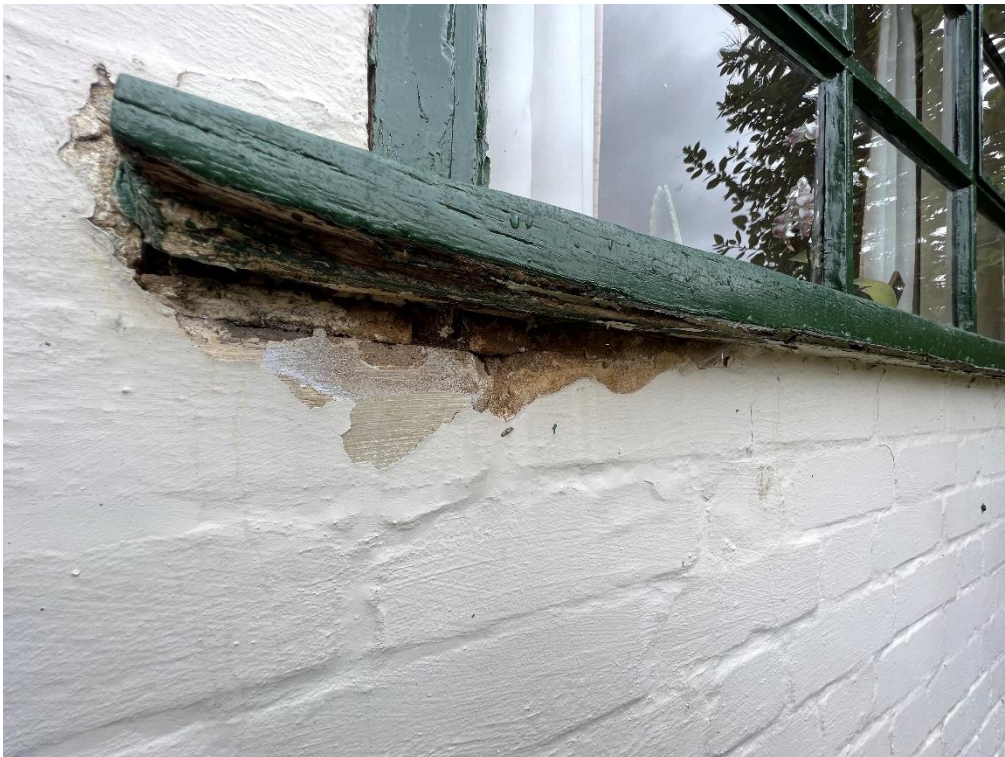
3.3.4. Defective single-glazed windows, see photograph 12.

12 – DEFECTIVE WINDOWS

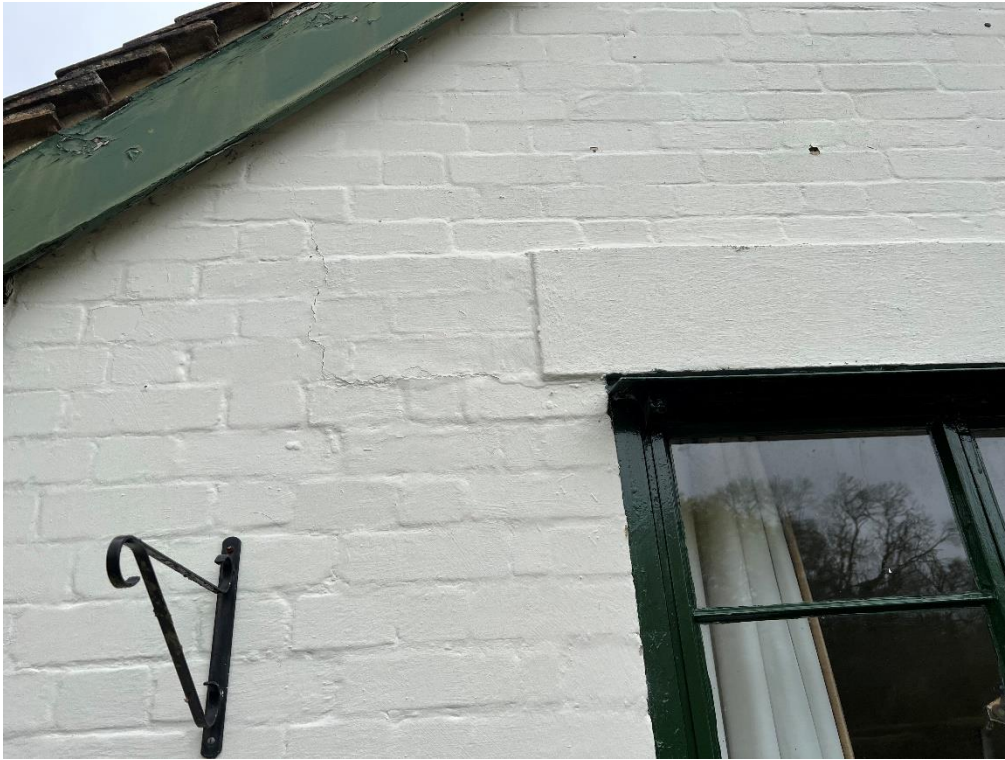
3.3.6. Wall cracks in external walls, see photographs 13 and 14.

13 – WALL CRACKING

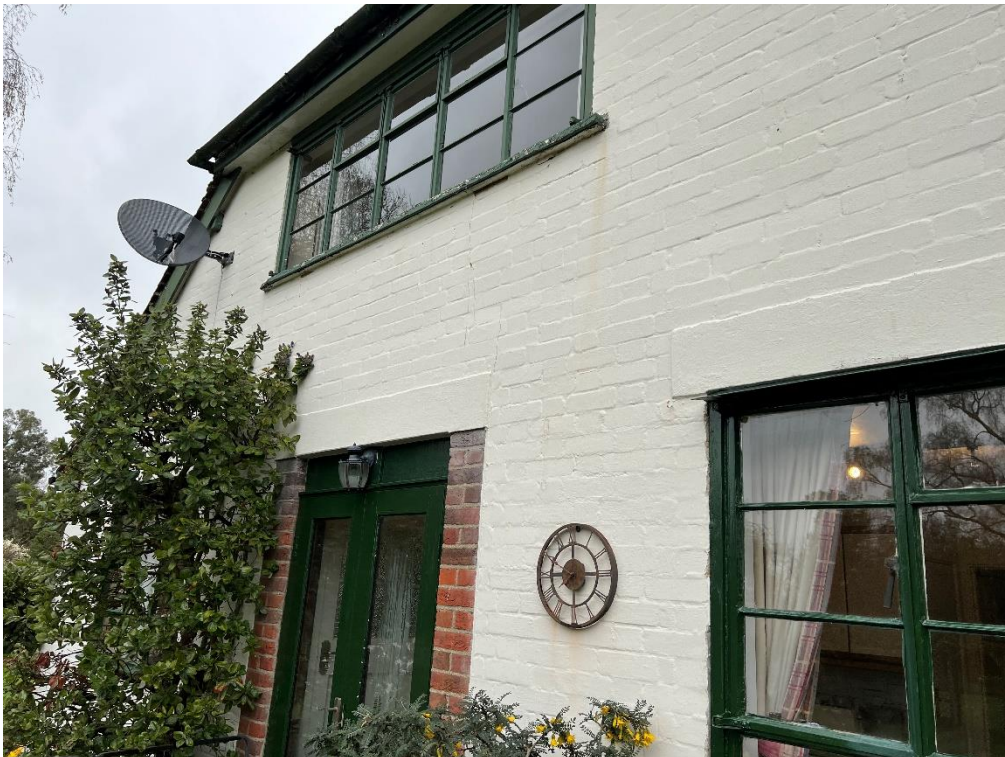
14 – WALL CRACKING

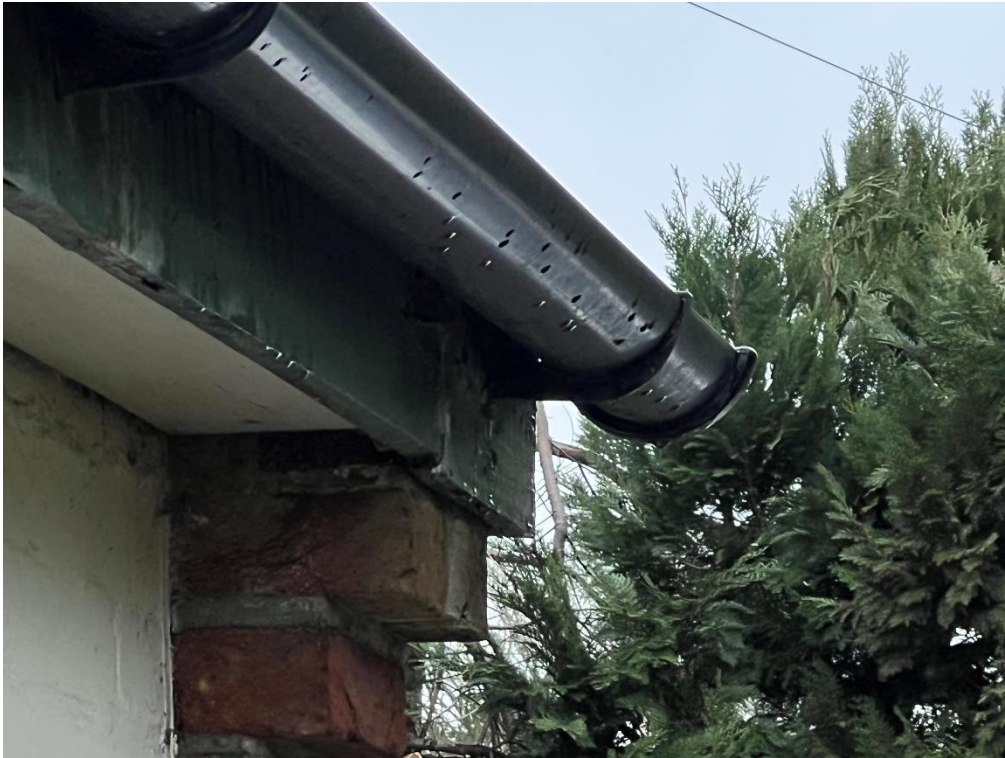
3.3.5. Defective rainwater goods, see photograph 15.

15 – DEFECTIVE RAINWATER GOODS

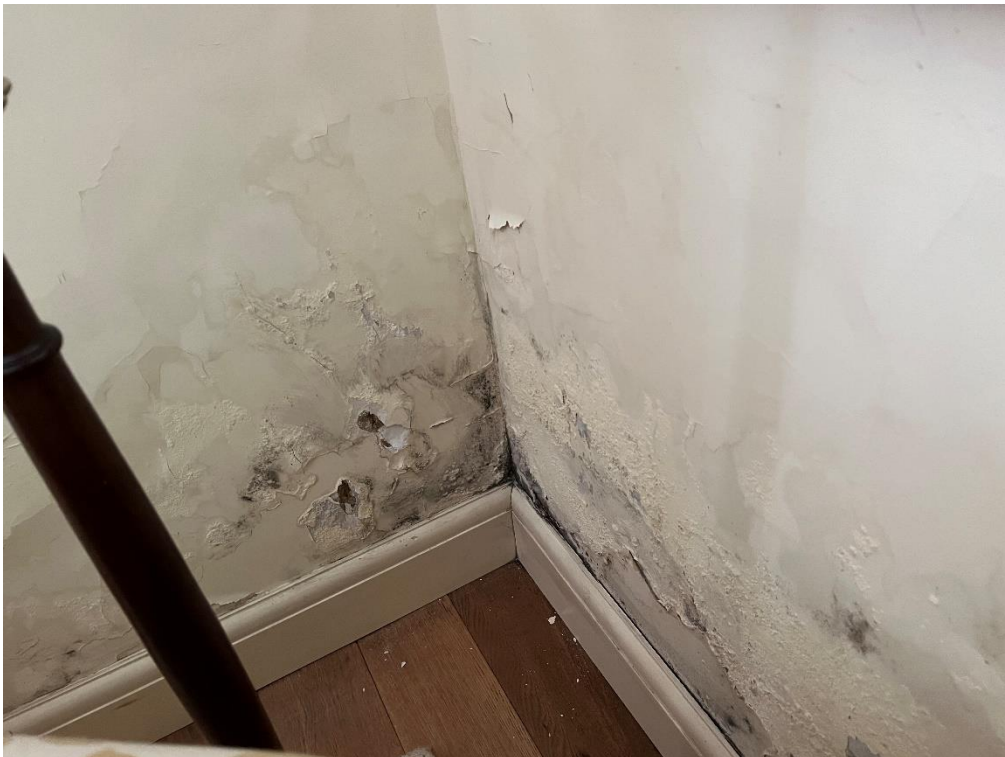
3.4.1. Evidence of defective damp course, see photographs 16 and 17.

16 – INTERNAL DAMP PENETRATION

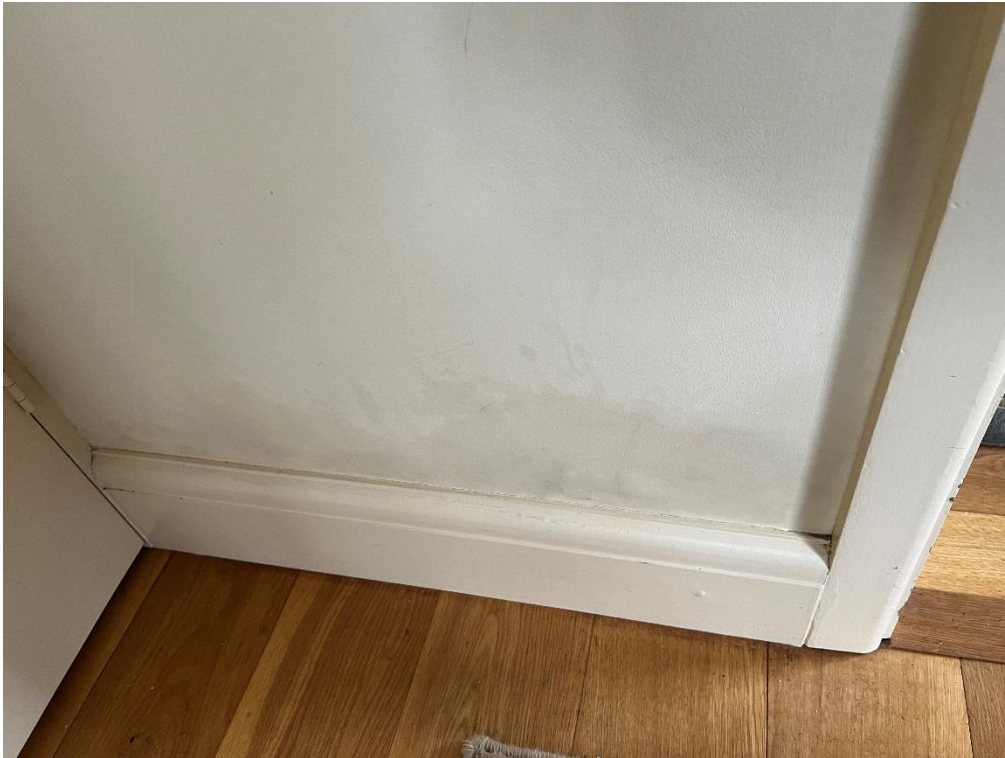
17 – INTERNAL DAMP PENETRATION

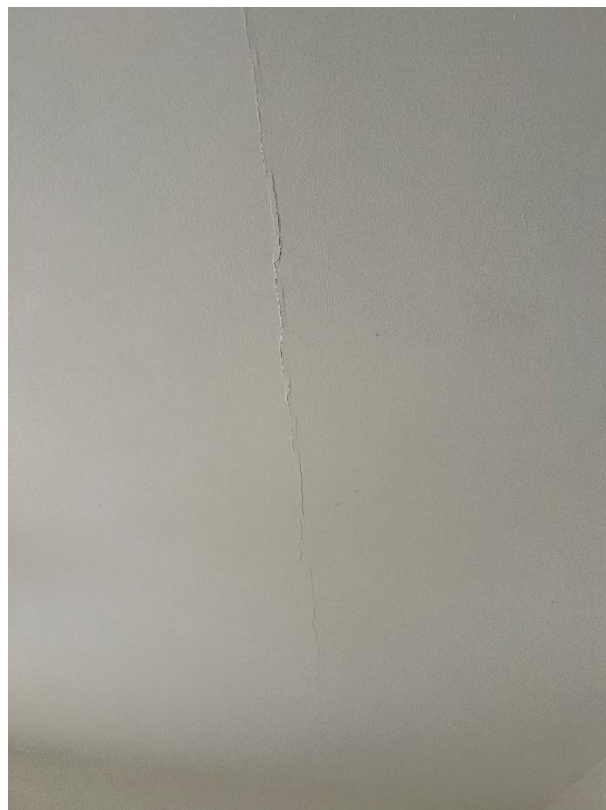
18 – CEILING CRACKS

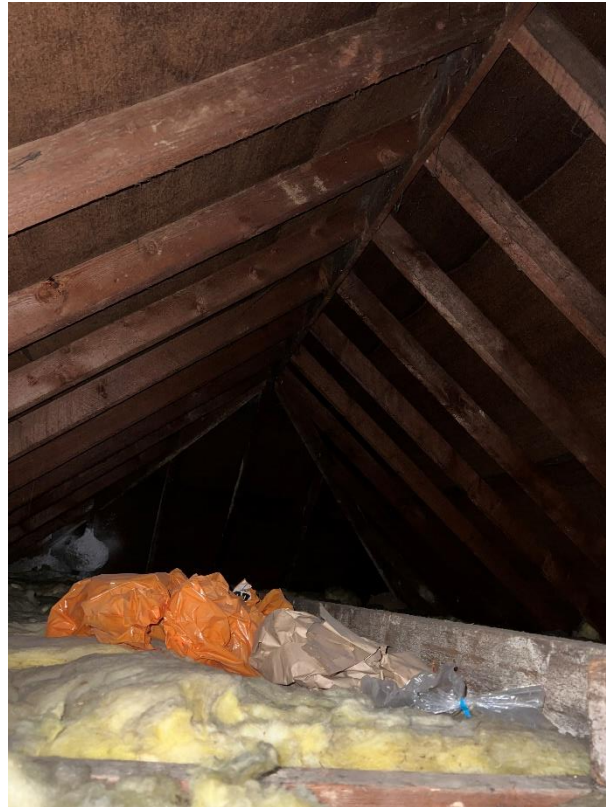
19 – ROOF TIMBERS EARLY SIGNS OF DECAYS

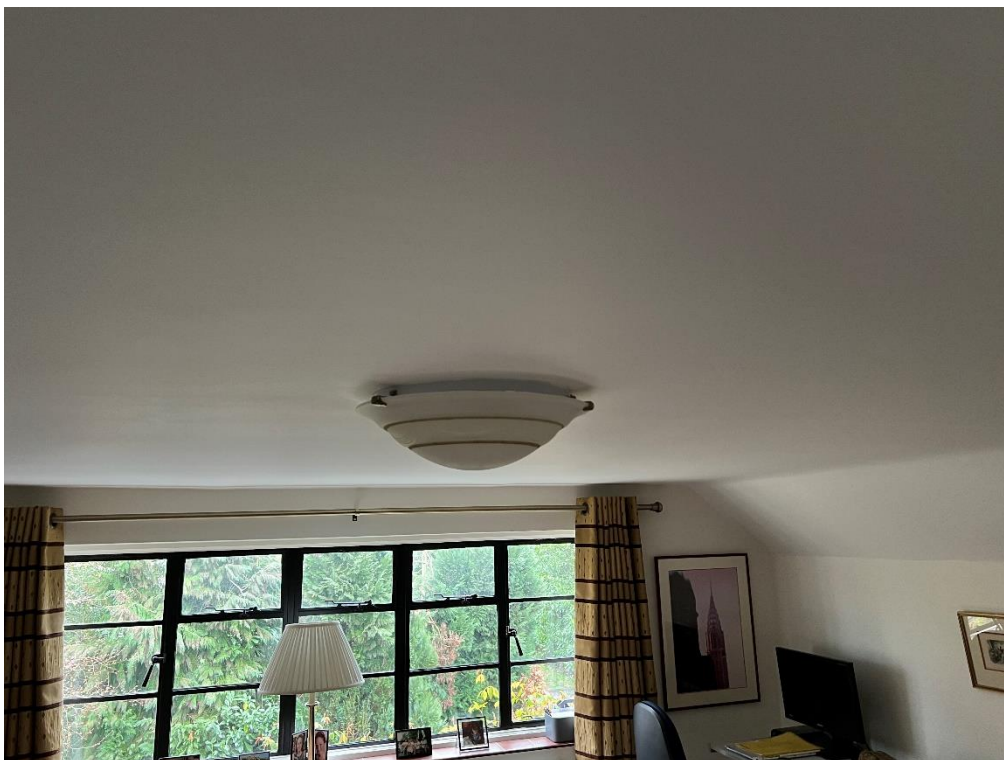
3.4.2. Cracks to ceilings at the centres of floor spans. Ceilings bowed and out of level, see photograph 20.

20 – DEFLECTED CEILING

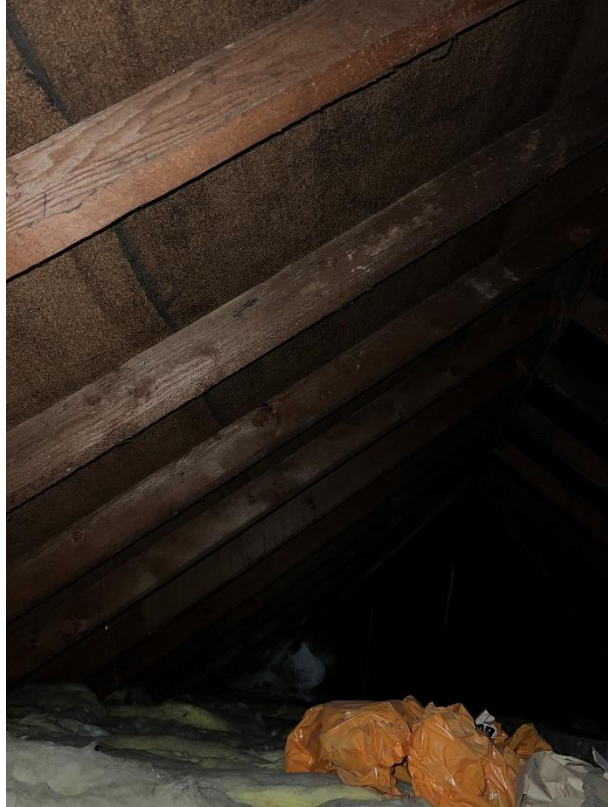
3.4.3. Roof timbers showing early signs of decay, see photographs 21 and 23.

21 – ROOF TIMBERS EARLY SIGNS OF DECAYS

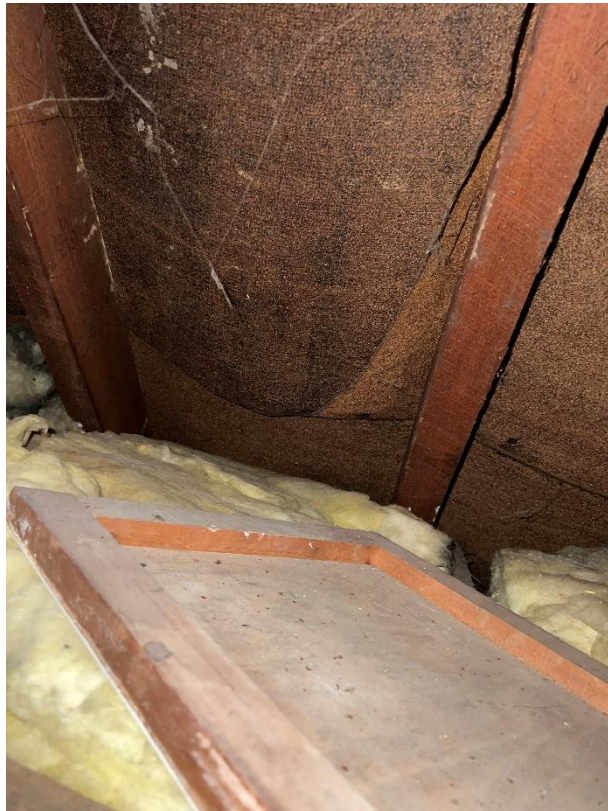
22 – UNDERSIZED RAFTERS

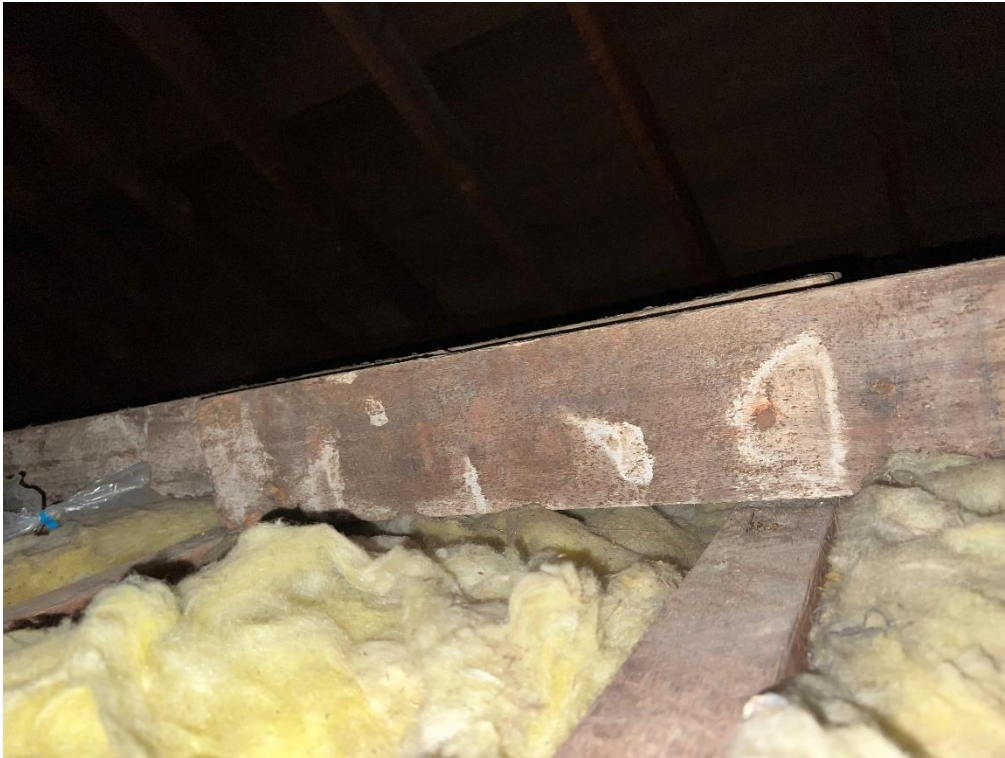
23 – ROOF TIMBERS EARLY SIGNS OF DECAYS

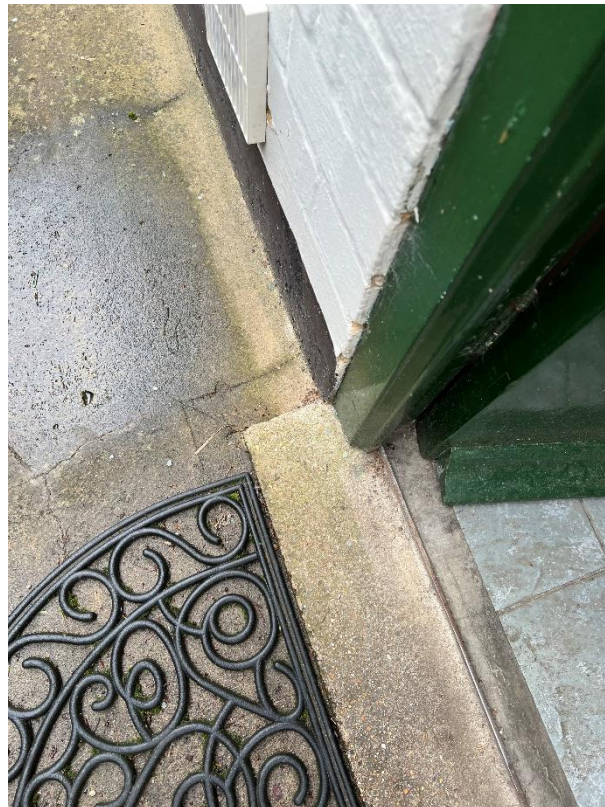
3.4.5. No evidence of any damp course, see photograph 24. Thresholds all level.

24 – LEVEL THRESHOLD NO D.P.C.
