Prepared by:	Maplebeck Tree Care
Address:	Clay Barn, Southwell NG22 0BS
Work Package:	Cedar House
Site Name/Order No:	<input type="text" value="Cedar House, Bleasby Rd Thurgarton"/>
Inspector's Name:	<input type="text" value="Andrew Fairhurst"/>
Date of Report:	<input type="text" value="09-01-2024"/>

Executive Summary:

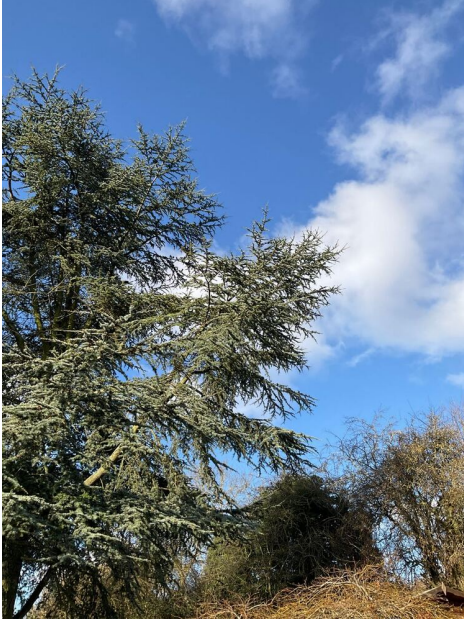
MapNo: T1 KTIId: 110128257
Date: 2024-01-09

No	Species	Height (m)	Age Class	Next Inspection	Priority	Est. Duration
T1	Cedrus atlantica (Atlas Cedar)	12	Mature	09-01-2027	4	0
<p>GENERAL OBSERVATIONS Failure at 4.5m in height on the southern side of the stem which has torn through to heart wood roughly 1/4 the width. Minor hung up branches around failure site. This had led to some of the southern aspect of the trees canopy becoming exposed, recommend selective reducing the lateral canopy to negate the chances of future failures. See photos for works required.</p> <p>PHYSICAL_CONDITION Good; STRUCTURAL_CONDITION Fair; KT ASSET ID 110128257; STEM DIAMETERS 49cm; COMMENT Conservation area; CAVAT FUNCTIONAL VALUE 75%; CAVAT CASH VALUE -; USER NAME Maplebeck Tree Care; LAST INSPECTED 09-01-2024</p>			<p>PRELIMINARY RECOMMENDATIONS</p> <p>Reduce Crown (Selectively reduce crown in three areas as described in the photos.) Priority 4; Remove Deadwood (Degree Minor) (Remove deadwood over 25mm diameter throughout tree.) Priority 4</p>

Reduce sub dominant stem by 1.5m in height to reduce wind sail as it is now exposed due to recent failure.

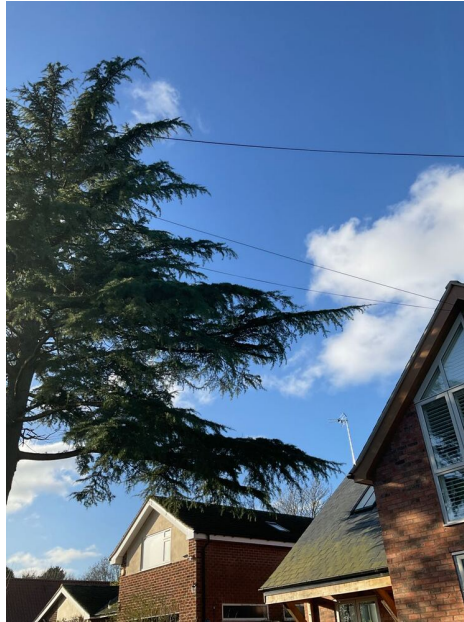
MapNo: T2 KTIId: 110128258
Date: 2024-01-09

No	Species	Height (m)	Age Class	Next Inspection	Priority	Est. Duration
T2	Cedrus atlantica (Atlas Cedar)	14	Mature	09-01-2027	4	0
<p>GENERAL OBSERVATIONS Tree in good health, encroaching towards property (garage and house). Some of the canopy is over extending its natural canopy line, therefore recommending to sympathetically reduce this growth back within natural canopy line.</p> <p>PHYSICAL_CONDITION Good; STRUCTURAL_CONDITION Good; KT ASSET ID 110128258; STEM DIAMETERS 64cm; CAVAT FUNCTIONAL VALUE 75%; CAVAT CASH VALUE -; USER NAME Maplebeck Tree Care; LAST INSPECTED 09-01-2024</p>			<p>PRELIMINARY RECOMMENDATIONS</p> <p>Reduce Crown (Selectively reduce canopy as per the descriptions attached to the photos.) Priority 4; Remove Deadwood (Degree Minor) (Remove deadwood over 30mm diameter.) Priority 4; Cut back from property (Prune to give give 2m clearance from the garage and 3m clearance from the house.) Priority 4</p>

Reduce the four limbs over extending towards the property by a maximum of 3.5m back to within natural canopy line.
