Arboricultural Method Statement

Plus Arboricultural Impact Assessment & Tree Survey

Land to the south of Seacroft Crescent Seacroft Leeds

> Report reference: AR-5059-03.02 AMS May 2023 Revised August 2023 Revised December 2023

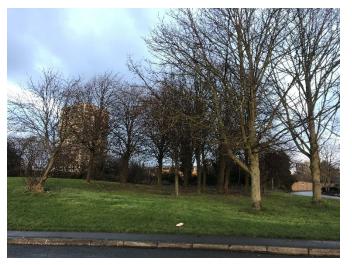
Figure 1

Looking north-west through the south eastern area with T19 in the foreground showing a stand of mature specimens.

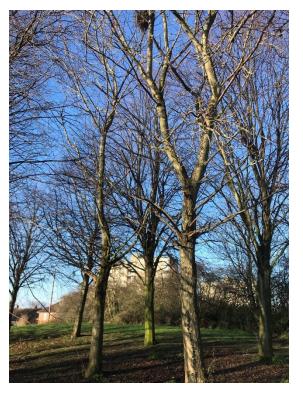
Figure 3

127	Poplar	M	14	10	320	N 1.4 E 1.7 S 3.8 W 2.37	F	Single vertical stem with a balanced canopy. High canopy with significant dead wood below. Dead wood and stubs noted throughout.	Crown Clean	10+	C1

Looking West from the South East of the site with T27 and 28 in the centre of the image. Note birds nest and significant deadwood in lower canopy.
