The Old Crown, Weston Turville

Test panels conducted by Stewart Ivory for Lost Marble Conservation on 12th January 2024

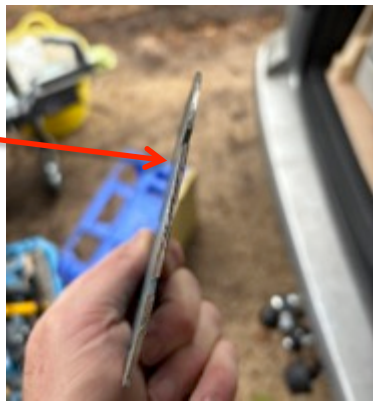
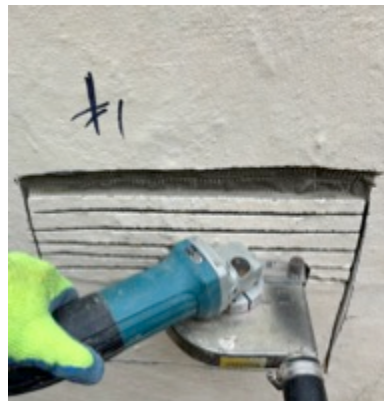
Front Test Panel #1

- Incredibly hard cement render, single coat, between 15-20mm thick.
- Brickwork laid in non-hydraulic lime mortar in Flemish Bond
- This panel was reasonably dry behind the render
- Hand made iron nails set into the mortar joints had been rendered over
- Render was removed with minimal damage to brickwork but did remove a microscopic layer from the fired face

- Remove all the cement render to the front
- Remove all concrete apron – this may be enough to allow wall to dry out – there may be no need for French drain or even a small trench, just lower ground level and expose air bricks
- Consult with Conservation Officer to decide upon wall covering:
- 1. If the brick panels are all in a good condition use 4 coats of traditional hotmixed lime wash
- 2. If bricks not in suitable condition to be exposed, then 2no. coats of lime render

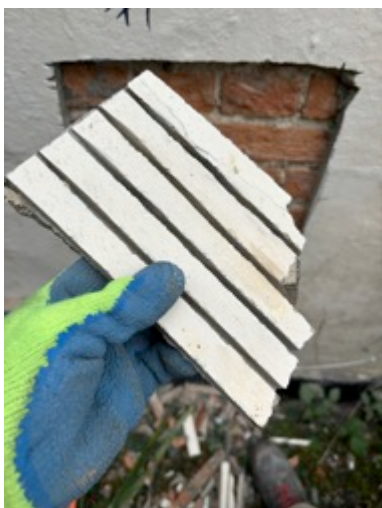
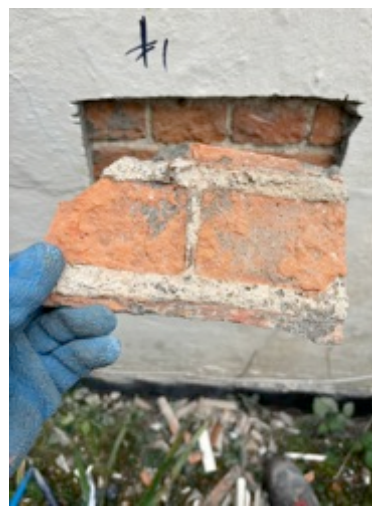
Showing detail of mortar and brick face adhering to cement render plus damp spores beneath the render, iron nail embedded in cement mortar

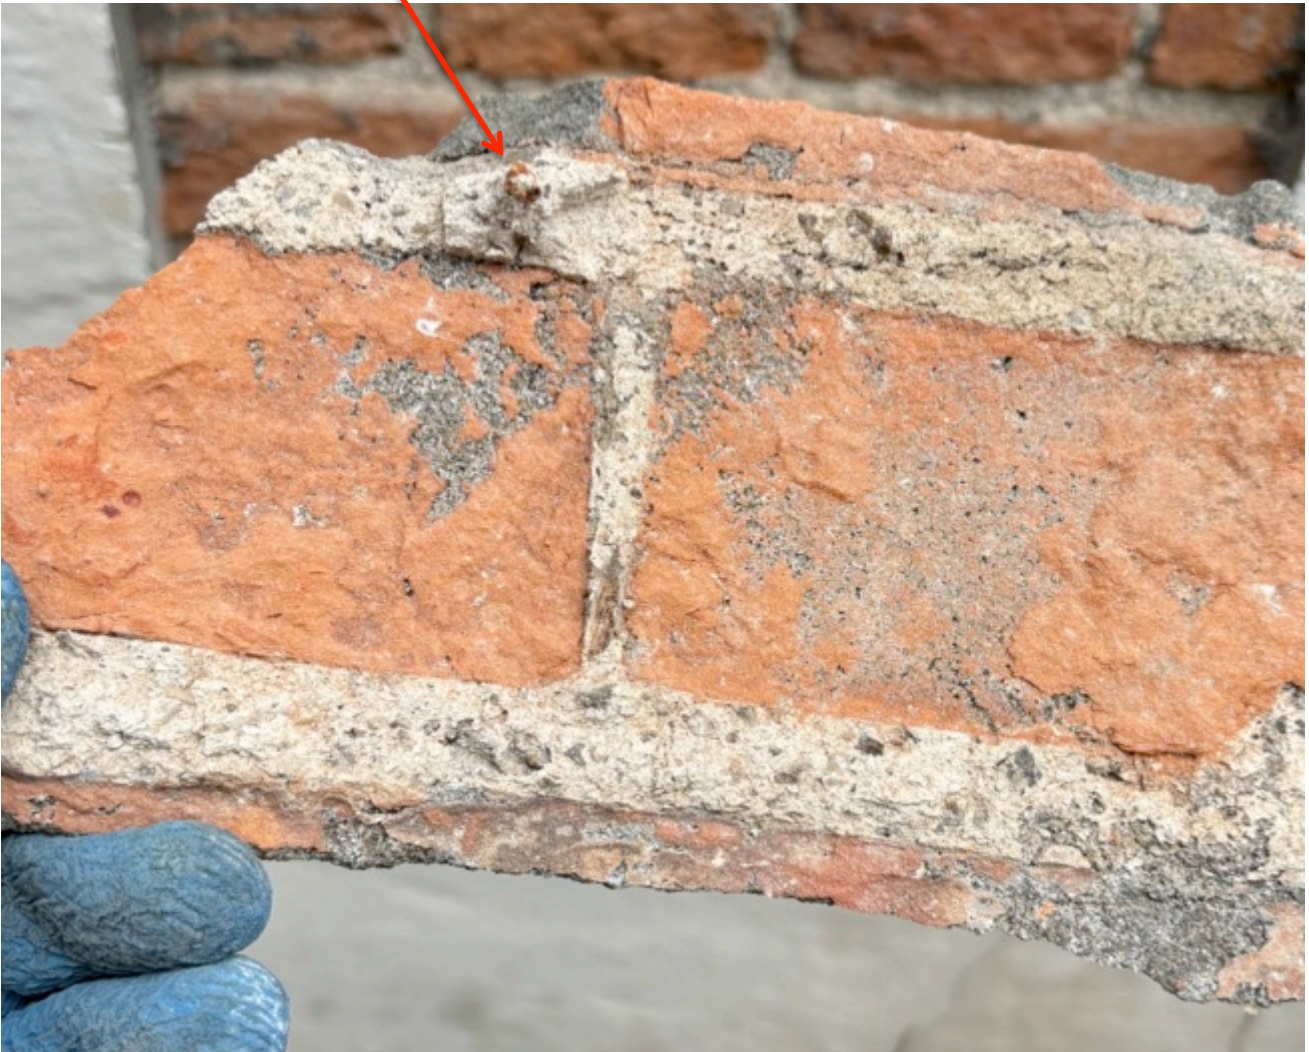
Front Test Panel #2

- Same very hard cement render, single coat
- Iron nails evident
- Areas of render delaminated from brickwork
- This area is very damp behind the render
- Evidence of historic lime render on face of bricks

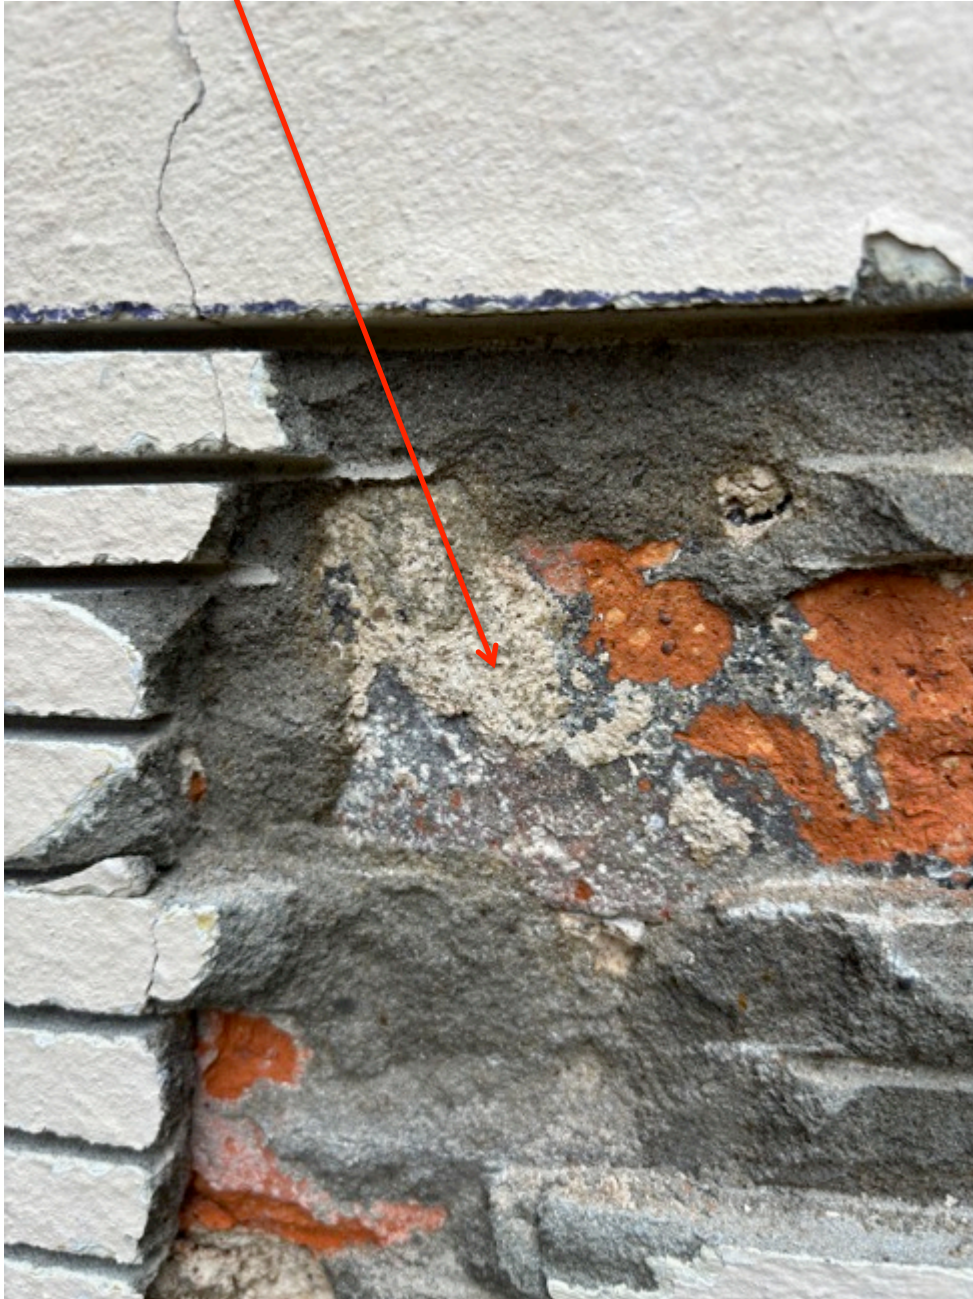
Front Test Panel #3

- Same single coat, very hard cement render
- Iron nails rendered over
- Cracks in render follow brick joints and not – as originally suspected – in line with timber frame
- Slate DPC is effective]
- Below DPC the brickwork is very damp
- The protruding plinth has evidence of an older skin of 2 inch thick render below ground level
- The plinth area is so damp it contains worms
- Concrete apron trapping moisture but not connected to the house wall
- Air brick found to be blocked with concrete and covered over by concrete apron

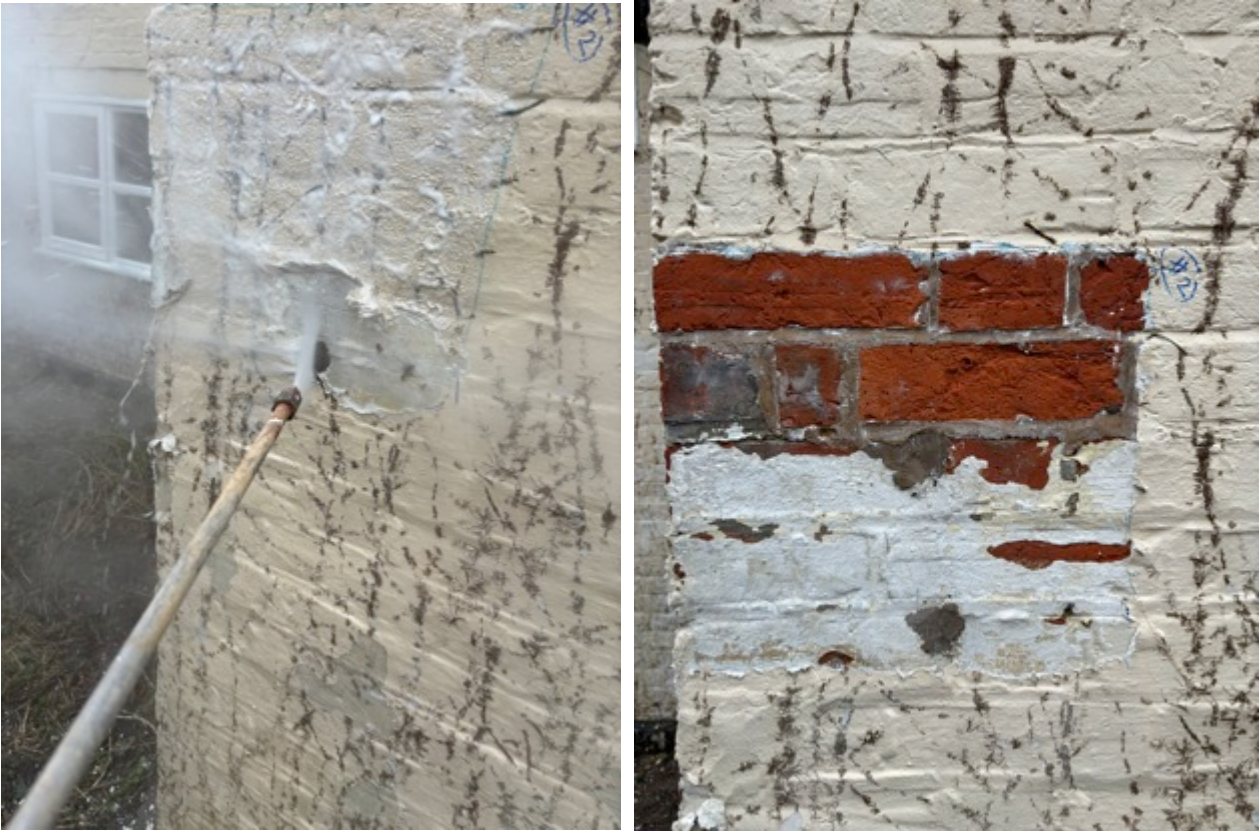
- DOFF removed the plastic paint with ease, causing zero damage to the brickwork
- DOFF exposed areas that had previously been lime washed and, as seen above, areas that were added to the building after lime washing was the traditional coating
- The flint and brick test panel #4 was lime washed – an extensive build up of historical lime wash is evident
- Other areas around the base of the single story barn revealed cement pointing, trapping damp within the brick plinth of the barn. This – and other modern materials in conjunction, is causing failure of the wall coatings inside (gypsum and modern paints) caused primarily by damp trapped within.

- Remove concrete apron
- Remove all modern paint using DOFF
- Remove all cement pointing
- Repoint using traditional hotmixed lime mortar
- Lime wash 4no. coats using hotmixed traditional lime wash

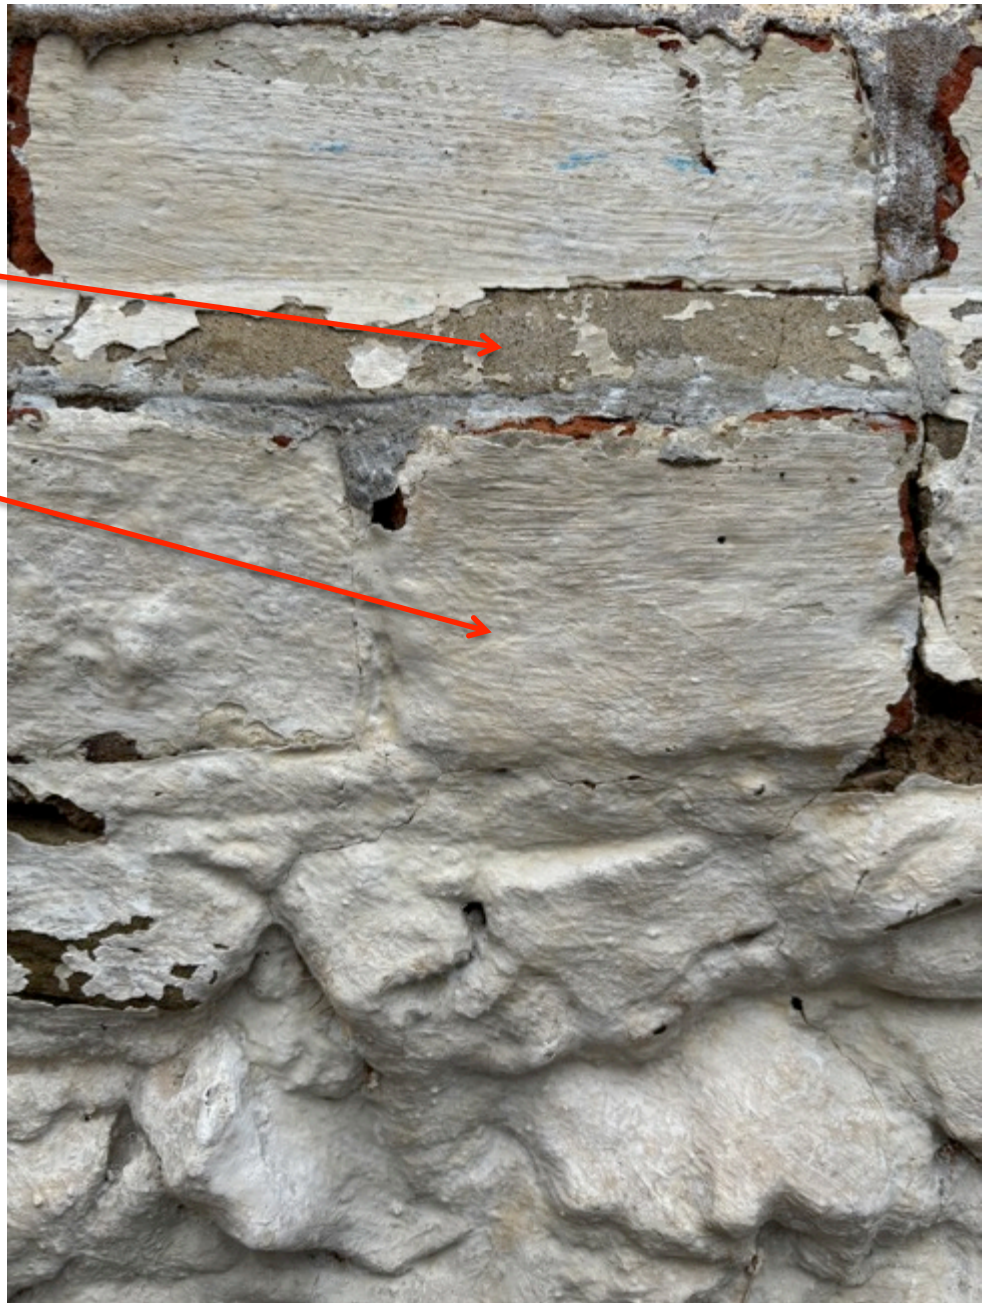
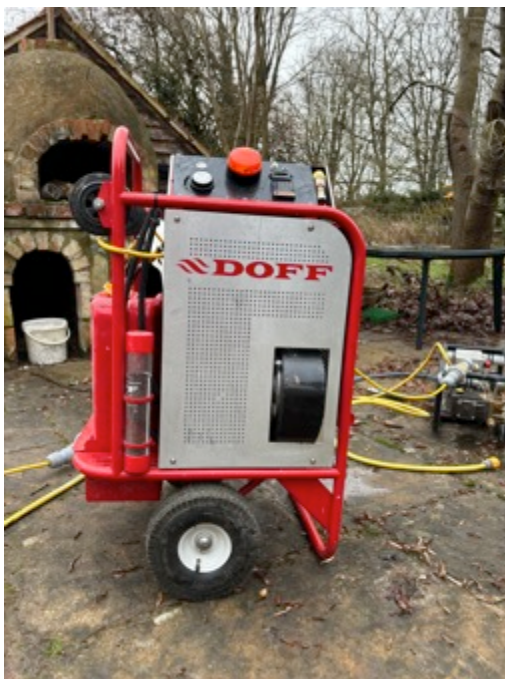
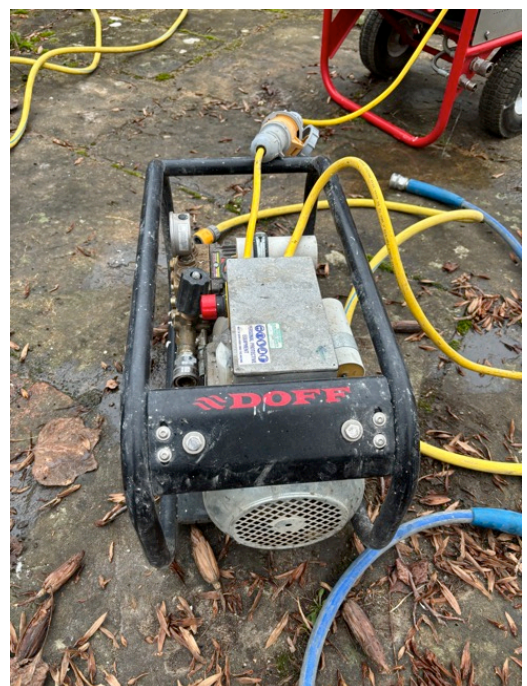
DOFF panel #4

Cement

Historical lime wash
