Arboricultural Consultancy for Lloyds Bank

1. Case Details

Insured	[REDACTED]	Address	Hilldene, Norwich Road, Scole, IP21 4DY		
Client	Subsidence Management Services	Contact	[REDACTED]	Claim No.	[REDACTED]
ES Ref	[REDACTED]	Consultant	[REDACTED]	Contact No.	[REDACTED]
Report Date	16/10/2023

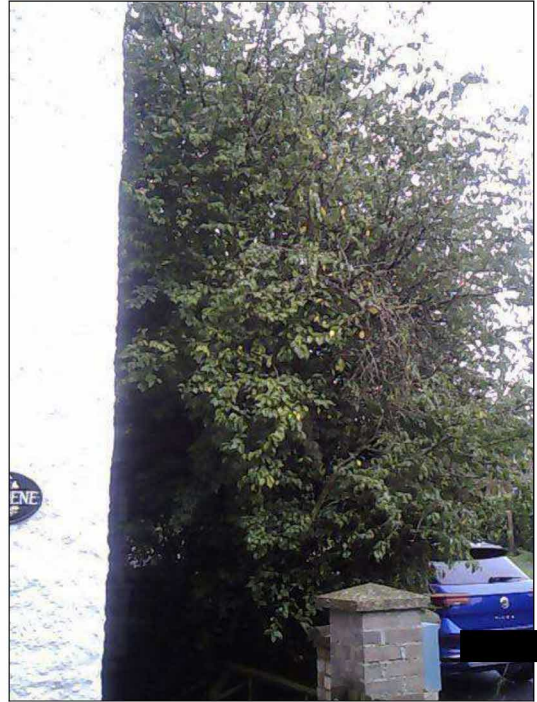
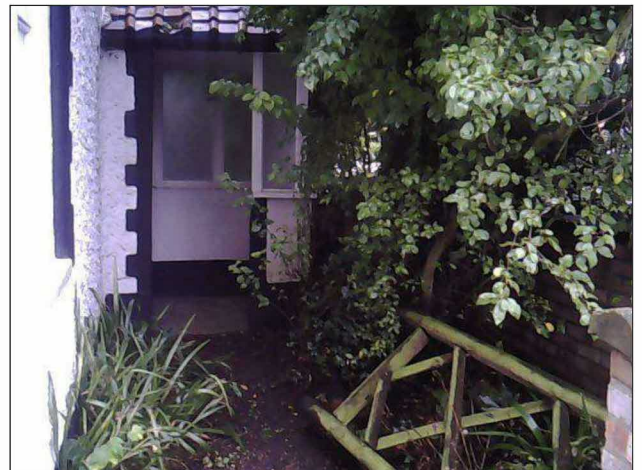
With due regards to species profile, size and proximity, T4 (Plum) is considered the dominant feature proximate to the focal area(s) of movement and accordingly, where vegetation is confirmed as being causal, we have identified it as the primary cause of the current subsidence damage.

T4 - Plum

Consequently, we have advocated the complete removal of T4 (Plum), T5 (Cupressus family) and TG1 (Prunus) as it will offer the most certain arboricultural solution likely to restore long-term stability.

Tree No.	Species	Age Cat	Approx. Height (m)	Distance to Building (m) *	Ownership	Action	Requirement
T4	Plum	1	6.4	1.7	C - Insured	Remove	Remove close to ground level; do not treat stump due to translocation risk. Where such a risk exists, we advise that any emergent regrowth is removed annually.
T5	Cupressus family	1	6.7	5.3	C - Insured	Remove	Remove close to ground level.
TG1	Prunus	1	3	4.0	C - Insured	Remove	Remove close to ground level and treat stumps to inhibit regrowth.

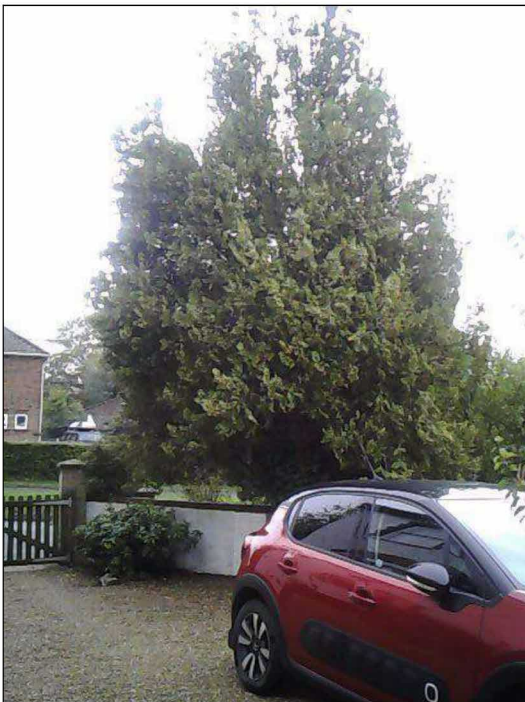
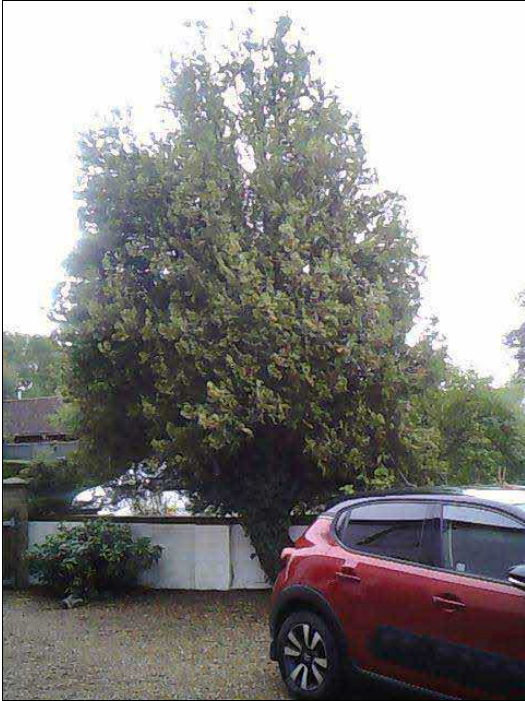
T5 (Cupressus family) and TG1 (Prunus) are also considered to retain a contributory influence, albeit in a secondary capacity when compared to the above.

T5 - Cupressus family

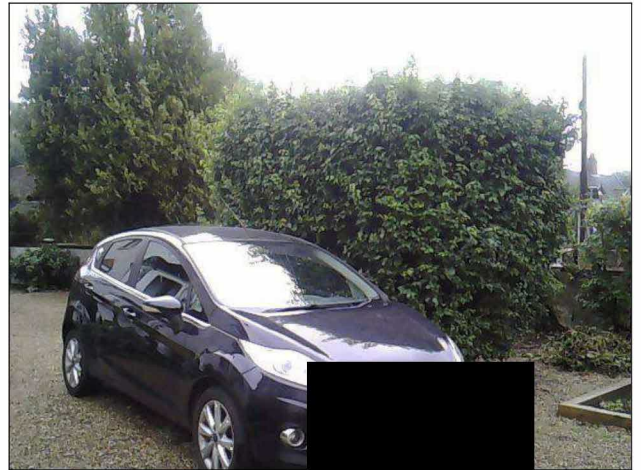
TG1 - Prunus
