# **Site Tree Appraisal**

## ***Land Opposite 18 Pendle Avenue, Bacup OL13 9DW***

**“BS 5837 2012: Trees in Relation to Design, Demolition and Construction – Recommendations”**

Date: 8<sup>th</sup> March 2023  
Ref: RTS/08032023 002  
Revision: 002

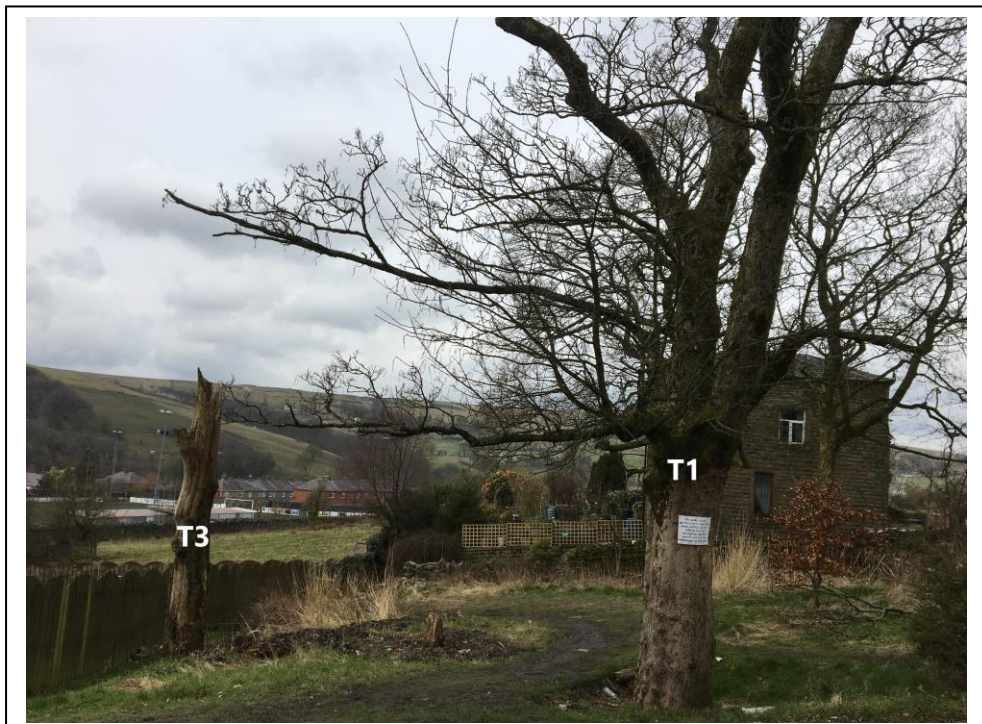
Photo 02:

**3.3** In order to facilitate the proposed single dwelling it will be necessary to remove one sycamore tree (T1) and the dead trunk of T3 (photo 02). T1 was noted to have general low vigour (very short annual twig extension). This could be the result of previous ground level alterations. The ground level around the tree appears to have been raised by approximately 300mm to 400mm around the root zone and trunk, photo 03. Given the current low vigour of T1 and its realistic longevity, estimated to be less than 20 years, the tree has been categorised C1 using the BS 5837:2012 Cascade Chart for tree quality. This suggests that it would be unreasonable to allow T1 to restrict a small development on the site, especially if new tree planting to mitigate the loss of T1 is undertaken post development. The dead trunk (T3) is in such condition that it cannot realistically be retained as a living tree in the context of the current land use for longer than 10 years, thus category U.

| Tree | Tree Work | Priority |
|---|--|---|
| T1 & T3 | Fell to ground level and dig out the remaining stumps. | Prior to any other site works |
