Arboricultural Consultancy for Aviva

Insured	Mr Peter White	Address	21 Cotham Grove, Bristol, BS6 6AN		
Client	Subsidence Management Services	Contact	Ben John	Claim No.	IFS-AVI-SUB-23-0106370
ES Ref	SA-253304	Consultant	Giles Mercer	Contact No.	0330 380 1036
Report Date	26/06/2023

21 Cotham Grove, Bristol, BS6 6AN

Drainage Investigation Report

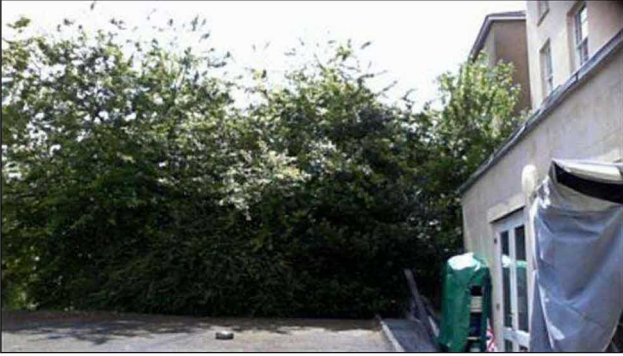
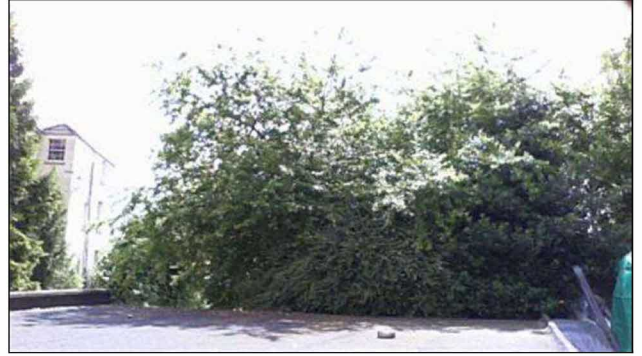
With due regards to species profile, size and proximity, the mixed species group (TG1) is considered the dominant feature proximate to the focal area(s) of movement and accordingly, where vegetation is confirmed as being causal, we have identified it as the primary cause of the current subsidence damage.

The size and proximity of the above vegetation is consistent with the advised location(s) of damage and it is our opinion, on balance of probability, that roots from the above vegetation will be in proximity to the footings of the insured property.

TG1 - Mixed species group

Consequently, we have advocated the complete removal of the mixed species group (TG1) as it will offer the most certain arboricultural solution likely to restore long-term stability.

Tree No.	Species	Age Cat	Approx. Height (m)	Distance to Building (m) *	Ownership	Action	Requirement
TG1	Mixed Species Group: includes apple, Ionicera, holly and prunus.	1	6.5	2	A - Third Party	Remove	Remove close to ground level and treat stumps to inhibit regrowth.
Age Cat: 1 = Younger than property; 2 = Similar age to the property; 3 = Significantly older than property

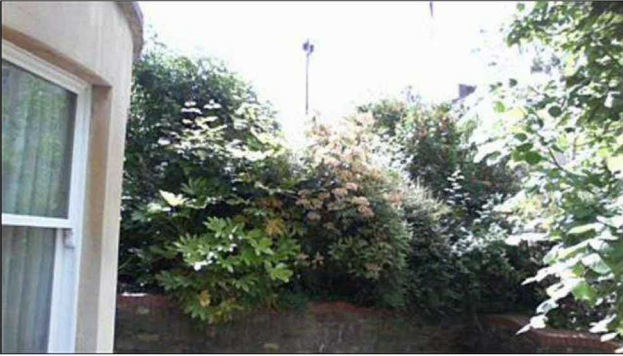
Please note that the footing of the insured property fall within the anticipated rooting distance of additional vegetation which we believe presents a foreseeable risk of future damage and accordingly we have made recommendations in respect of this.

SG1 - Mixed species shrubs

Tree No.	Species	Age Cat	Approx. Height (m)	Distance to Building (m) *	Ownership	Action	Requirement
SG1	Mixed species shrubs: includes fatsia, elder, sycamore saplings and lilac.	1	3.1	2.5	E - Boundary Veg (ownership to be confirmed)	Action to avoid future risk	Maintain at, or below current dimensions by way of regular pruning.
T1	Cedar	1	16	9.6	A - Third Party	Action to avoid future risk	Maintain at broadly current dimensions by way of regular pruning.
T2	Lime	1	7	4	C - Insured	Action to avoid future risk	Maintain at, or below current dimensions by way of regular pruning.
Age Cat: 1 = Younger than property; 2 = Similar age to the property; 3 = Significantly older than property

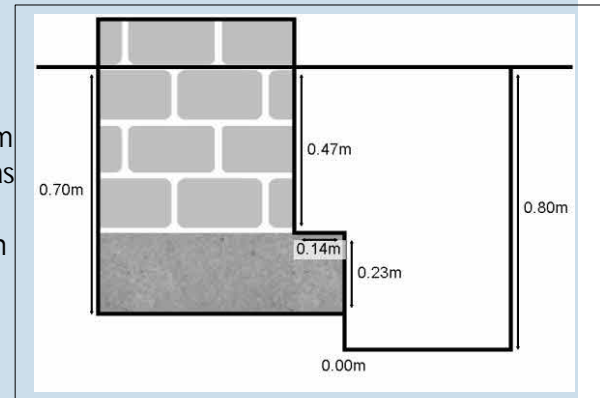
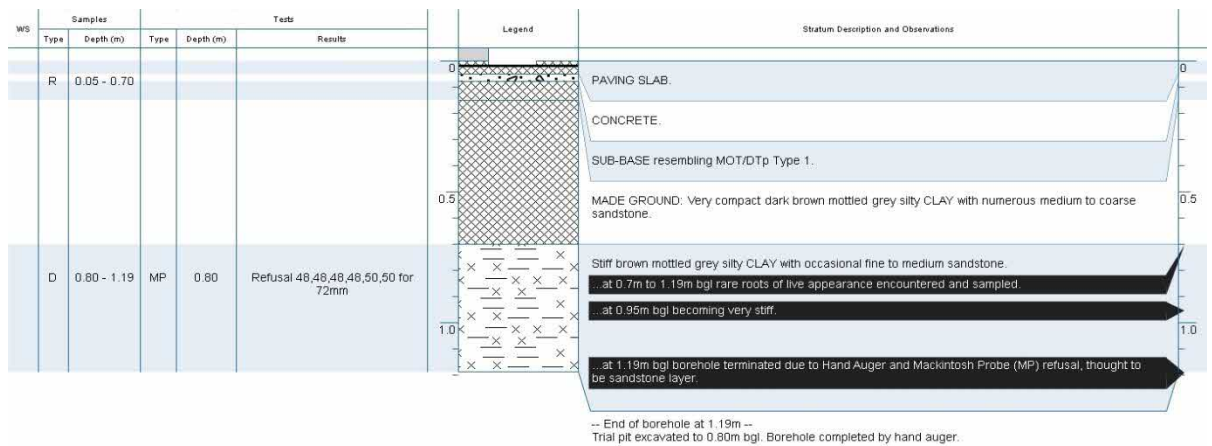
TP/BH1 Foundation Detail and Borehole Log

Extension foundation comprised of blockwork wall to 470mm bgl, bearing on concrete to an estimated depth of 700mm bgl, with a total projection of 140mm from the elevation. Underside of foundation (USF) was estimated by pushing a probe, approximately 110mm back from the face of the foundation, at an angle with no apparent contact with the face of the foundation beyond the estimated depth.

At 1.19m bgl borehole terminated due to Hand Auger and Mackintosh Probe (MP) refusal, thought to be sandstone layer in TP/BH1.

At 0.95m bgl becoming very stiff in TP/BH1.

At 0.7m to 1.19m bgl rare roots of live appearance encountered and sampled in TP/BH1.

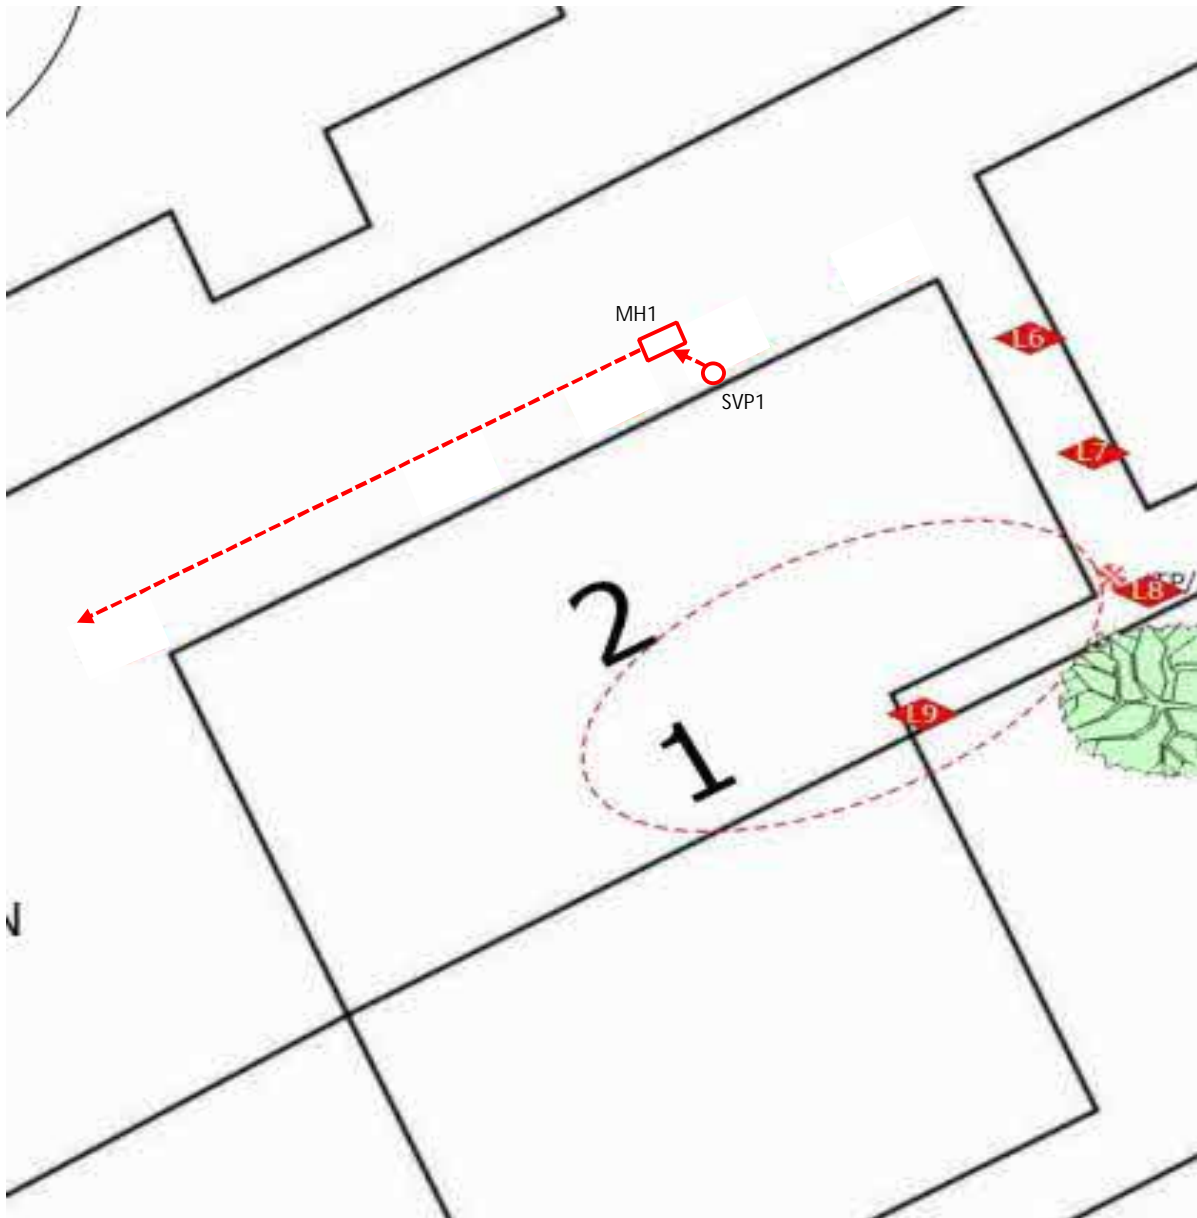
Upon arrival, we could see no drainage runs within the area of concern. There was a SVP on the opposite side of the building which is taking all foul waste effluent from the rooms and a look-see CCTV survey showed this to run into a manhole and down the opposite side of the building.

Therefore, no further works are recommended.
