# Tree assessment report

For: Cheltenham College

Tree ref: 10

17th January 2024

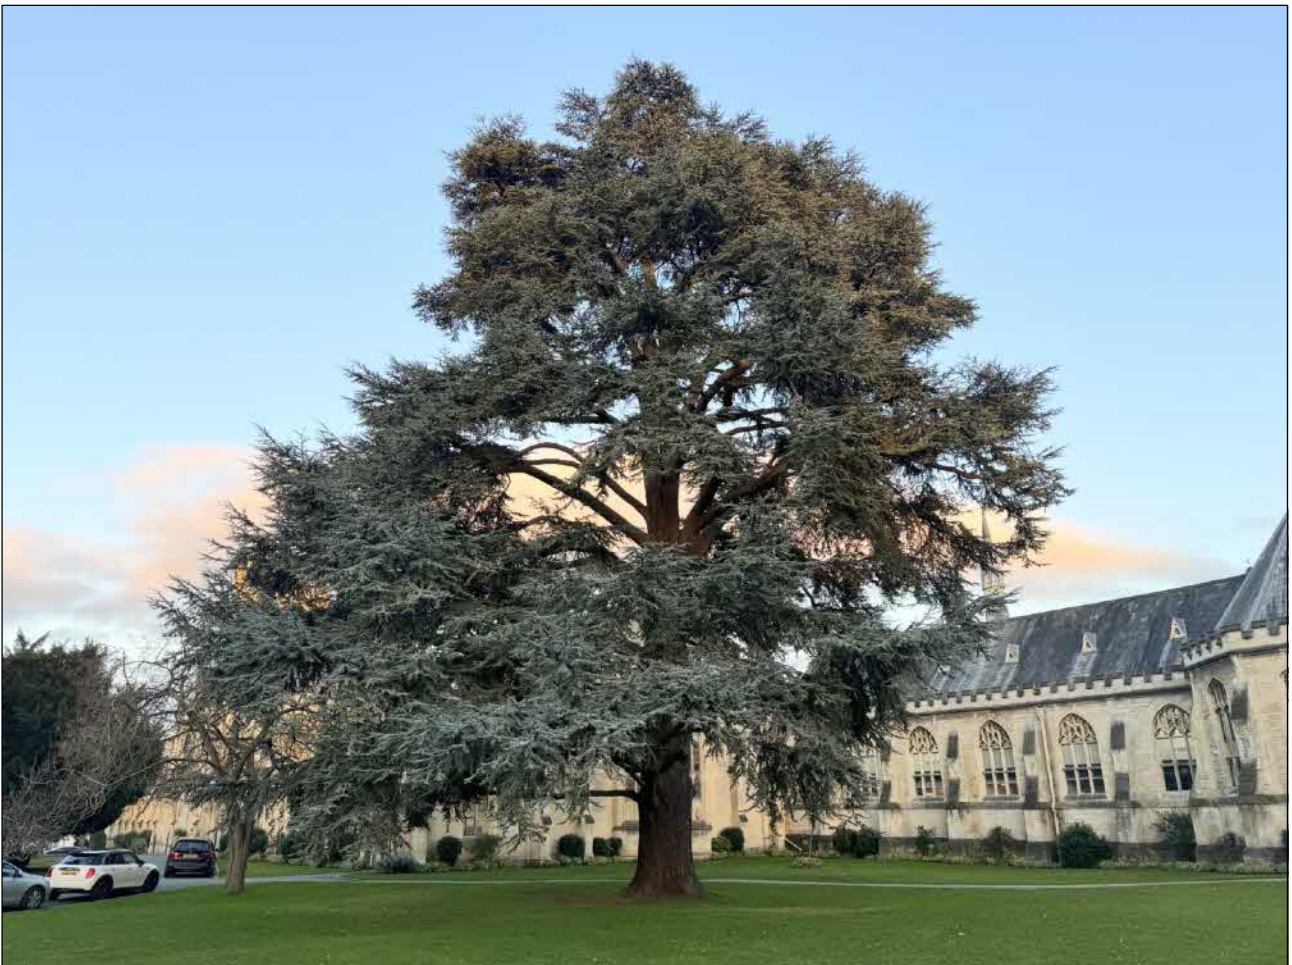
The tree appears to be in good health, and has produced new growth near the branch tips since the reduction pruning carried out in 2020. There are no signs of dieback or discoloration of the foliage.

Structurally, there are no signs of crown separation from sagging branches or visible cracks (viewed from ground level).

The tree overhangs a footpath on the east side. This is not one of the most commonly used paths within the school as it does not link classrooms, but is likely to have several people per hour use it.

*PHOTO 1: THE CEDAR AS VIEWED FROM THE SOUTHWEST*

There are no significant 'defects' observable at present, such as fungal induced decay, reduced vitality or visible cracks. However, mature cedars often suffer damage via branch failures when snow falls or strong winds are accompanied by heavy rain as the foliage becomes very heavy when wet and this adds significant load to the branches.

This tree has previously suffered a large branch failure on the east side over the footpath, prior to being pruned. Since the reduction pruning was carried out, there have been no failures. However, since the pruning was carried out over three years ago, there has been inevitable new growth near the tips of the branches which is gradually increasing the end-weight of the branches. In my opinion, this increased loading of the branches could lead to further branch failures in strong wind or under loading from snow.

Therefore, on balance I conclude that it is desirable to prune the tree again to proactively try and reduce the likelihood of future failures.

I recommend that the crown is pruned to reduce the radial length of lateral branches by up to a maximum of 2 metres, using a 'reduction via thinning' approach to leave as natural as possible. The maximum pruning cut size shall be 10cm and the reduction via thinning to remove around 20% of the density of the branch ends.

The work shall be carried out in accordance with the recommendations of BS3998:2010.
