Engineers Report

48 Gwendoline Drive
Countesthorpe
Leicester
LE8 5SE

360 Reference LIV-SN-22-005359
Insurer Reference 100-50-196159
Policy Holder Mr. Barry Hibberd

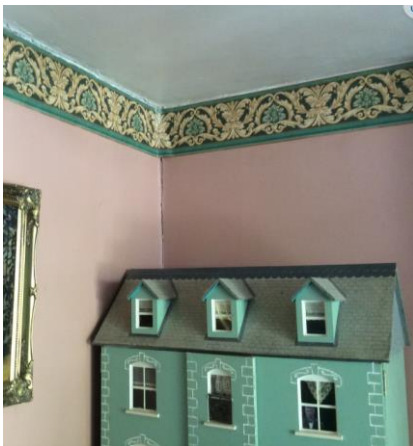
Vertical cracking, up to approximately 2/3mm wide is evident at the junction of the left and right elevations and internal division wall where these abut the rear elevation of the main house. The cracking extends the full height of the walls. There is also horizontal cracking evident to the ceiling, running from left to right, at the junction with the rear elevation of the main house.

Picture 1: Internal cracking to rear extension

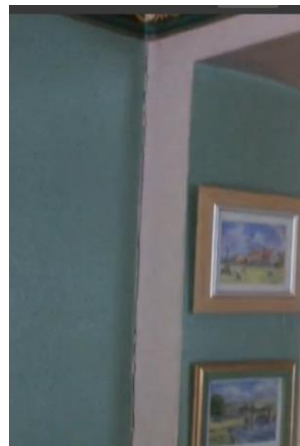
Picture 2: : Internal cracking to rear extension

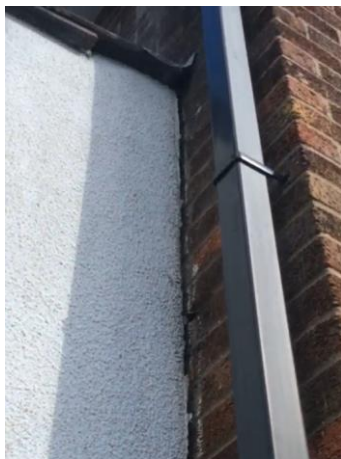
The internal damage to the extension is generally reflected externally, in the form of a tapered, diagonal / stepped crack, varying in width up to approximately 2mm wide, to the left-hand side elevation at the junction with the rear elevation of the house. The crack extends from external ground level, up towards the roof.

Picture 3: External cracking to rear extension

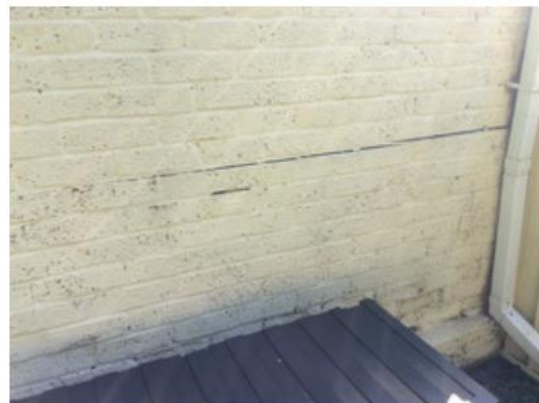
To the garage there is horizontal and stepped cracking to the rear left-hand corner of the garage, varying in width up to approximately 10mm wide. There is a crack running across the rear section of the garage, left to right.

Picture 4: External cracking to garage

It is common practice to categorise the damage in accordance with B.R.E. Digest 251 "Assessment of Damage in Low-Rise Buildings". In this case, the damage falls into Category 3 "Moderate" as there is cracking up to approximately 10mm wide.
