**CCTV REPORT FOR: 48 GWENDOLINE DRIVE
COUNTESTHORPE
LEICESTERSHIRE
LE8 5SE**

Site Visit: 17-Jan-23
Report Date: 28-Mar-23

Brief:	The Drainage Repair Company Ltd were commissioned to undertake a CCTV survey / inspection of the drainage at the property.
Specific Area of Interest:	Accessible drainage at the rear right of the property.
System Access:	Inspection chamber to rear right.
Visual Survey:	N/A
Water Pressure Test:	No

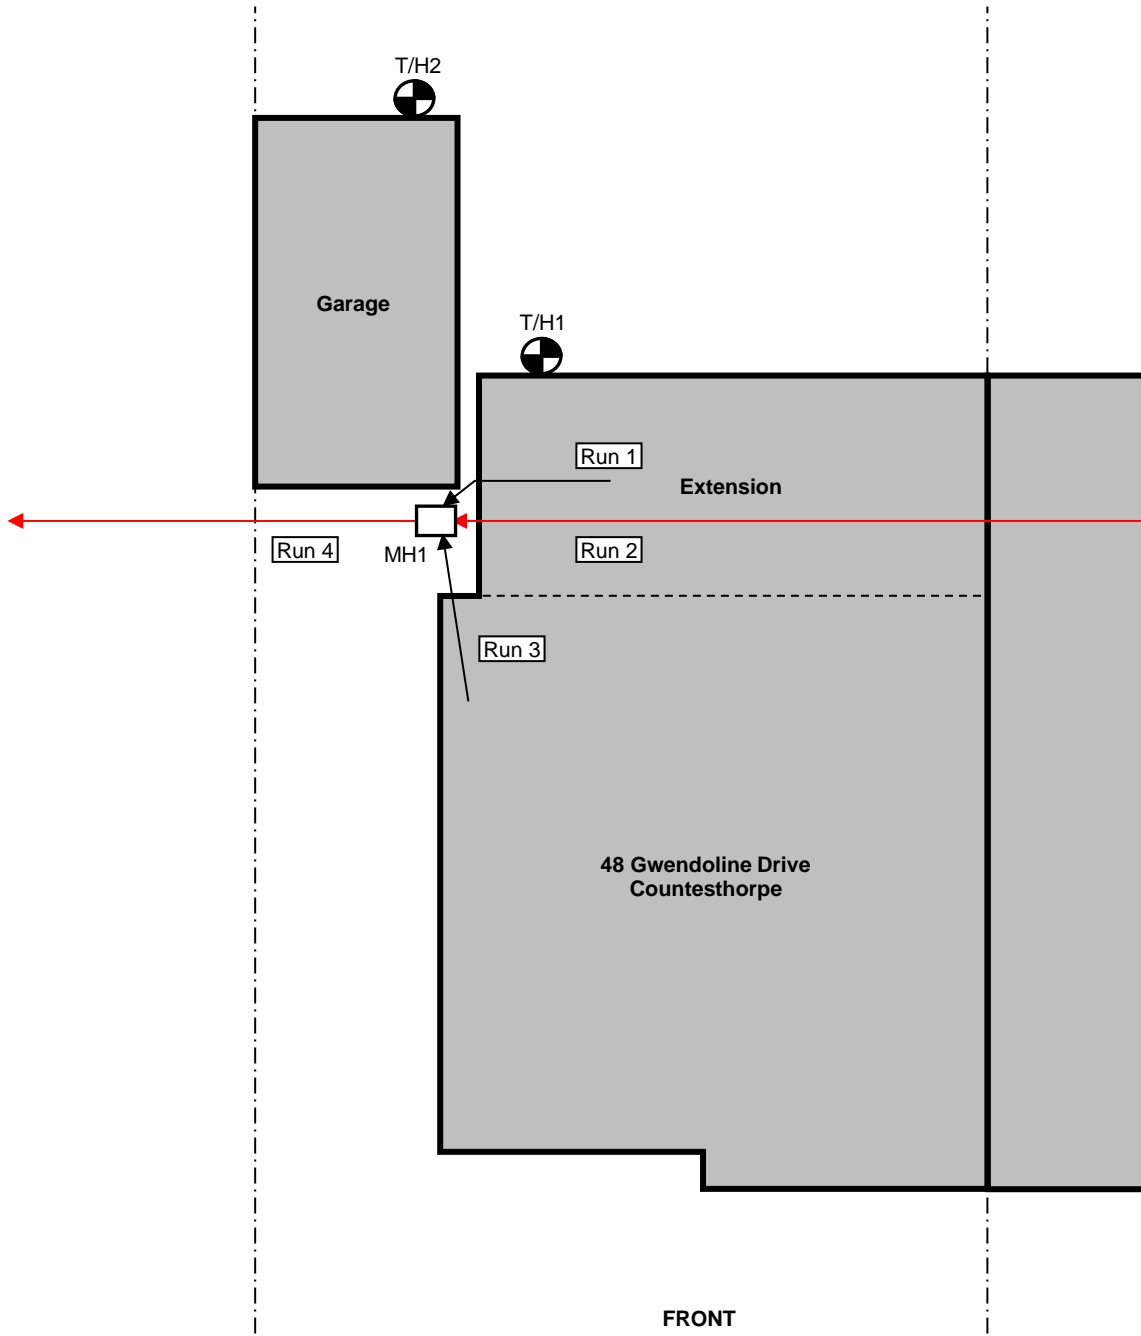
Note: Runs shown in red have been adopted by the local water authority.

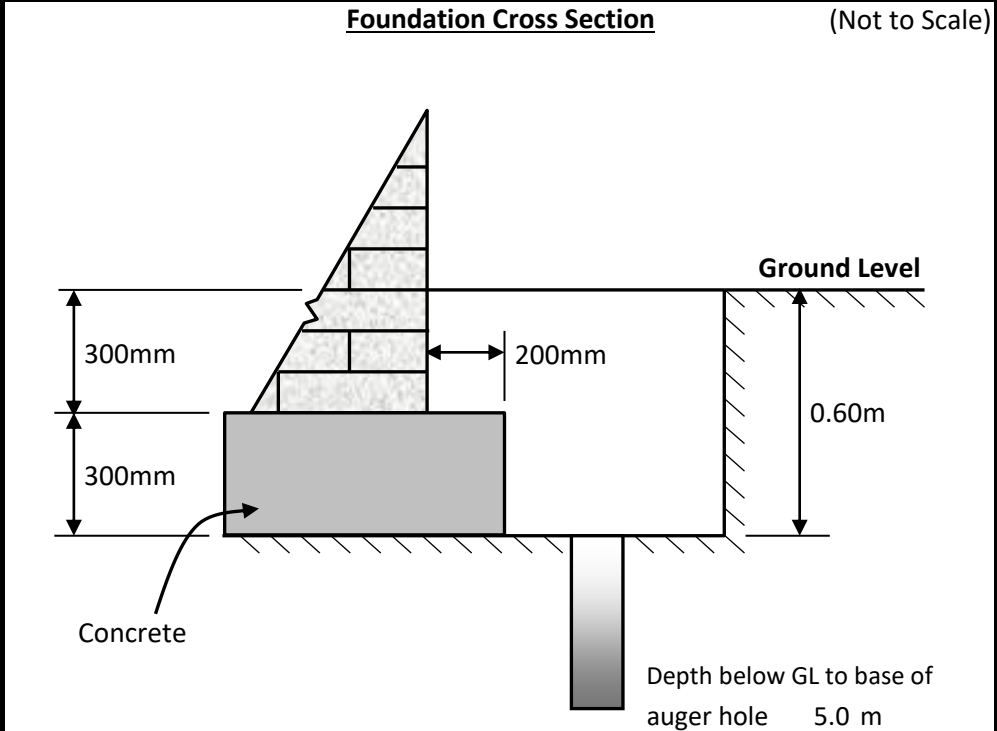
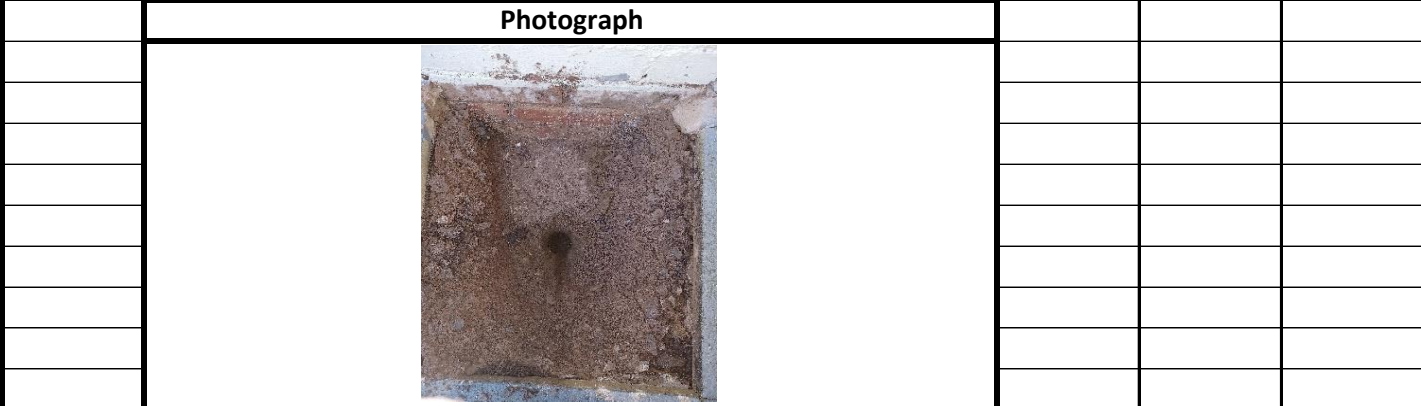
Location: **Rear Left Corner of Rear Extension** T/H No. **1**
 Ground Surface: **Damp** Weather: **Dry** Date: **17-Jan-23**

Roots Depth & Diameter:
 From 0.6m
 Down to 3.6m
 up to 3mm diameter

Depth (m)	Soil Descriptions <i>(NB: Field crew description only)</i>	Test Type	Depth (m)	
			From	To
G.L.				
0.60	Firm brown very gravelly sandy CLAY	V(n) 55	0.600	
1.60	Firm brown slightly gravelly sandy CLAY	V(n) 62	1.600	
2.60	Firm/stiff brown slightly gravelly slightly sandy CLAY	V(n) 78	2.600	
5.00	End of Borehole	V(n) 95	3.600	
		V(n) 94	4.600

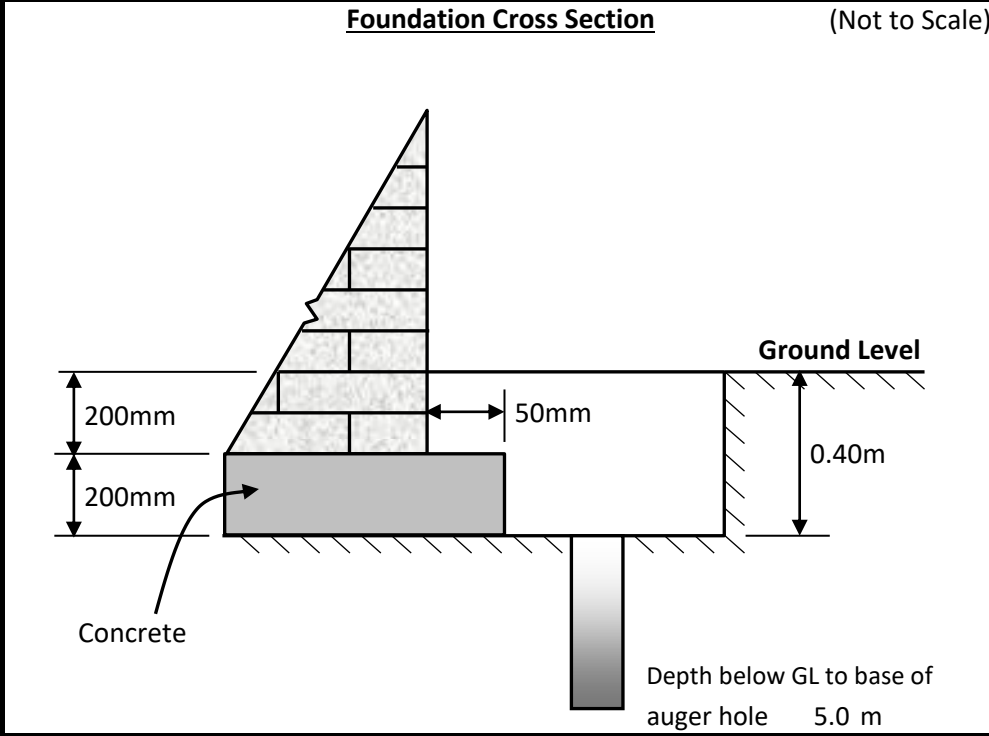
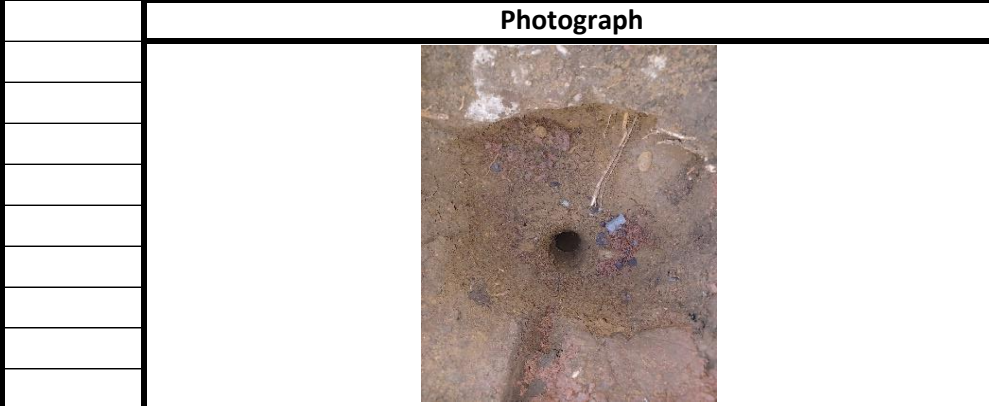
Location: **Rear Left Corner of Rear Extension** T/H No. **2**
 Ground Surface: **Damp** Weather: **Dry** Date: **17-Jan-23**

Roots Depth & Diameter:
 From 0.4m
 Down to 3.4m
 up to 3mm diameter

Depth (m)	Soil Descriptions <i>(NB: Field crew description only)</i>	Test Type	Depth (m)	
			From	To
G.L.				
0.40	Soft/firm brown slightly gravelly sandy CLAY	V(n) 54	0.400	
2.40	Firm/stiff brown slightly gravelly slightly sandy CLAY	V(n) 60	1.400	
3.40	Stiff brown slightly gravelly slightly sandy CLAY	V(n) 77	2.400	
5.00	End of Borehole	V(n) 92	3.400	
		V(n) 96	4.400
