**Geo-Serv Limited**  
17 Hoveden Road  
London NW2 3XE

Monitoring visit 3 of 4

### Monitoring Plus Report

Owners name	Mr. Barry Hibberd	Suspected cause	to be advised	Monitoring type	levels & cracks
Address	48 Gwendoline Drive Countesthorpe Leicester  LE8 5SE	Principal area of damage	to be advised	Installed	11/07/2023
Comment		Damage category	to be advised	Frequency (weeks)	8.7
Max moveme	2.3 mm	Surface geology	to be advised	Completion date	Jan 24
Focal area	Pts 8, 12, 13,	Feedback from last visit		Status	open
no comment for this visit		no feedback for this visit			
		Sketch showing location of monitoring points			
		<p style="text-align: center;">Front Elevation</p>

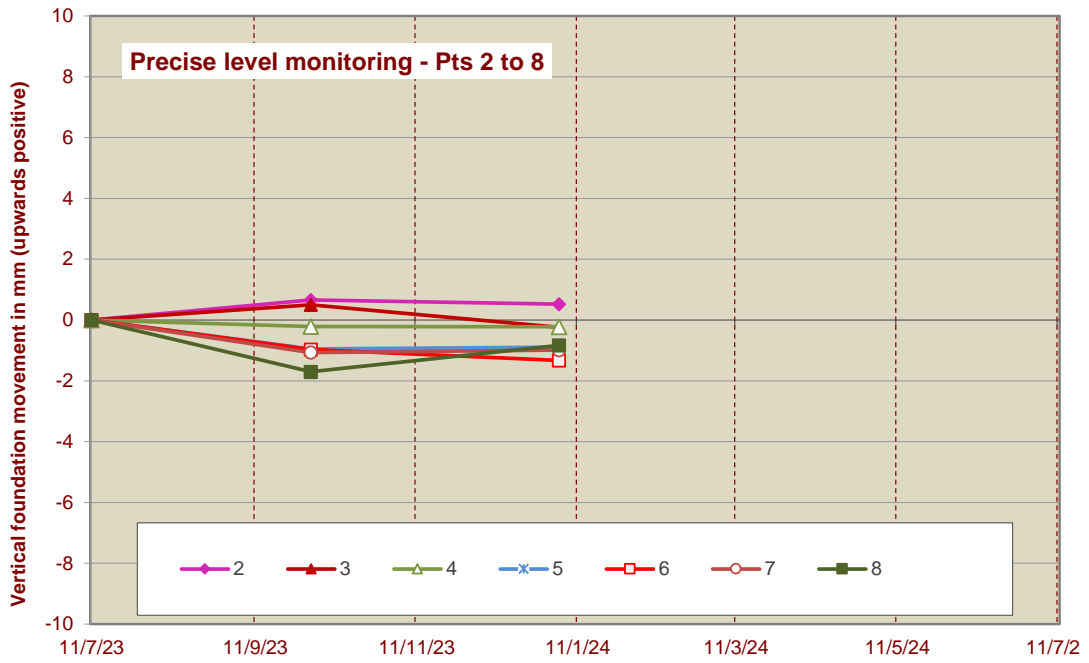
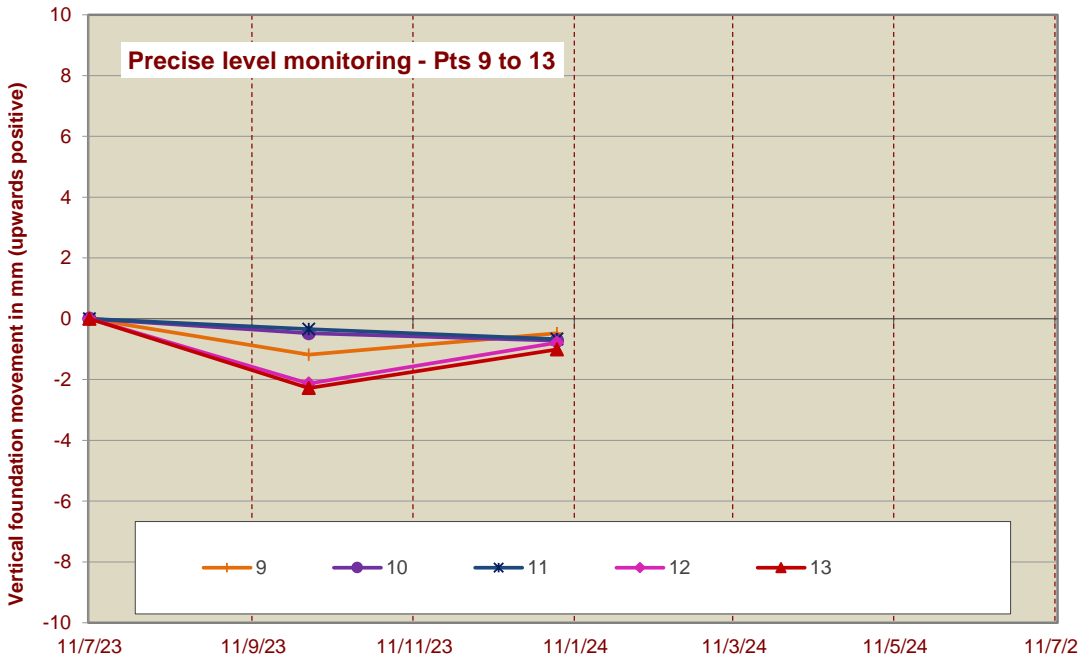
### Precise level monitoring related to Point 1

Survey:	1		2		3		4		5	
By:	CF		MA		SC		#N/A		#N/A	
Date:	11/07/2023		02/10/2023		04/01/2024		#N/A		#N/A	
Point ID	levels mm	<i>chngs</i> <i>mm</i>	levels mm	<i>chngs</i> <i>mm</i>	levels mm	<i>chngs</i> <i>mm</i>	levels mm	<i>chngs</i> <i>mm</i>	levels mm	<i>chngs</i> <i>mm</i>
1	<b>1000.00</b>	<b>0.0</b>	<b>1000.00</b>	<b>0.0</b>	<b>1000.00</b>	<b>0.0</b>		#N/A		#N/A
2	1033.19	<b>0.0</b>	1033.85	<b>0.7</b>	1033.71	<b>0.5</b>		#N/A		#N/A
3	1034.30	<b>0.0</b>	1034.80	<b>0.5</b>	1034.06	<b>-0.2</b>		#N/A		#N/A
4	1020.51	<b>0.0</b>	1020.30	<b>-0.2</b>	1020.29	<b>-0.2</b>		#N/A		#N/A
5	942.54	<b>0.0</b>	941.59	<b>-0.9</b>	941.65	<b>-0.9</b>		#N/A		#N/A
6	876.54	<b>0.0</b>	875.57	<b>-1.0</b>	875.21	<b>-1.3</b>		#N/A		#N/A
7	871.52	<b>0.0</b>	870.45	<b>-1.1</b>	870.53	<b>-1.0</b>		#N/A		#N/A
8	863.64	<b>0.0</b>	861.94	<b>-1.7</b>	862.81	<b>-0.8</b>		#N/A		#N/A
9	867.55	<b>0.0</b>	866.37	<b>-1.2</b>	867.07	<b>-0.5</b>		#N/A		#N/A

10	892.68	<b>0.0</b>	892.20	<b>-0.5</b>	891.96	<b>-0.7</b>		#N/A		#N/A
11	864.34	<b>0.0</b>	864.00	<b>-0.3</b>	863.67	<b>-0.7</b>		#N/A		#N/A
12	870.72	<b>0.0</b>	868.59	<b>-2.1</b>	869.93	<b>-0.8</b>		#N/A		#N/A
13	874.82	<b>0.0</b>	872.54	<b>-2.3</b>	873.81	<b>-1.0</b>		#N/A		#N/A

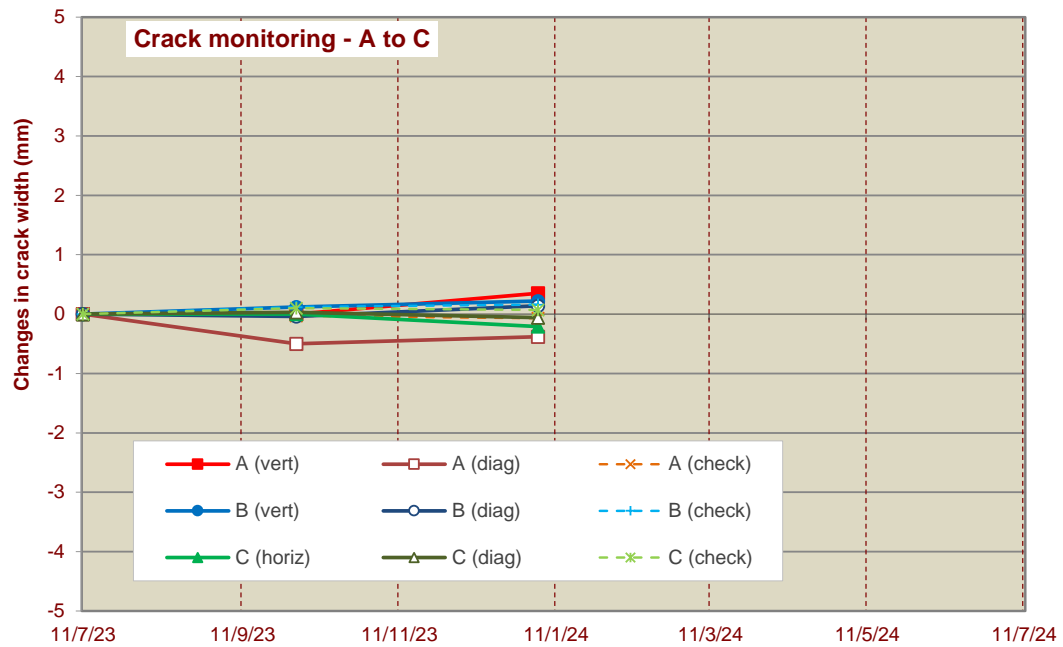
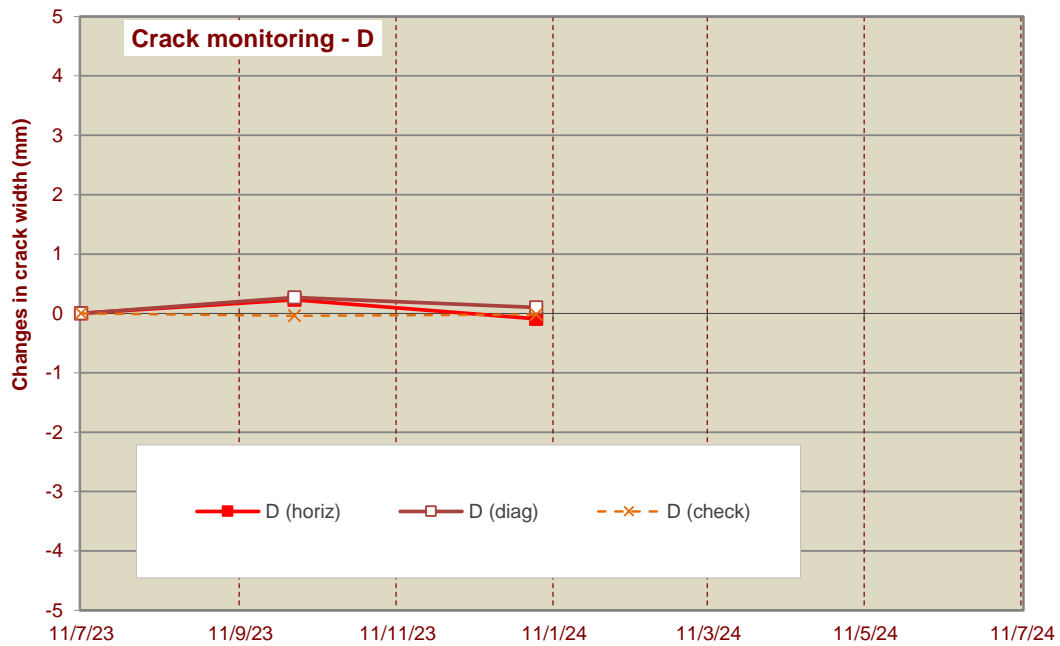
## Crack monitoring

Survey: By: Date:		1 CF 11/07/2023		2 MA 02/10/2023		3 SC 04/01/2024		4 #N/A		5 #N/A	
Crack ID	initial width mm	sprtn mm	<i>chngs mm</i>	sprtn mm	<i>chngs mm</i>	sprtn mm	<i>chngs mm</i>	sprtn mm	<i>chngs mm</i>	levels mm	<i>chngs mm</i>
A (vert)	1.10	72.77	<i>rogue</i>	69.99	<i>0.0</i>	70.34	<i>0.4</i>		#N/A		#N/A
A (diag)		84.76	<i>0.0</i>	84.26	<i>-0.5</i>	84.38	<i>-0.4</i>		#N/A		#N/A
A (check)		47.37	<i>0.0</i>	47.34	<i>0.0</i>	47.30	<i>-0.1</i>		#N/A		#N/A
B (vert)	1.00	81.15	<i>0.0</i>	81.27	<i>0.1</i>	81.37	<i>0.2</i>		#N/A		#N/A
B (diag)		90.04	<i>0.0</i>	90.00	<i>0.0</i>	90.18	<i>0.1</i>		#N/A		#N/A
B (check)		44.23	<i>0.0</i>	44.35	<i>0.1</i>	44.39	<i>0.2</i>		#N/A		#N/A
C (horiz)	2.20	45.75	<i>0.0</i>	45.75	<i>0.0</i>	45.54	<i>-0.2</i>		#N/A		#N/A
C (diag)		83.12	<i>0.0</i>	83.15	<i>0.0</i>	83.06	<i>-0.1</i>		#N/A		#N/A
C (check)		68.13	<i>0.0</i>	68.23	<i>0.1</i>	68.20	<i>0.1</i>		#N/A		#N/A

D (horiz)	5.00	67.92	<i>0.0</i>	68.15	<i>0.2</i>	67.83	<i>-0.1</i>		#N/A		#N/A
D (diag)		93.69	<i>0.0</i>	93.96	<i>0.3</i>	93.79	<i>0.1</i>		#N/A		#N/A
D (check)		72.12	<i>0.0</i>	72.08	<i>0.0</i>	72.10	<i>0.0</i>		#N/A		#N/A

A (vert)	Demec triplet, rear extension, left
B (vert)	Demec triplet, rear extension, right
C (horiz)	Demec triplet, side elevation, junction between house and extension
D (horiz)	Demec triplet, Garage, rear elevation
