Wilby Barns - Timber Replacement and Wall Repair - Part One

Subgero Limited

Wilby Manor, Wooten Green,
Wilby, Suffolk, IP21 5LB

Wilby Barns – Wall Repair and Timber Replacement

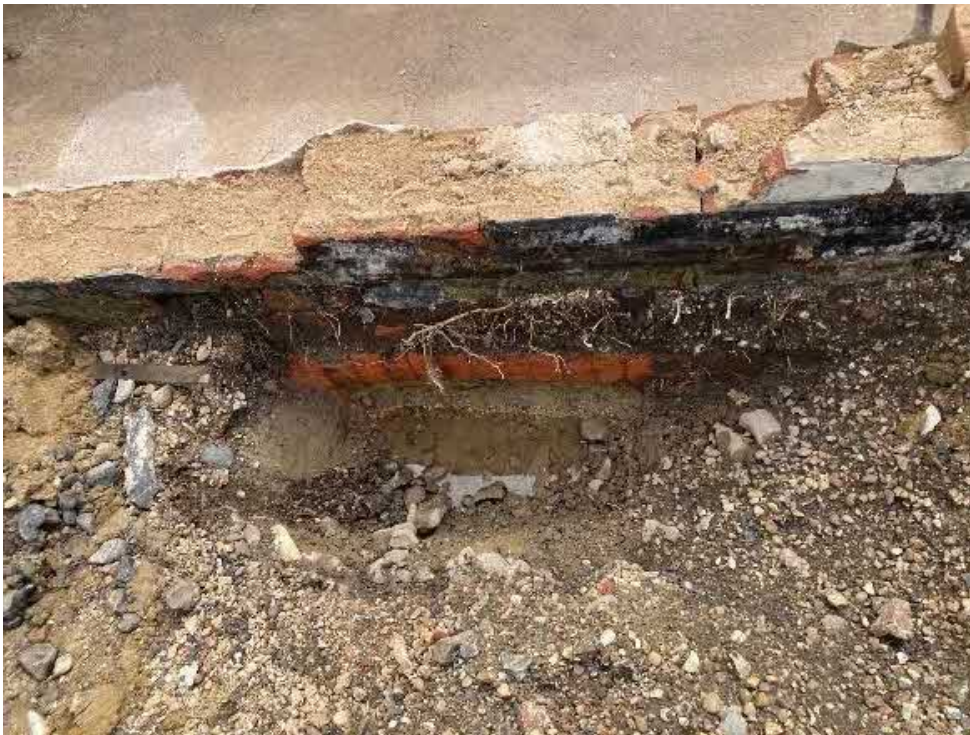
ORIGINAL

On inspection of the foundations, it was deemed that insufficient footings existed for the two sections of brickwork that were due to remain. Therefore, the structural engineer advised taking the sections of walls down and putting in a continuous foundation along the wall in lieu of underpinning the two sections in order to improve the overall strength of support for the wall.

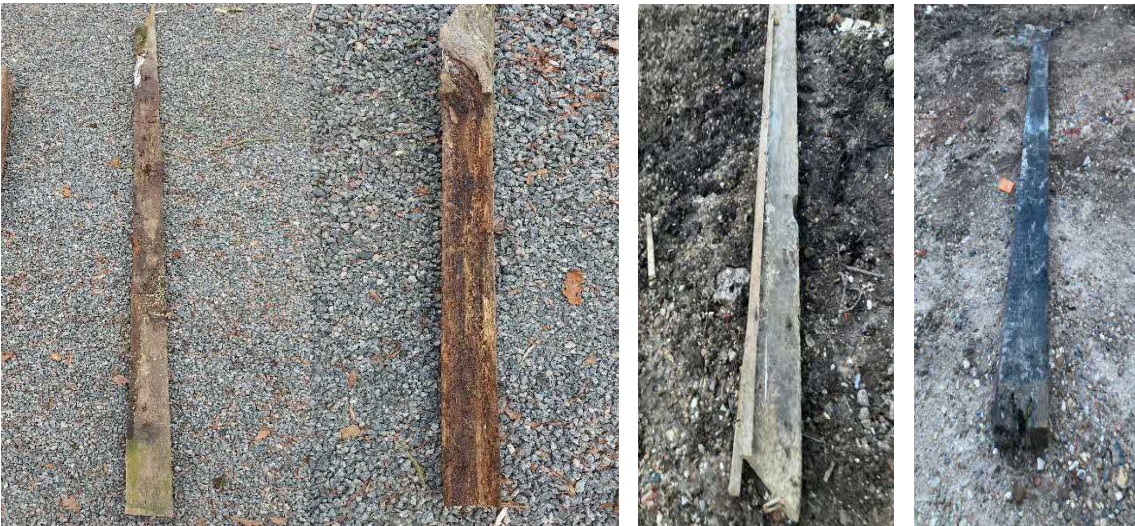
ORIGINALS (EXAMPLES)

Reasoning for replacement: Rafters were rotten and structurally unstable for further use, as agreed by Adam Power Structural Engineers.
