# LISTED NOTIFICATION

## Wilby Barns - Timber Replacement and Wall Repair - Part Two

# Wilby Barns - Wall Repair and Timber Replacement

## Item Three – Floor Joists on First Floor

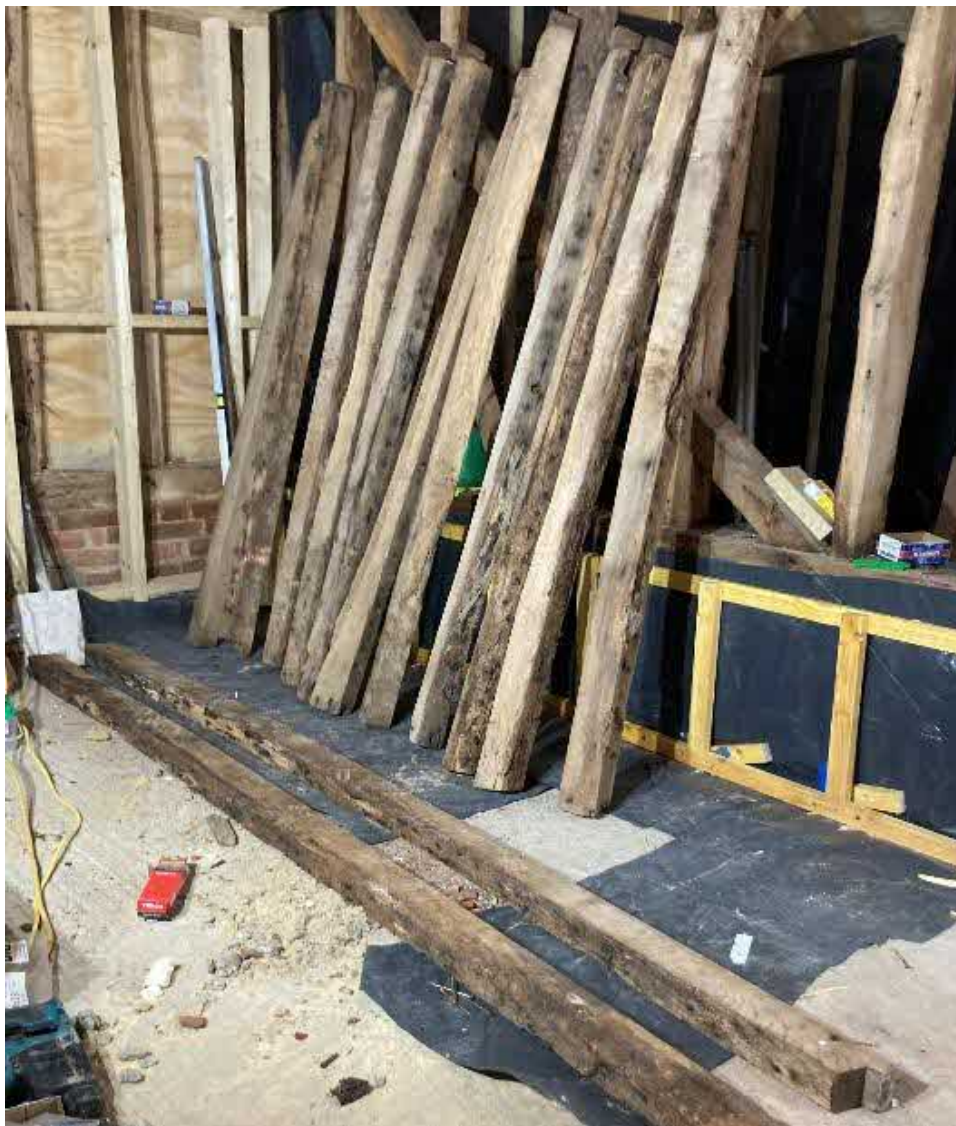
### OLD FLOOR JOISTS

Reasoning for replacement: Floor joists were rotten, bowed or structurally unsafe for further use. These are load bearing joists for the development of the first floors and were deemed unstable by Adam Power Structural Engineers.

Specification: 12 x new oak floor joists installed.

Average timber size 125mm x 100mm (Original oak floor joists 110mm x 85mm)

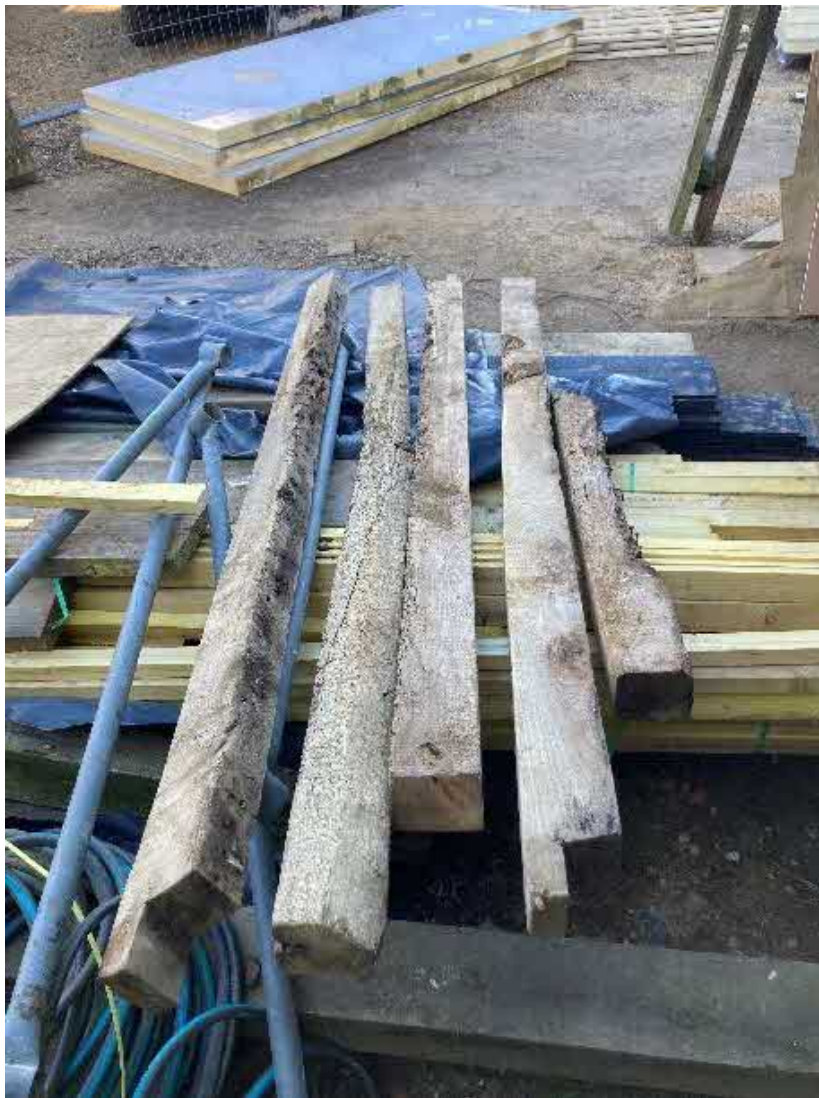
### OLD FLOOR JOISTS

Reasoning for replacement: Floor joists were rotten, bowed or structurally unsafe for further use. These are load bearing joists for the development of the first floors and were deemed unstable by Adam Power Structural Engineers.

Specification: 7 x new oak floor joists installed.

Average timber size 125mm x 100mm (Original oak floor joists 110mm x 85mm)

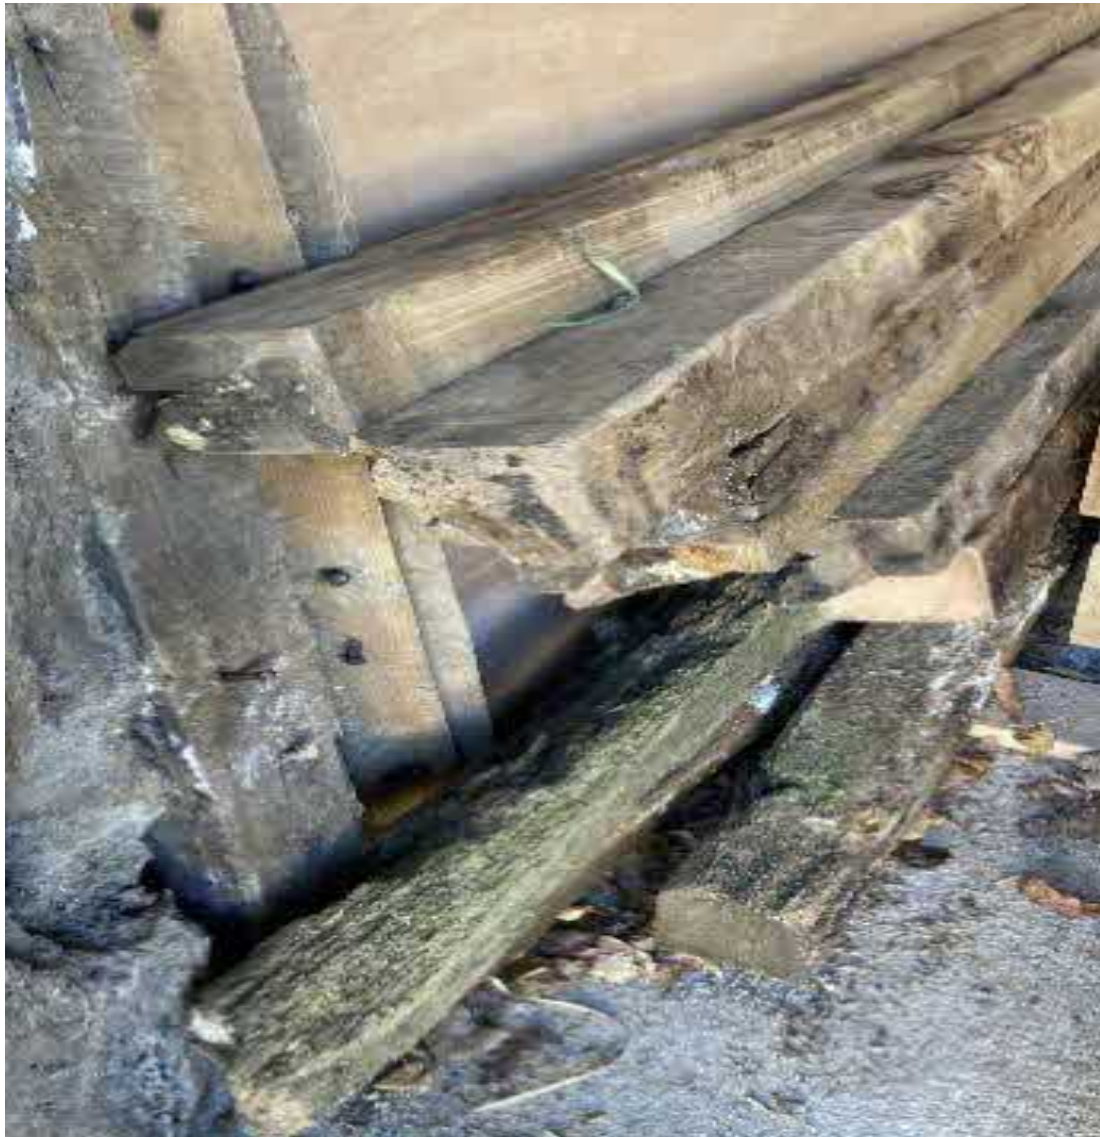
### OLD FLOOR JOISTS

Reasoning for replacement: Floor joists were rotten, bowed or structurally unsafe for further use. These are load bearing joists for the development of the first floors and were deemed unstable by Adam Power Structural Engineers.

Specification: 12 x new oak floor joists installed.

Average timber size 125mm x 100mm (Original oak floor joists 110mm x 85mm)

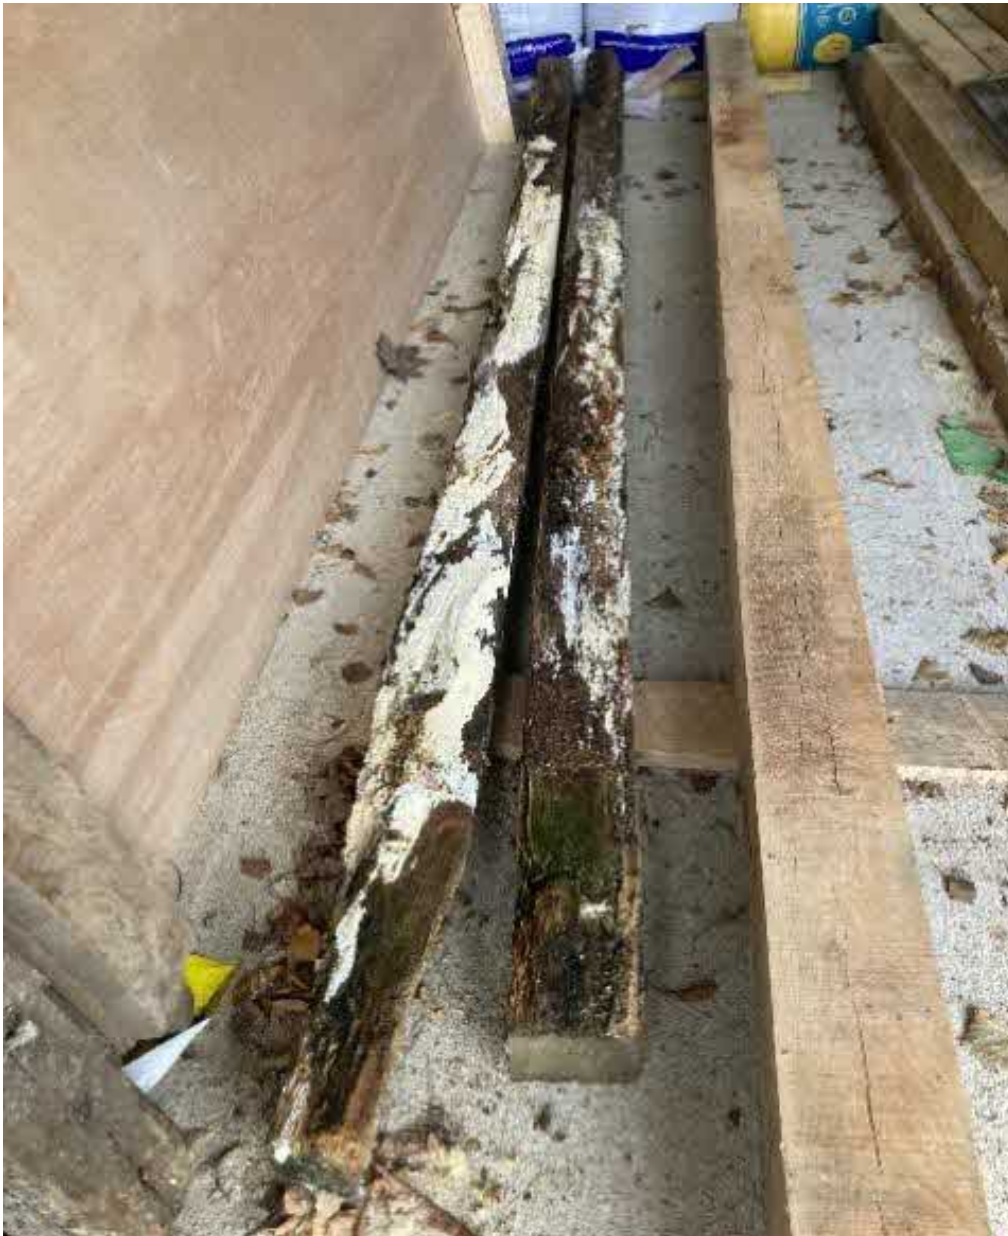
### OLD FLOOR JOISTS

Reasoning for replacement: Floor joists were rotten, bowed or structurally unsafe for further use. These are load bearing joists for the development of the first floors and were deemed unstable by Adam Power Structural Engineers.

Specification: 11 x new oak floor joists being installed.

Average timber size 125mm x 100mm (Original oak floor joists 110mm x 85mm)

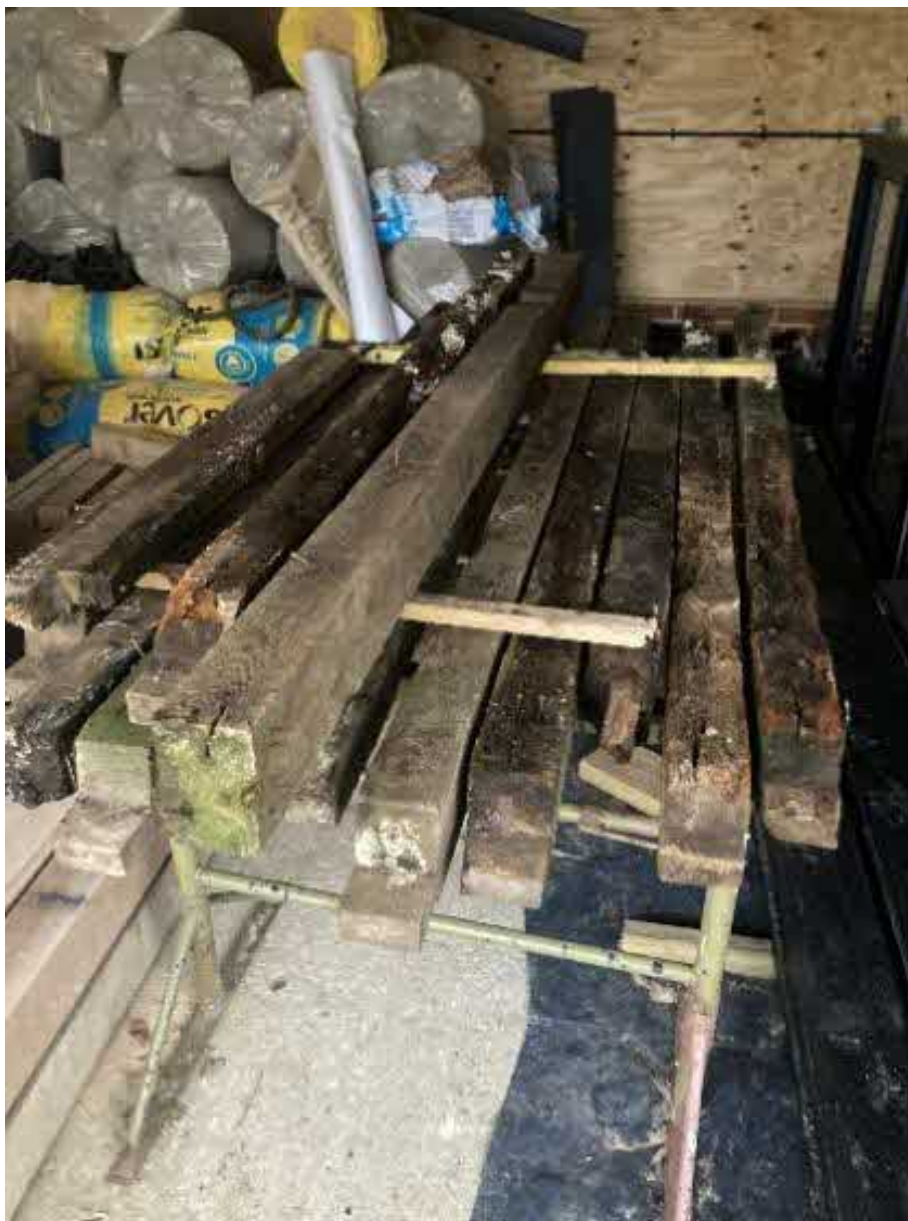
### OLD FLOOR JOISTS

Reasoning for replacement: Floor joists were rotten, bowed or structurally unsafe for further use. These are load bearing joists for the development of the first floors and were deemed unstable by Adam Power Structural Engineers.

Specification: 11 x new oak floor joists to be installed.

Average timber size 125mm x 100mm (Original oak floor joists 110mm x 85mm)

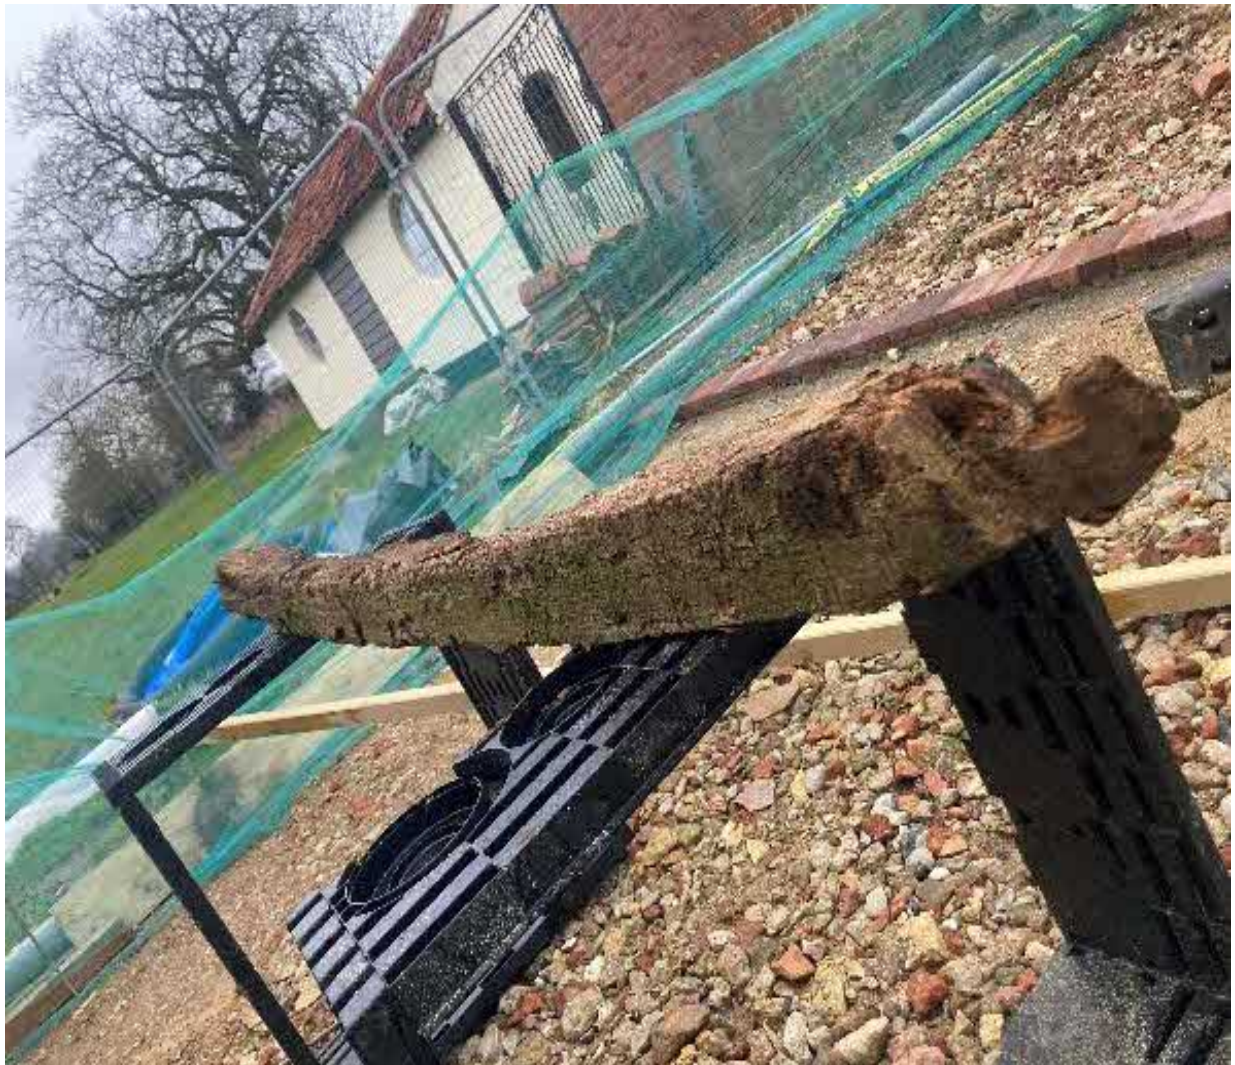
### OLD FLOOR JOISTS

Reasoning for replacement: Floor joists were rotten, bowed or structurally unsafe for further use. These are load bearing joists for the development of the first floors and were deemed unstable by Adam Power Structural Engineers.

Specification: 13 x new oak floor joists to be installed.

Average timber size 125mm x 100mm (Original oak floor joists 110mm x 85mm)

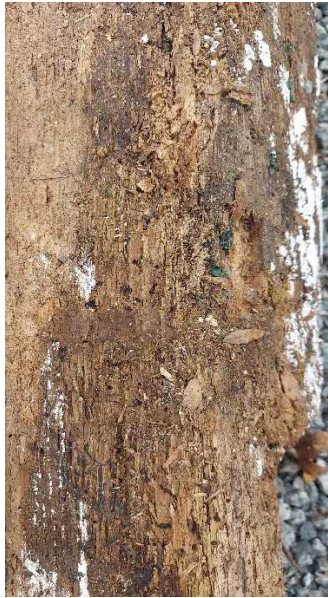
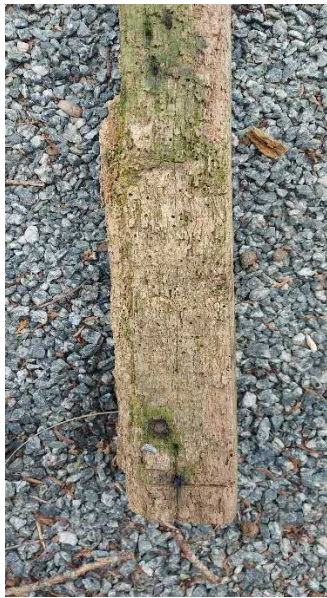
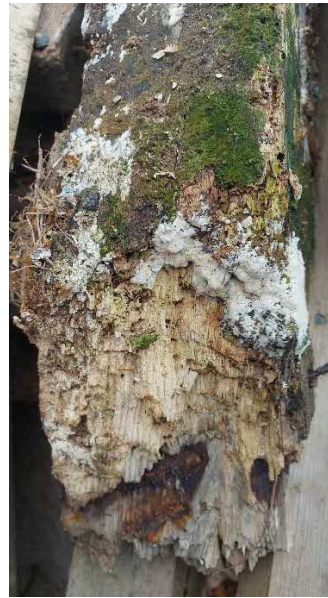
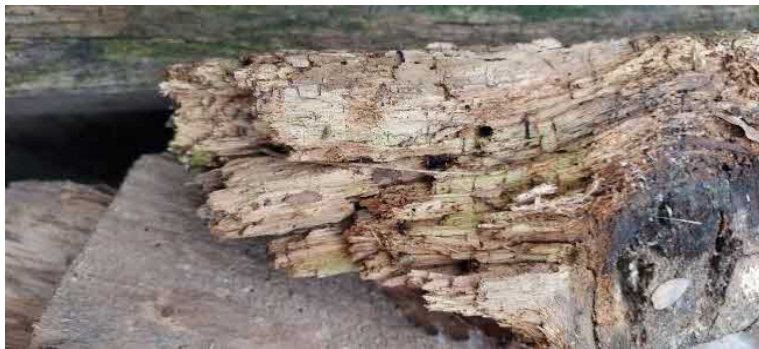
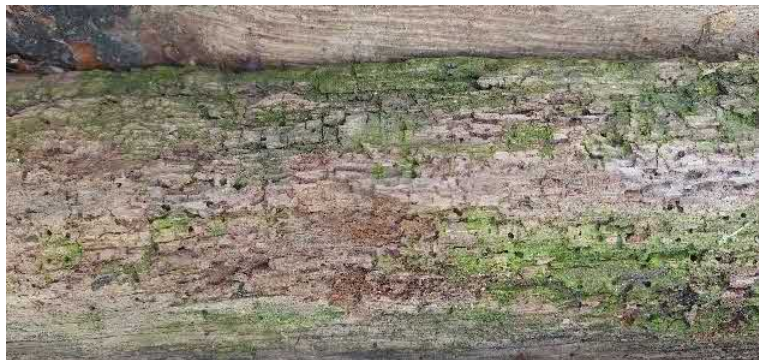
EVIDENCE OF MAJOR ROT AND WOODWORM INFESTATIONS THROUGHOUT FLOOR JOISTS
