Internal Decay Assessment of Common Lime (O)

1-9 Old Park Hill Bristol BS2 8BB

For University of Bristol October 2023

Ref: 23642Dv01

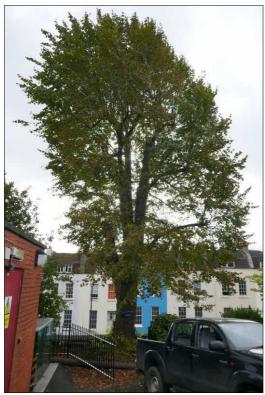
Pl. 1 – Common lime

Growing on top of 10m high retaining wall overhanging Park Row. 27m N of buildings. Extensive basal epicormics.

Bark anomaly/dysfunction from 0.6m-1.2m above ground level (agl) on N aspect.

Stem lesion on S aspect with bark fissure from 1m-2.5m agl.

Virtually occluded cavity at approx. 1.2m agl on S aspect with significant exudation. Probed to 30cm radial depth.

Partially occluded pruning wound/cavity at 2.2m agl on SW aspect.

Scaffold stem at 2.5m agl on E aspect truncated at approx. 2m from union.

Lapsed pollard at 3.5m agl to 3x primary stems and 1x sub-dominant stem (plus 1x truncated) – acute forks with bark inclusion.

Reduced at 10m agl with approx. 5m regrowth.

- 6.7 In my opinion, based on the survey findings, the tree may be retained but should be visually inspected annually to monitor any change to its condition. Given its location on top of a large retaining wall, it should continue to be managed at a reduced scale by cyclical crown pruning.

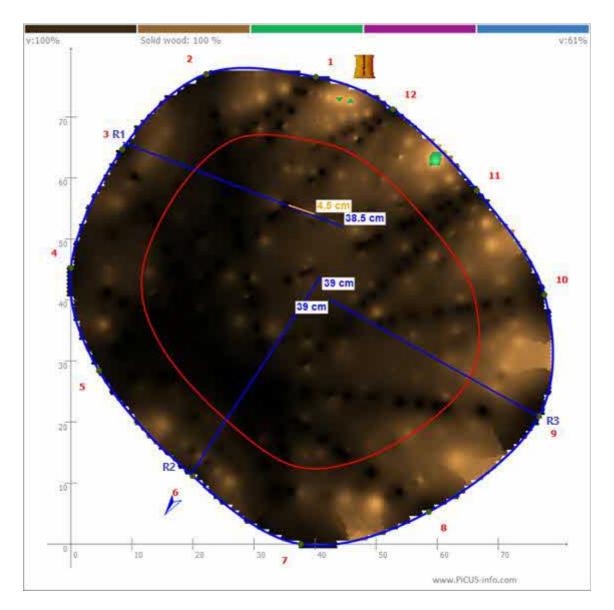
Tomogram taken at 120m agl.

- 6.1 The tomograph indicates no decay or reduction in wood density at measurement level with 100% of the cross-section identified as sound wood. The most likely reason for this is that the cavity/decay is too small in diameter to register a sufficient sonic delay to trigger a change of colour on the tomograph image. Furthermore, the defect is virtually occluded and surrounded by strong reaction wood. This type of wood has significantly better acoustic properties and modulus of elasticity than primary growth. Analysis of the sound paths confirm consistent transmission speeds throughout the cross-section, which therefore hide the defect.

- 6.6 The small cavity is presumably a result of historical branch removal, which has now virtually occluded and is surrounded by strong wound wood. The ratio of remaining sound wood is within accepted safety margins and the tree has a modified crown structure and therefore a high basic safety factor.

Stem diameter at measurement level is 80cm.

The direction and radial depth of sound wood (excluding bark) identified by the resistograph readings (R1, R2, R3) is shown in centimetres and indicated by the blue lines. The extent of decay identified at R1 is shown by the orange line.

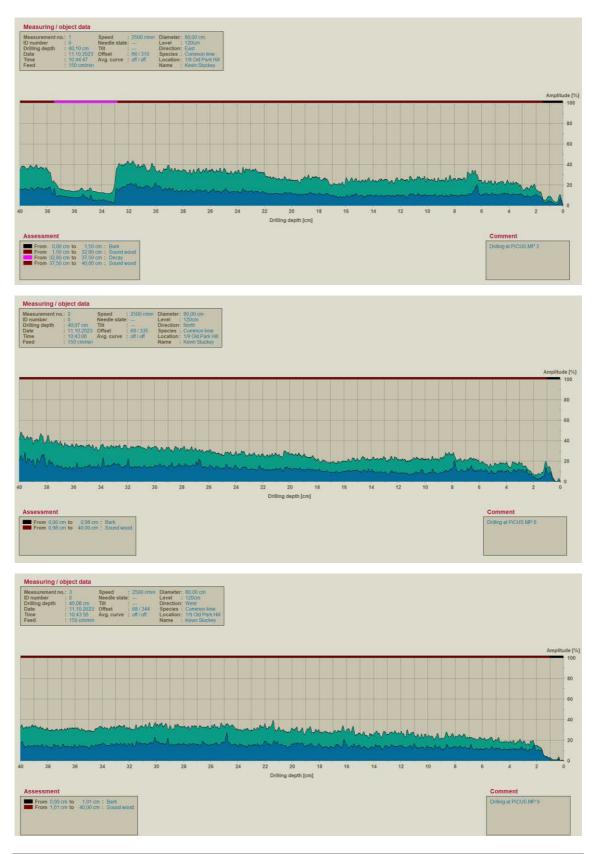
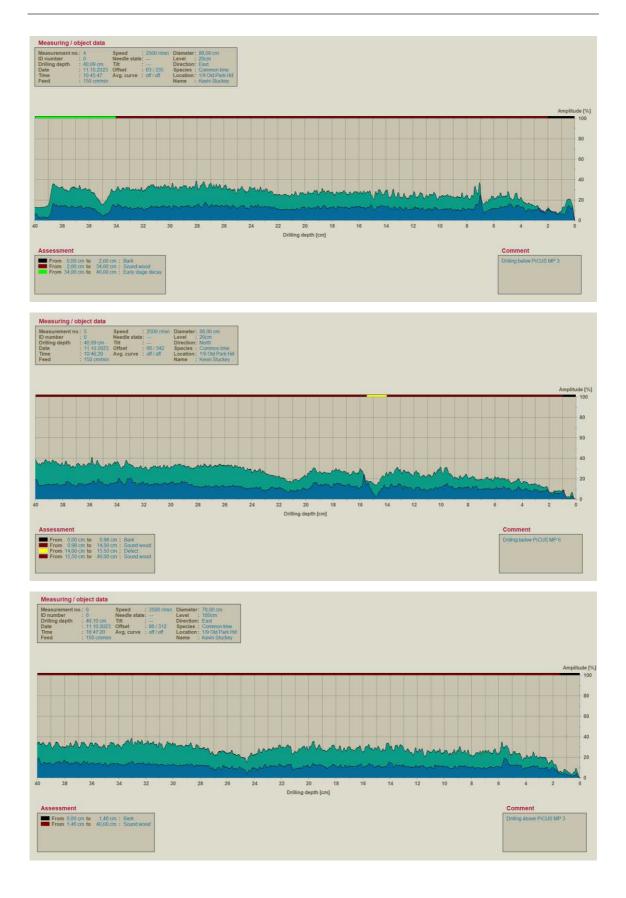
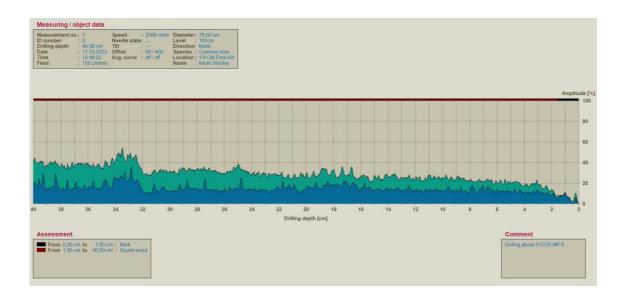
- 6.2 Three resistograph readings taken at 120cm agl confirm that the cavity/decay is very small. Reading R1 taken on the east aspect identifies a small pocket of decay from 31.5cm to 36cm. Readings R2 and R3 taken on the north and west aspects indicate sound wood to maximum drill depth.

- 6.3 R4 taken at 20cm agl on the east aspect also identifies a small pocket of decay at a depth of 32cm. R5 taken on the north aspect confirms sound wood to maximum drill depth.

- 6.4 Two readings R5 and R6 taken at 160cm agl identify sound wood to maximum drill depth.
- 6.5 It was not possible to take resistograph readings on the south aspect due to the proximity of the retaining wall.

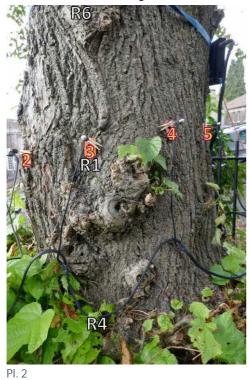
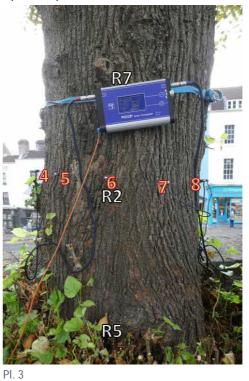
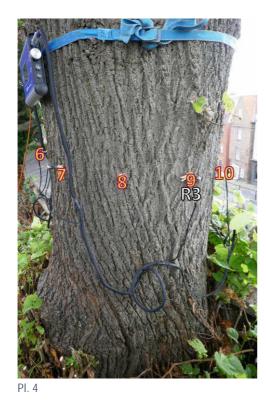
PiCUS MPs at 120cm agl shown in red. Resistograph drill points R1 to R7.
