Development tree report for Mr & Mrs Grimwood

1 Lancaster Avenue,
Guildford,
Surrey,
GU1 3JR

This report is an arboricultural assessment to cover the requirements under B.S.5837:2012 - Trees in relation to design, demolition, and construction.

Prepared by Steve Wood (O.N.D. Arboriculture M.Arbor.A.) for and behalf of SMW (Tree) Consultancy Ltd on 21st November 2023

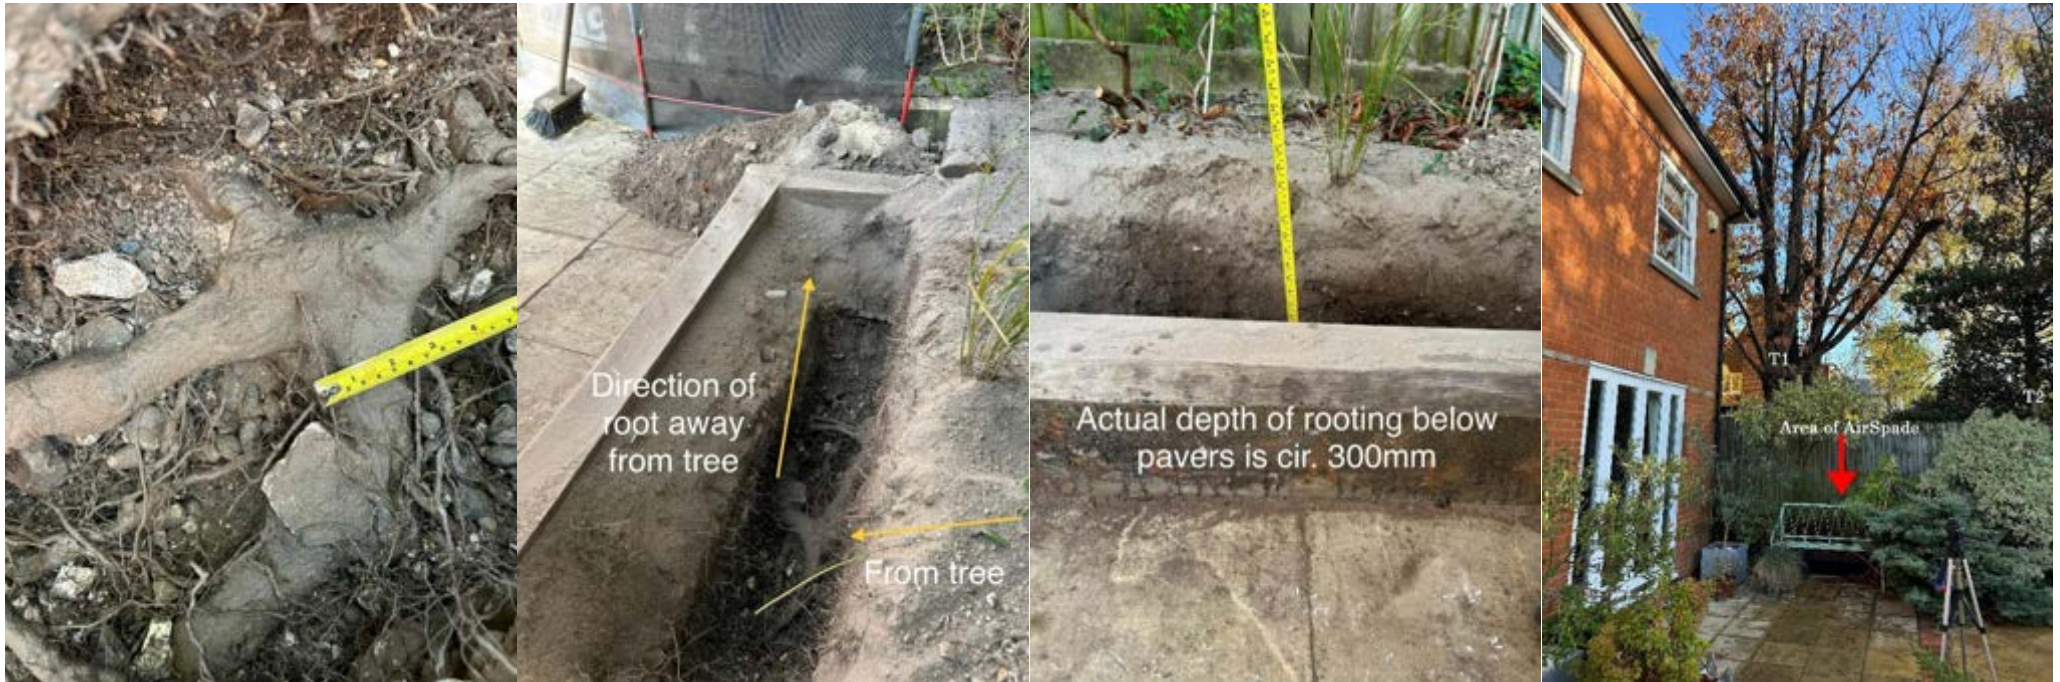
An AirSpade investigation was implemented approx. 0.5m from the proposed foundations of the conservatory and approx. 1m from T1. This revealed a root structure at approx. 300mm below the level of the patio. At this point, the root towards the proposed conservatory foundation measures 55mm in diameter. We believe that at the point of the foundation, this root will be of a size which will either: a) be able to be professionally pruned by an arborist (below 25mm), or b) will be able to be bridged using a specialist foundation. An example of which can be found in the [Specialist engineered foundations within RPAs section](#) of this report.

The below pictures are photographic evidence taken at the time of the AirSpade investigation of the root mentioned above.

The foundation line of the proposed conservatory must be excavated by hand and under arboricultural supervision.

If roots under 25mm are found, these may be pruned by a suitably qualified arboriculturist, providing they do not form a cluster.

If roots larger than 25mm are found, these must be retained.

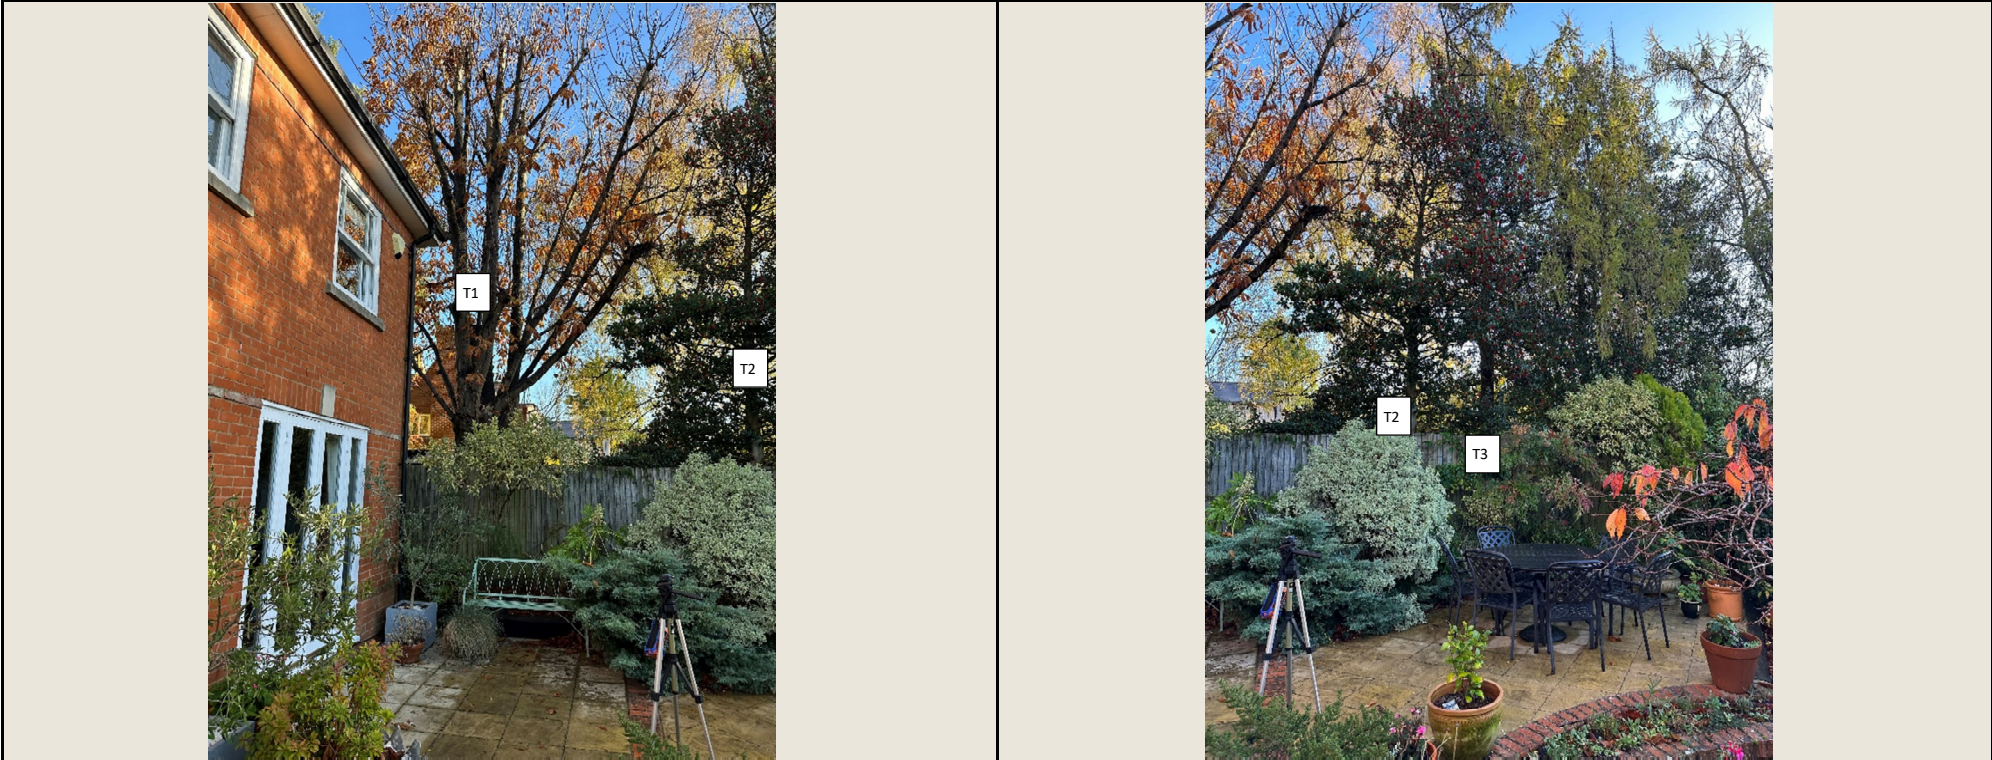
Surveyed trees located in neighboring property to the east.

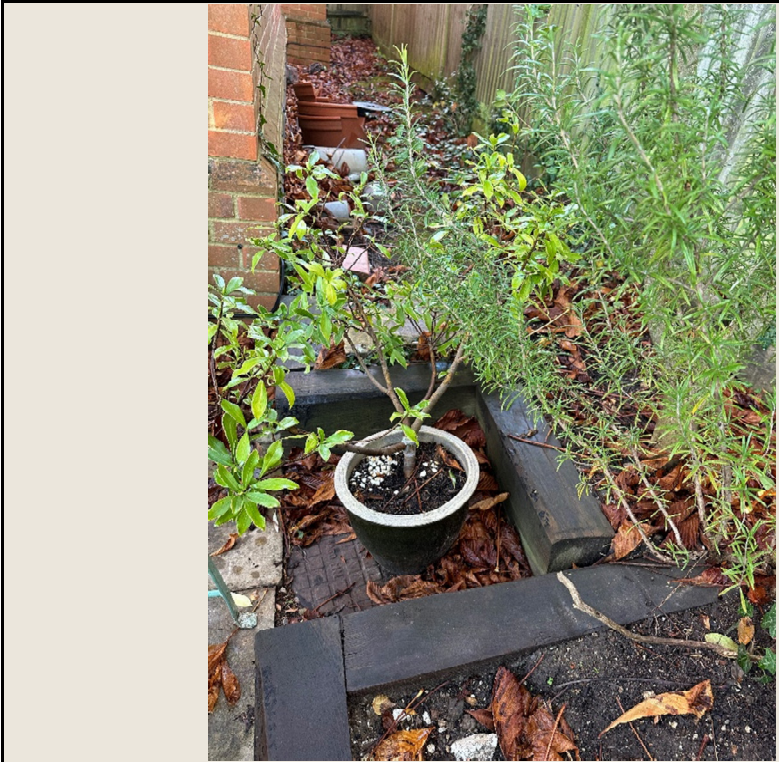
Drainage cover located close to existing property and surrounded by raised vegetation bed.

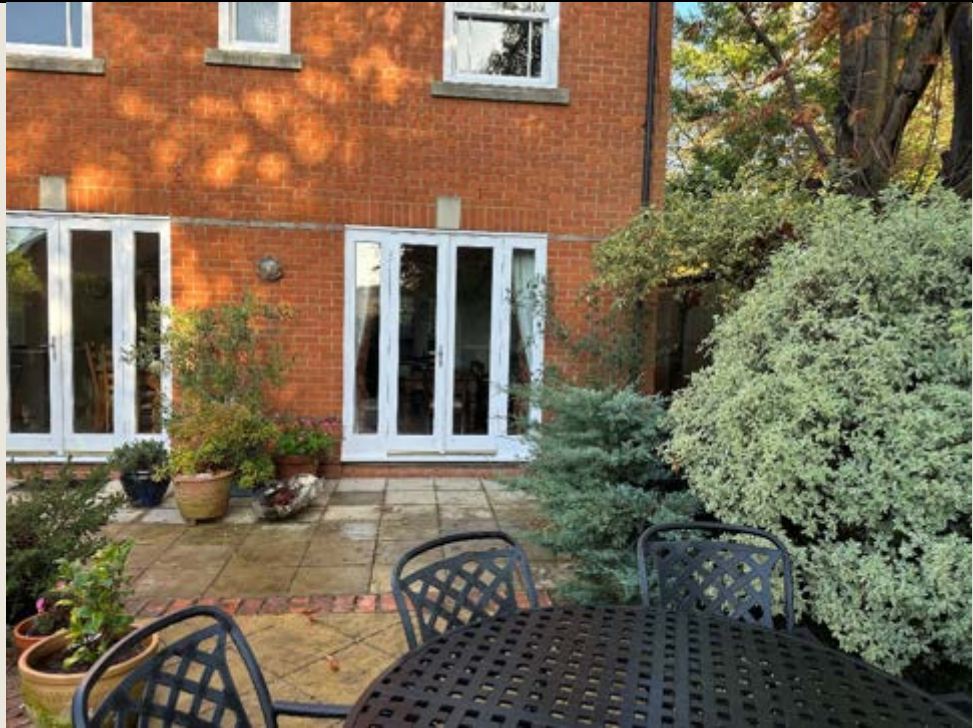
Area of proposed conservatory.
