# Tree Condition Survey and Report

The Old Vicarage, Nailsworth, GL60QS

19<sup>th</sup> January 2024

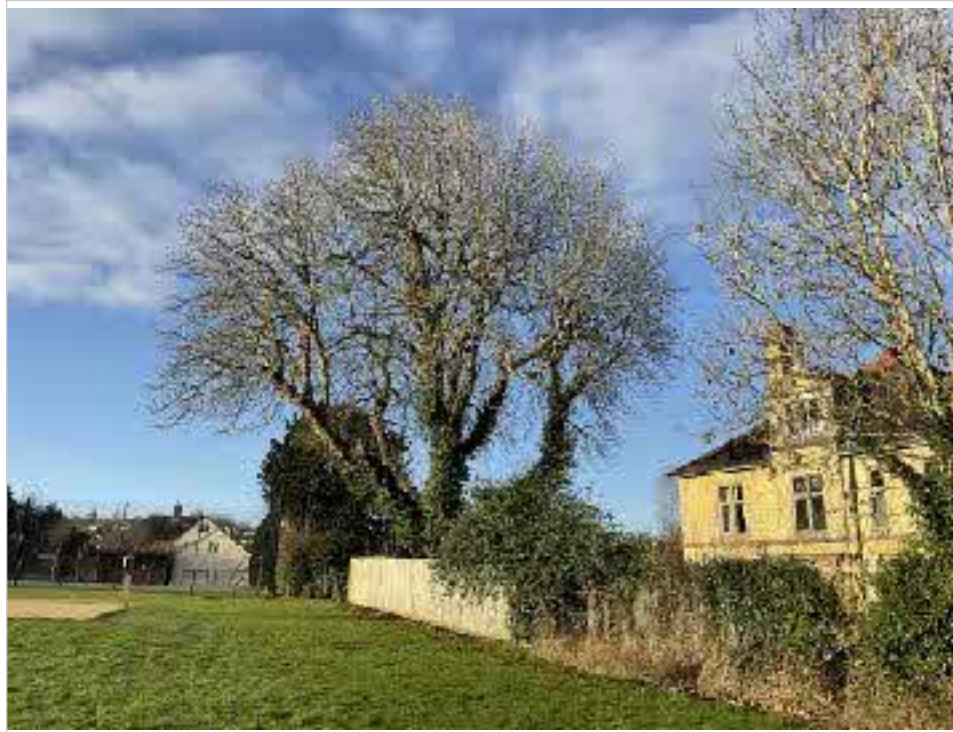
- 6.9 The tree is large for its location being under 9 metres from the rear elevation of the dwelling. The canopy does overhang the main dwelling as well as neighbouring gardens and the public open space to the south.

**Photo 1:** Looking west towards mature the Horse chestnut T1 which is situated close to the boundary fence to the property. Note the canopy overhangs part of the adjacent open space area.

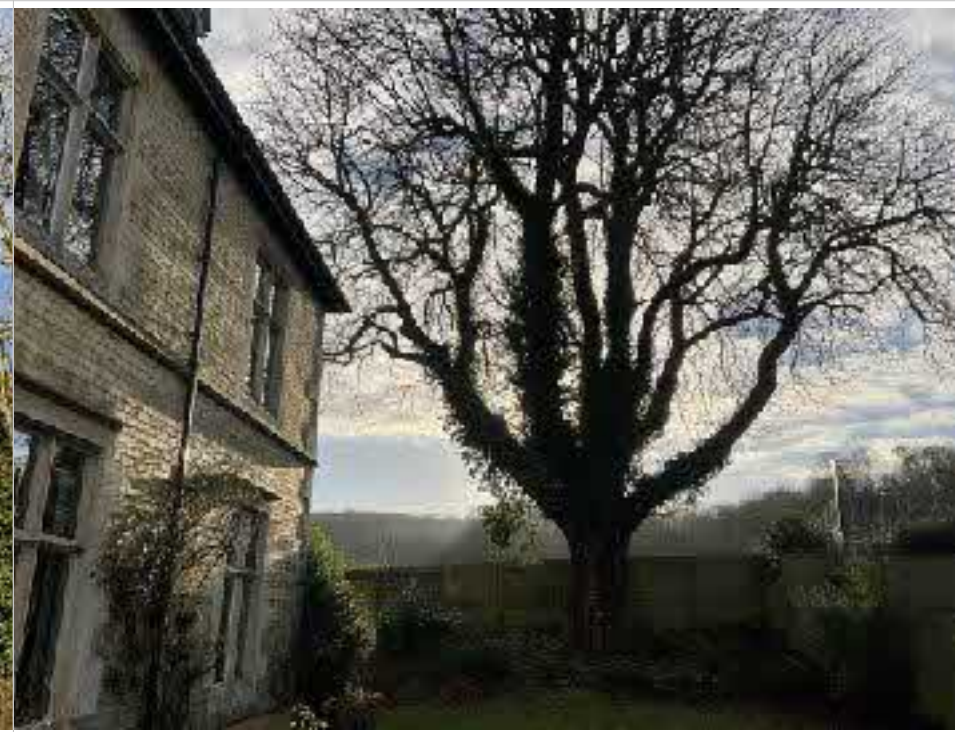
**Photo 2:** Looking south-east towards Horse chestnut T1. The tree is approximately 8.5m from the adjacent dwelling.

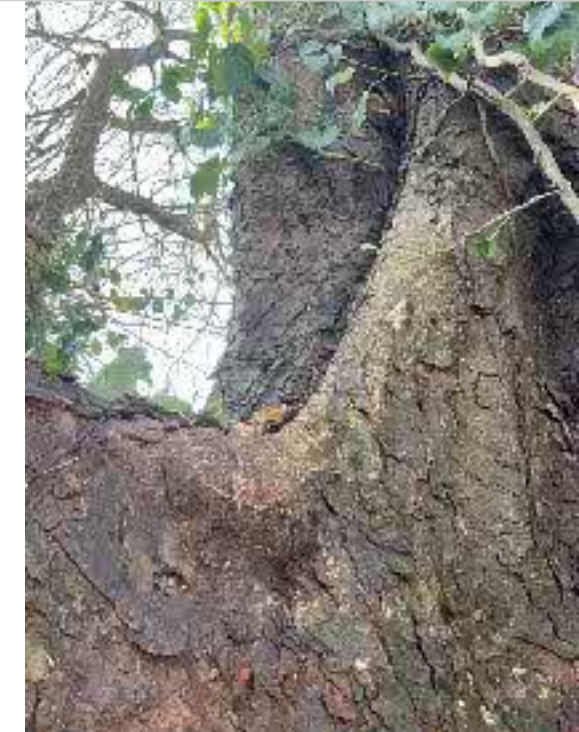
- 6.7 More of a concern is the recent (2017) excessive canopy lift to approximately 9 metres. This has resulted in the main scaffold branches being 'end weighed' (where all the weight and leaf mass is retained at the end of a main branch). This in turn can change the mechanical balance to the structure of the canopy. This 'high-canopy' form could make the tree more susceptible (during adverse weather conditions) to limb failure due to the increased stress between the unions and the main stem. Having said that, these unions are reasonably good, and the tree has laid down good adaptive growth on upper side of the union (Photo

- 3). It was also noted that the tree has recovered well from the canopy lifting works, with significant epicormic growth to all major limbs within the lower canopy section. This will form a new lower canopy over time and help stabilise the tree.

**Photo 3:** One of the unions (stem over open space area). Note adaptive growth on the upper side of the union. No decay pockets were noted at all unions within the bole.

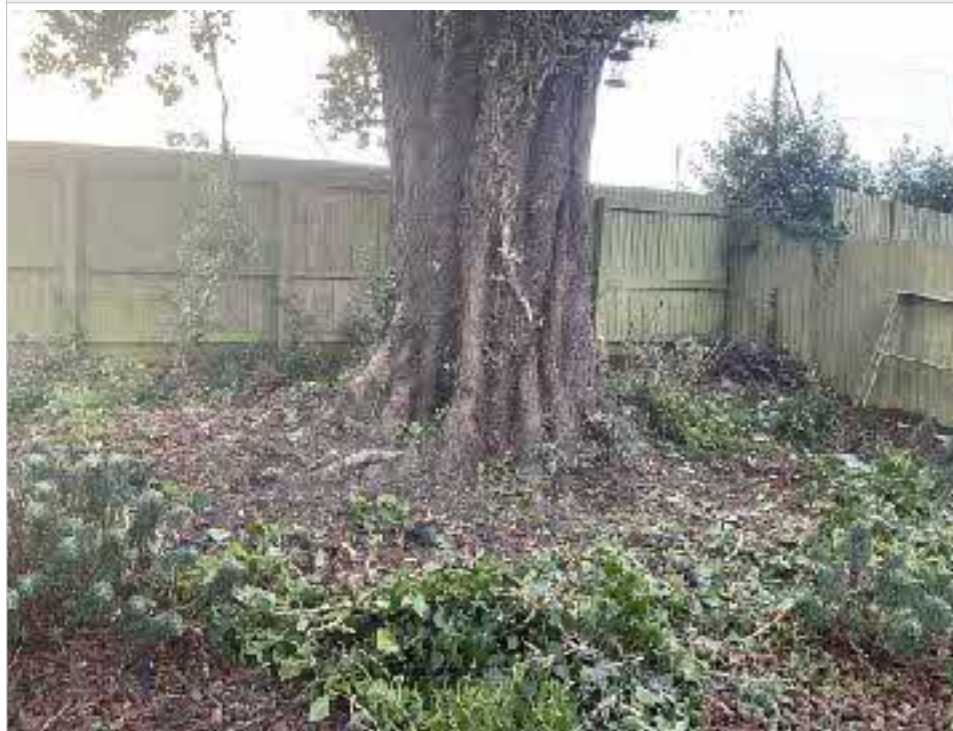
- 6.5 The tree had mature ivy to the stem which inhibited inspection and therefore was removed with hand tools to 4m in height to reveal the tree stem and bole area. On inspection, there are no significant defects to the stem and main bole area. Unions for the substantial main scaffold branches were considered good with adaptive growth bolstering the unions. Some fibre-buckling was noted to the underside of some of these substantial limbs but not thought to be significant.

**Photo 4:** Looking south towards the stem of Horse chestnut T1. The mature ivy was removed from the stem to allow the inspection.

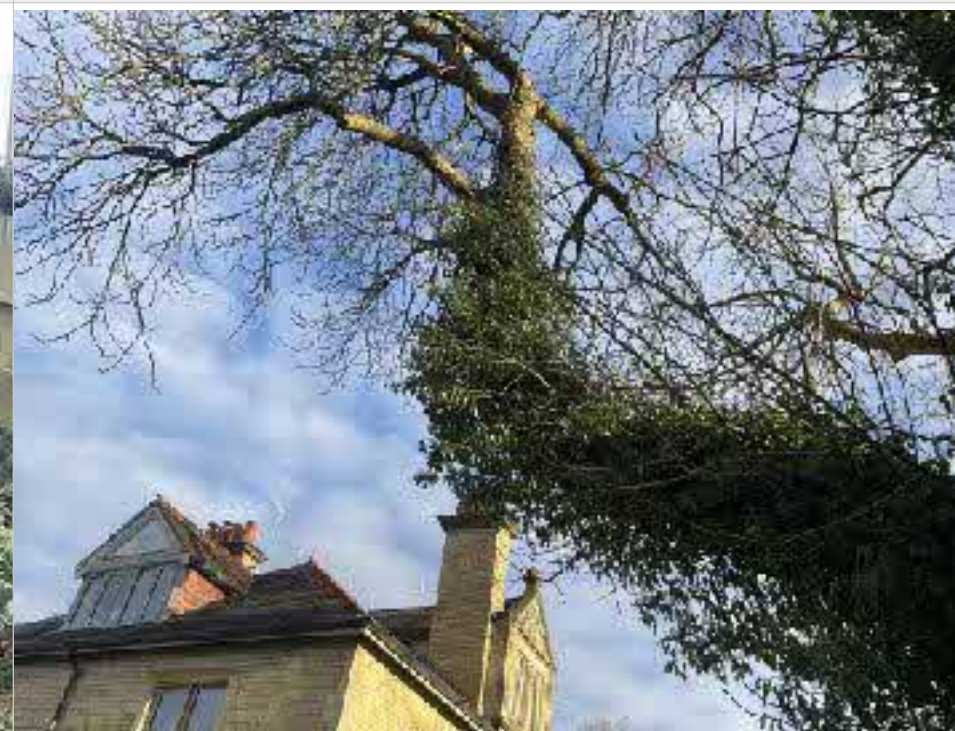
**Photo 5:** Limb to the north growing towards the dwelling. Note that the lower laterals have been removed in the past resulting in an end weighed limb, this is consistent with all other main scaffold limbs.

- 7.5 Considering the above, I would recommend a canopy reduction of the tree which would address many issues the tree presents for its location. It should be possible to reduce the canopy by 40% and still retain the overall amenity of the tree but reduce the over-bearing effect the tree presents. As other canopy reductions have already been allowed to other protected trees within Vicarage Gardens, this has set a precedent and SDC are likely to allow the proposed works.

- 7.6 As the tree was measured at 23 metres in height, this would equate to a 9-metre reduction from its height with a reduced lateral reduction (4-5 metres) to allow the trees form to be retained.

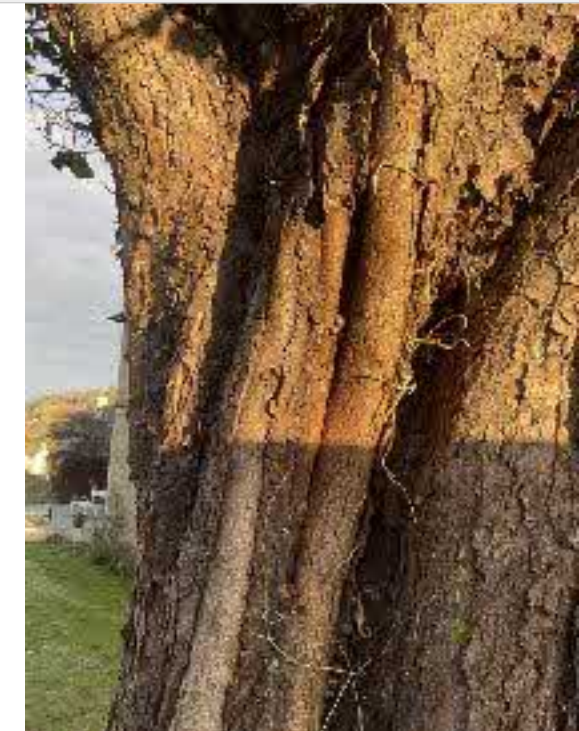
**Photo 6:** Longitudinal historic bark damage to south-western section of stem. No decay identified and adaptive growth noted around the old wound. This feature is not thought to be significant.
