BS: 5837:2012 paragraphs relevant to Arboricultural Report, The Bull, Langley, Essex.

Conversion of Nissen Hut, Garage Out-building, Associated Landscaping and New/Revised Vehicle Access & Parking Layouts

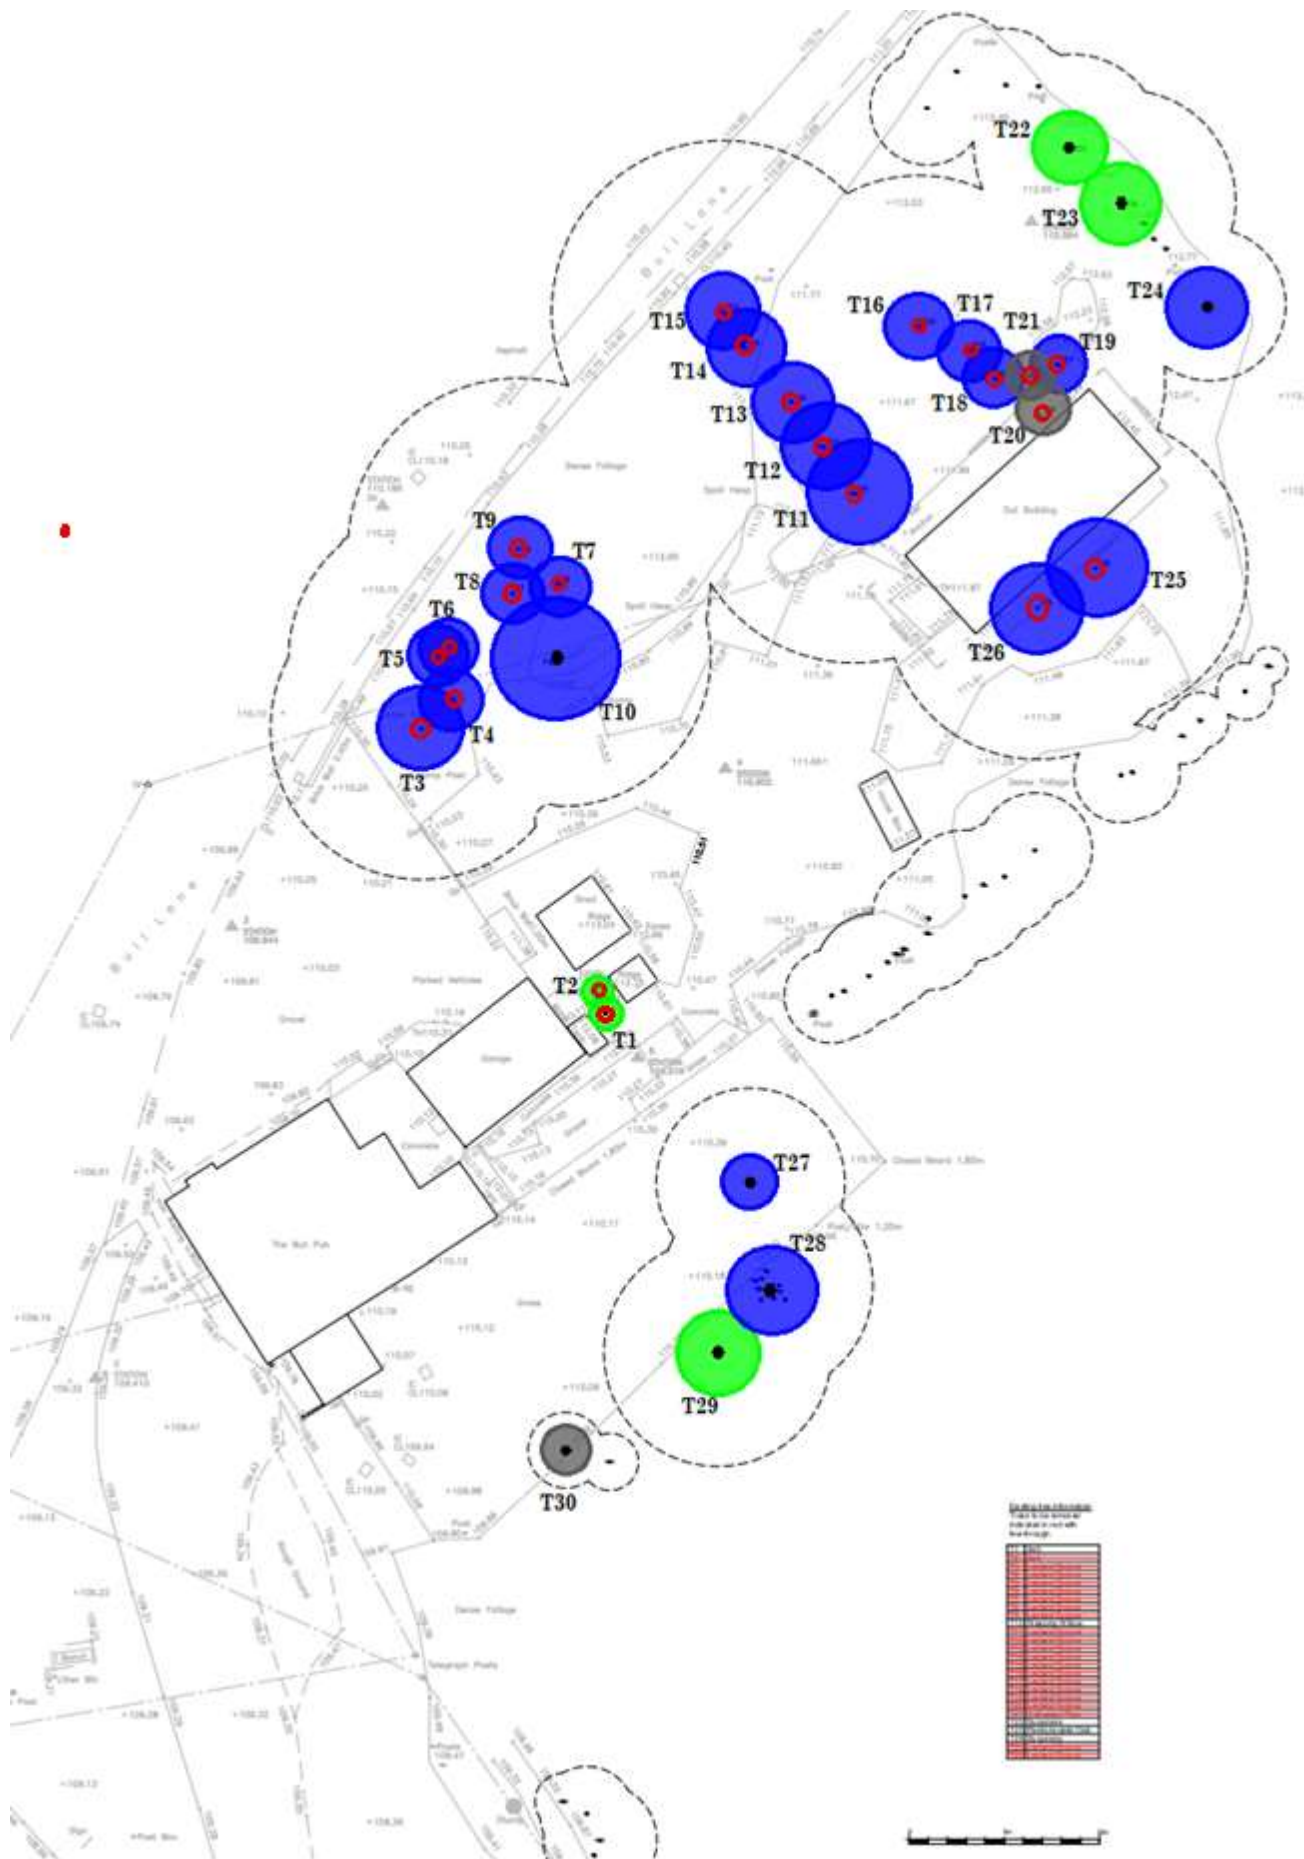
Above drawing number 25 HAR 3 showing position and condition in BS 5837: 2012 colours. RPAs are marked on 25 HAR 2.00, those marked with a Red Ring are proposed for removal.

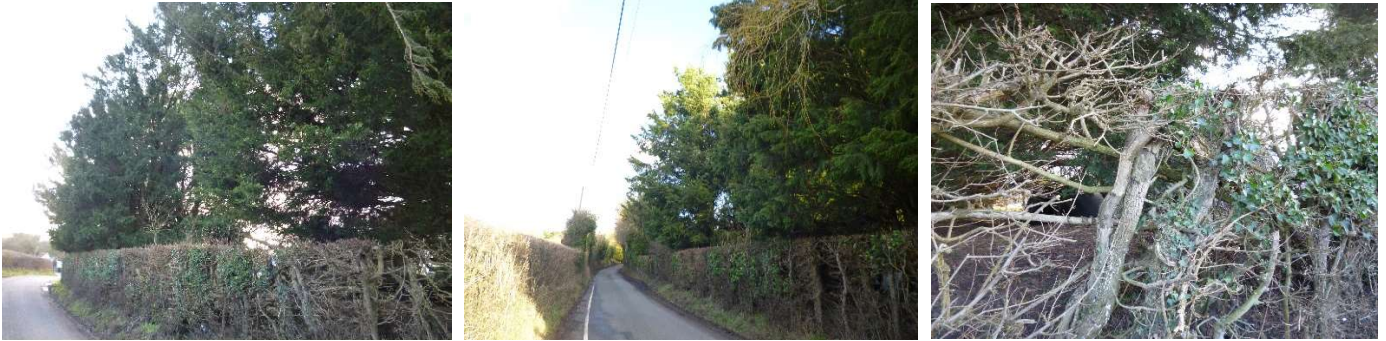
H1 A roadside hedge along Bull Lane which is very close cut comprising mostly of *Ulmus procera*, Rough Leaved or Small Leaved Elm. 28000 mm in length; 1800 mm in height

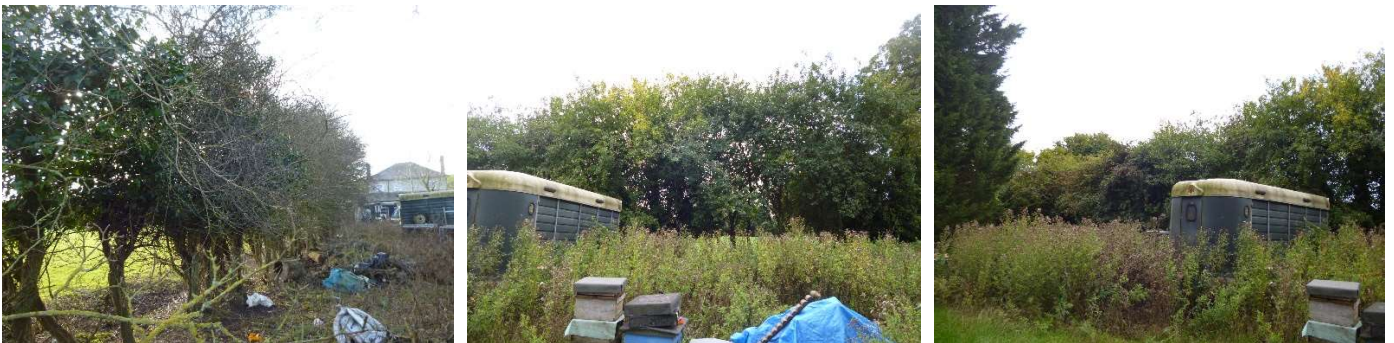
H2 is the mature unmanaged hedge along the southeast boundary. It comprises of mostly *Crataegus monogyna*, Common Hawthorn. Length 30000 mm with a few weak points along application SE boundary; 3000-3500 mm high.

1 Shading of buildings. The final design would receive natural sunlight from the NNE direction from sunrise at the summer solstice right through until late evening. At the winter solstice the same is true if the south-eastern boundary hedge is pruned and maintained to 2200 mm in height. A great deal of thought has gone into this hedge management to allow as much light as possible yet maintaining the biodiversity potential that can be achieved.

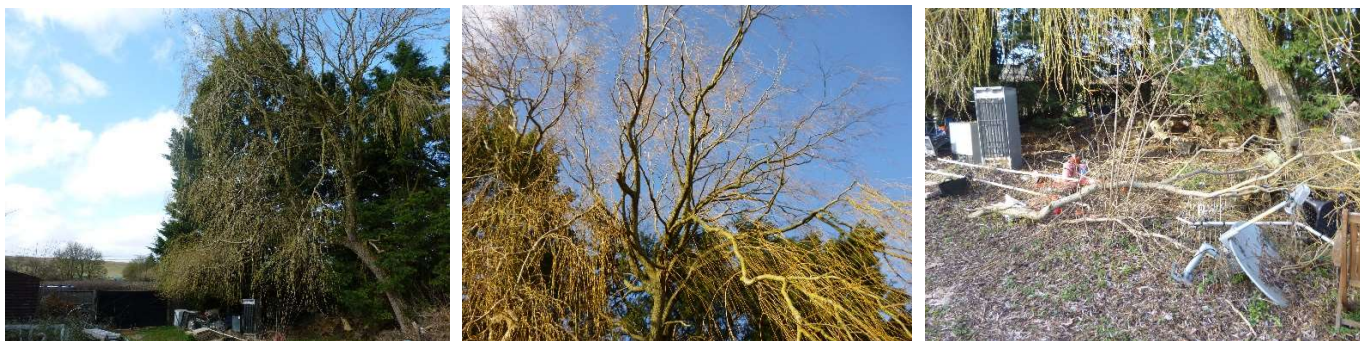
d) Only T10 requires pruning. At present this tree leans markedly to the south. Regardless of this application, this tree needs some remedial pruning to balance the crown and to remove the dead material. With this remedial work completed the long-term future of this tree is improved. See images below.

c) No pruning required with the exception of T10. This pruning is for the long-term benefit of the tree, it would not necessarily interfere with the designs in this application.

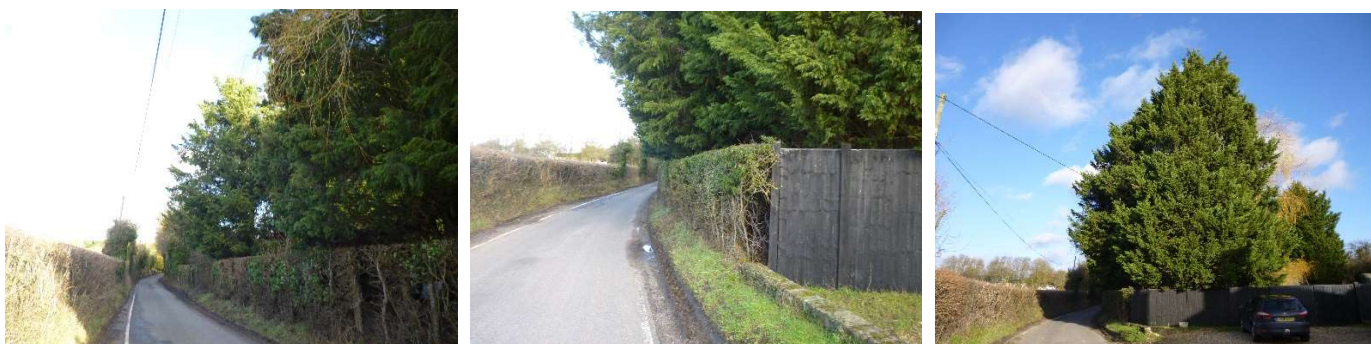
3. The loss of 21 *Cupressocyparis x leylandii* will have a large impact on the landscape. These trees as with so many others throughout the UK., were planted with the best intention. Having no maintenance for decades, these trees are now a liability as limb failure has commenced. Some canopies hang over the carriageway and are a threat to road users.

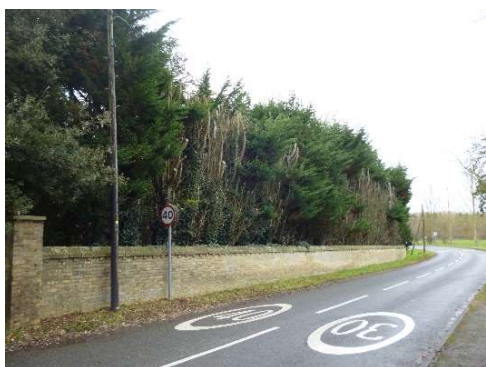
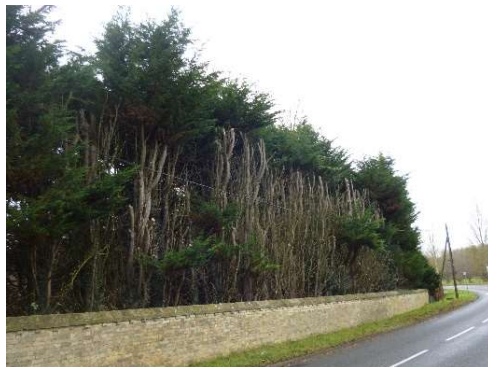
Rather than removing the roadside trees one could suggest pruning back the side growth level with the boundary. This would be ill-advised as regrowth is not always the result. See below an example of this in Whittlesford, South Cambridgeshire, 2023; surgery undertaken 2019.
