**Job No. 25454**

**NISSEN HUT,  
LAND REAR OF THE BULL,  
LANGLEY LOWER GREEN,  
ESSEX CB11 4SB**

**REPORT  
ON  
STRUCTURAL INSPECTION**

**Re : Structural Inspection of Existing Nissen Hut behind The Bull P.H., Langley Lower Green, Saffron Walden, Essex CB11 4SB.**

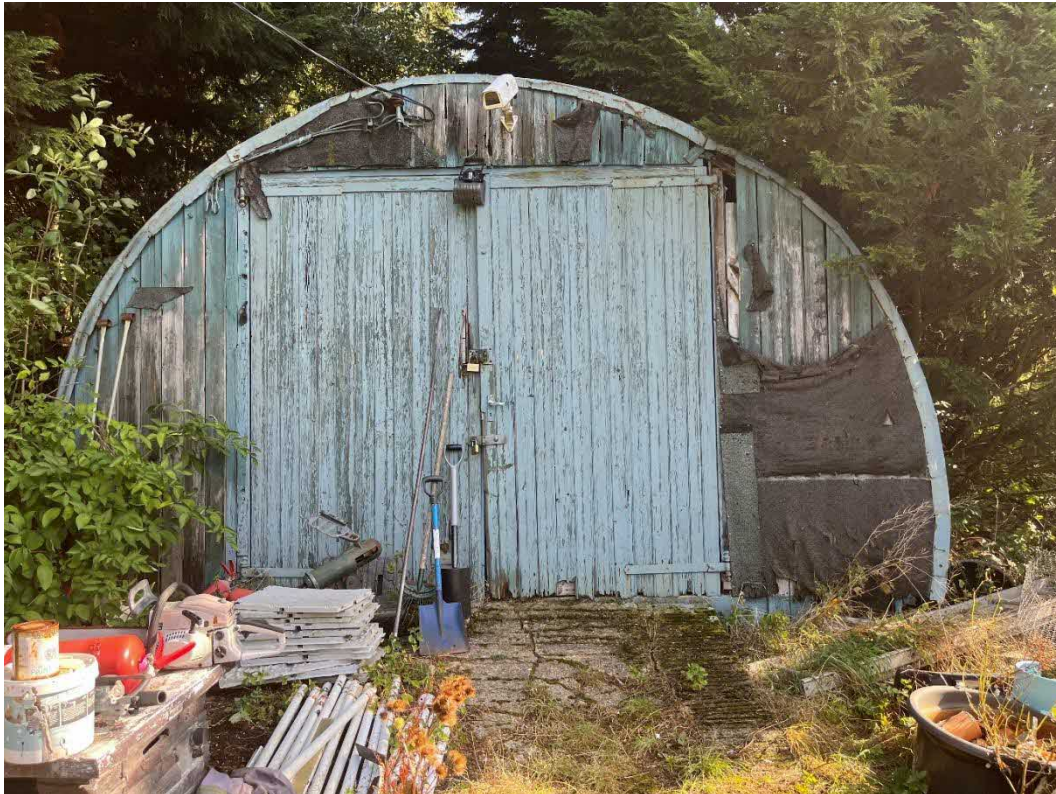
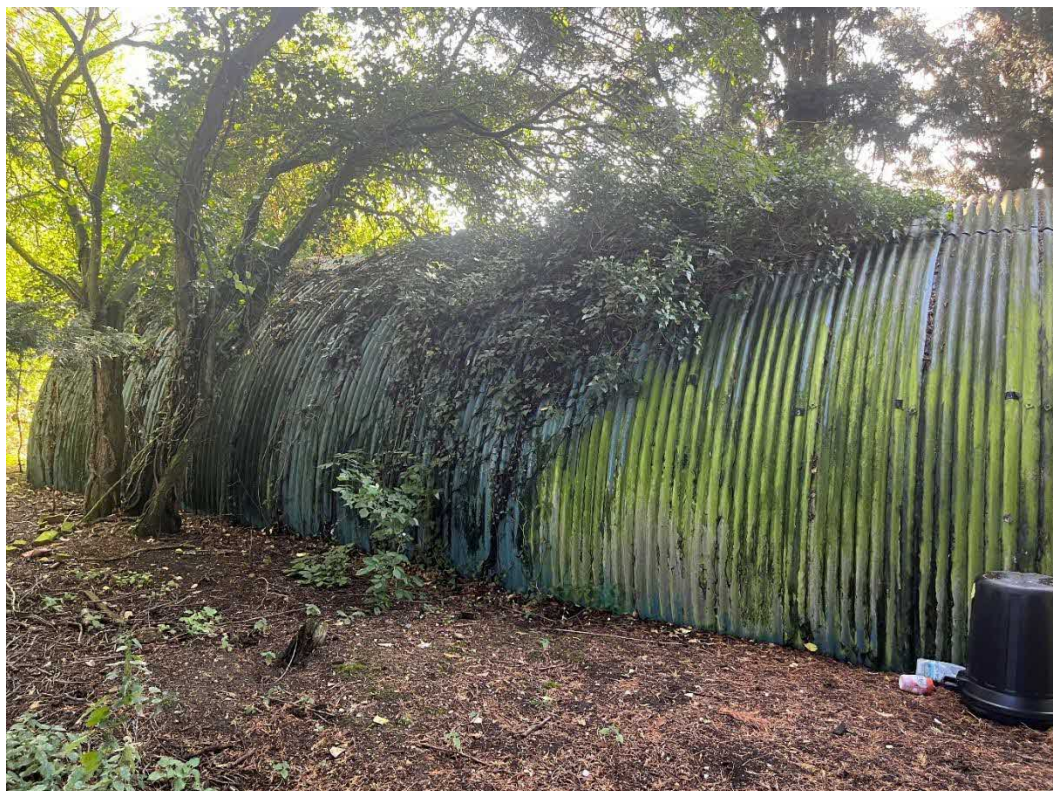
Existing Nissen Hut.

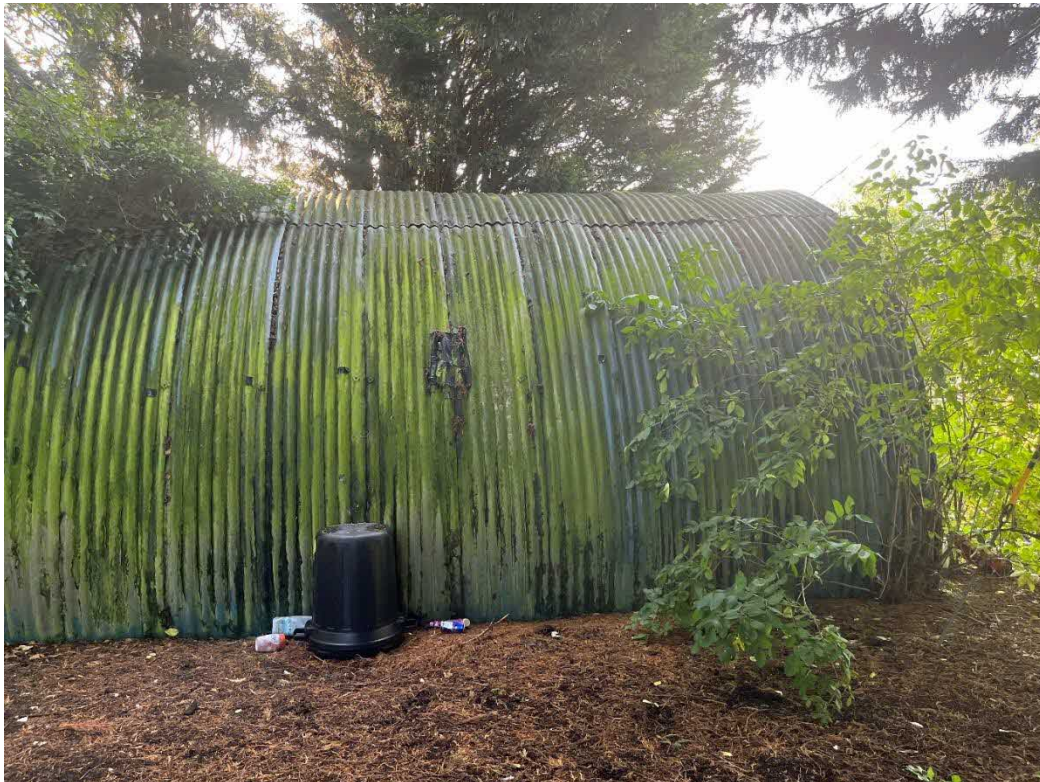
Side Elevation, showing the existing corrugated metal (Iron) sheeting.

- 4.02 We would recommend that new SIPS profiled panels are added to the exterior of the ribs and purlins, after removal of the corrugated iron sheeting. These ribs and purlins must be grit or sand blasted to remove all corrosion and rust and then painted with a primer and protective coatings to prevent any further corrosion. These existing ribs and purlins will be exposed and expressed on the interior as features, but will also support the weight of the new SIPS panels.

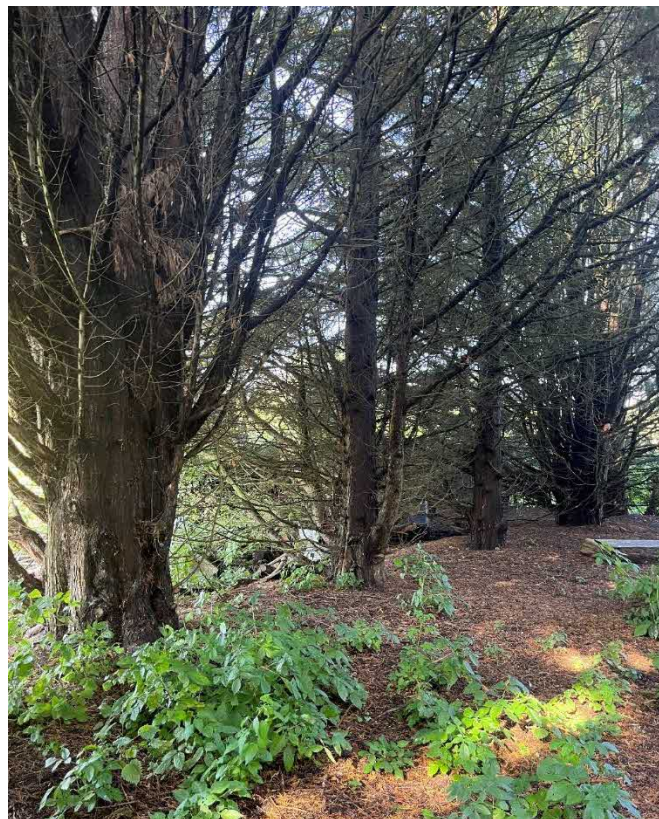
Trees nearby  
will need to be  
removed  
completely.

- 4.04 The mature trees around this hut should be removed completely and the roots ground out to prevent any re-growth.
- 4.05 Should you require any further clarification of any points in this report, or further information or assistance, please do not hesitate to contact the writer.

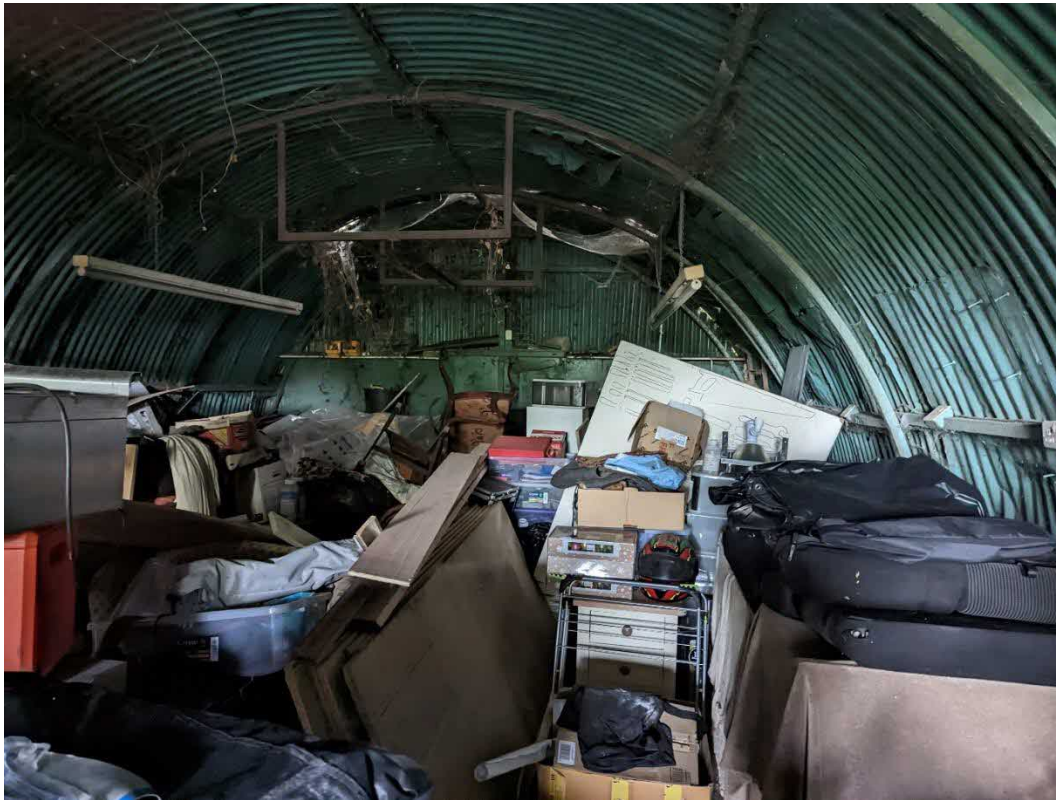
Internal view of Nissen Hut, showing the curved structural T-Shaped ribs, purlins and corrugated Iron sheeting exterior.

- 3.01 The renovation will consist of removing the corrugated iron sheeting, grit/sand blasting the steel ribs and purlins to remove all corrosion and rust and then painting these ribs with a primer and protective coatings to prevent any further corrosion. These existing ribs and purlins will be exposed and expressed on the interior, as a feature and new SIPS panels will be fixed to the exterior.

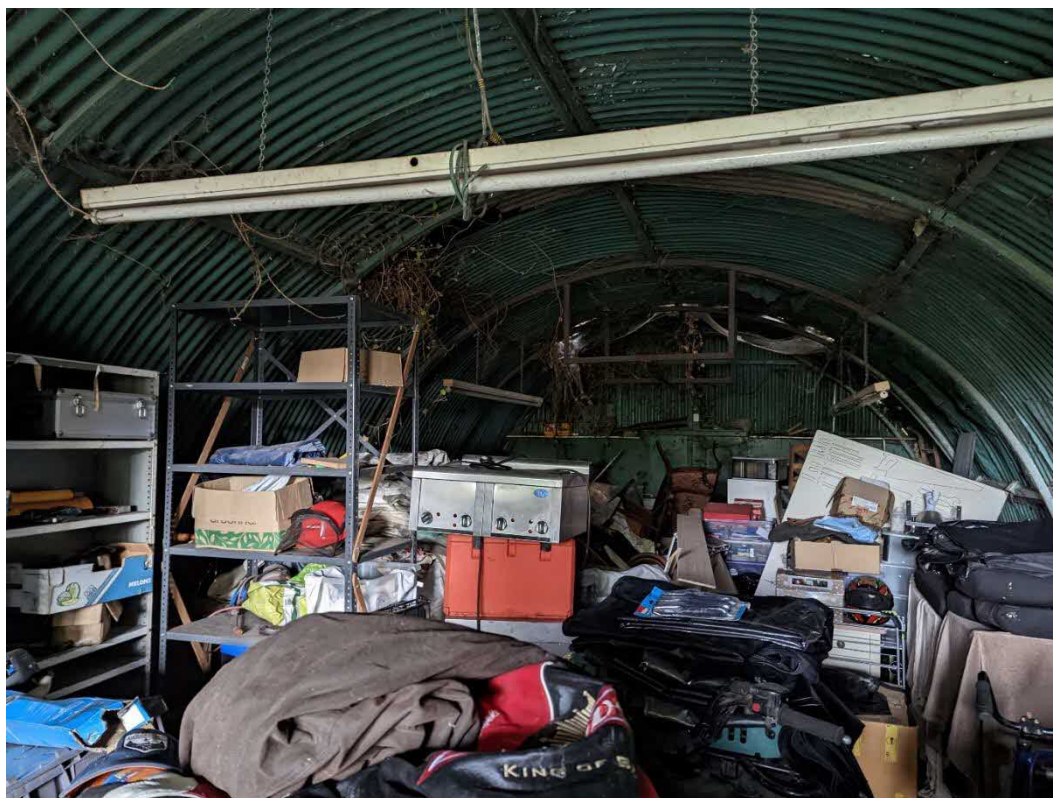
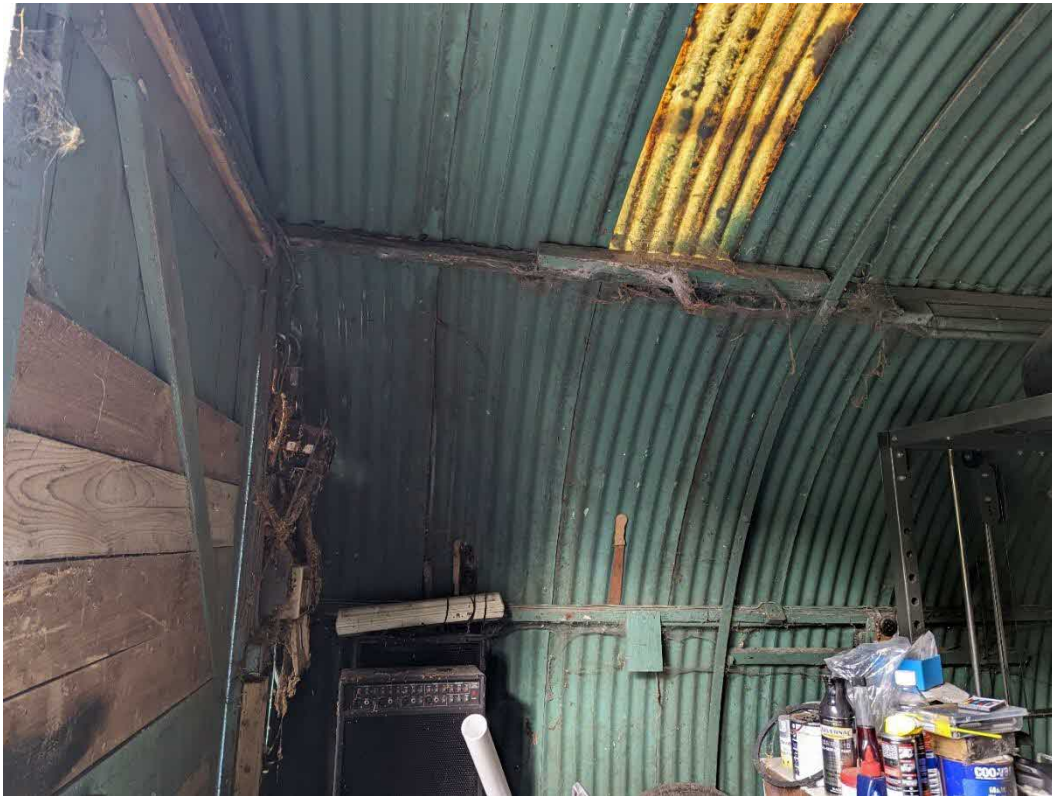
Internal view of Nissen Hut, showing the curved structural T-Shaped ribs, purlins and corrugated Iron sheeting exterior.

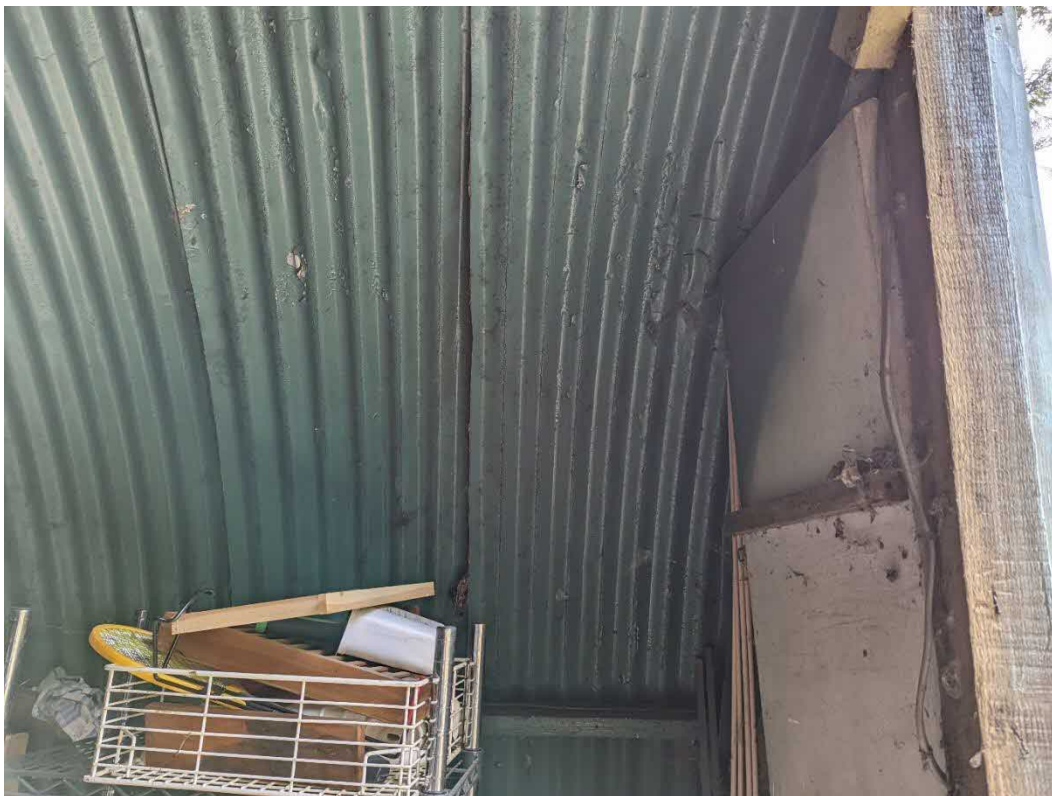
Internal view of Nissen Hut, showing the curved structural T-Shaped ribs, purlins and corrugated iron sheeting exterior.
