DESIGN AND ACCESS STATEMENT FOR CROWN HOUSE, GROTON STREET, GROTON, CO10 5EE

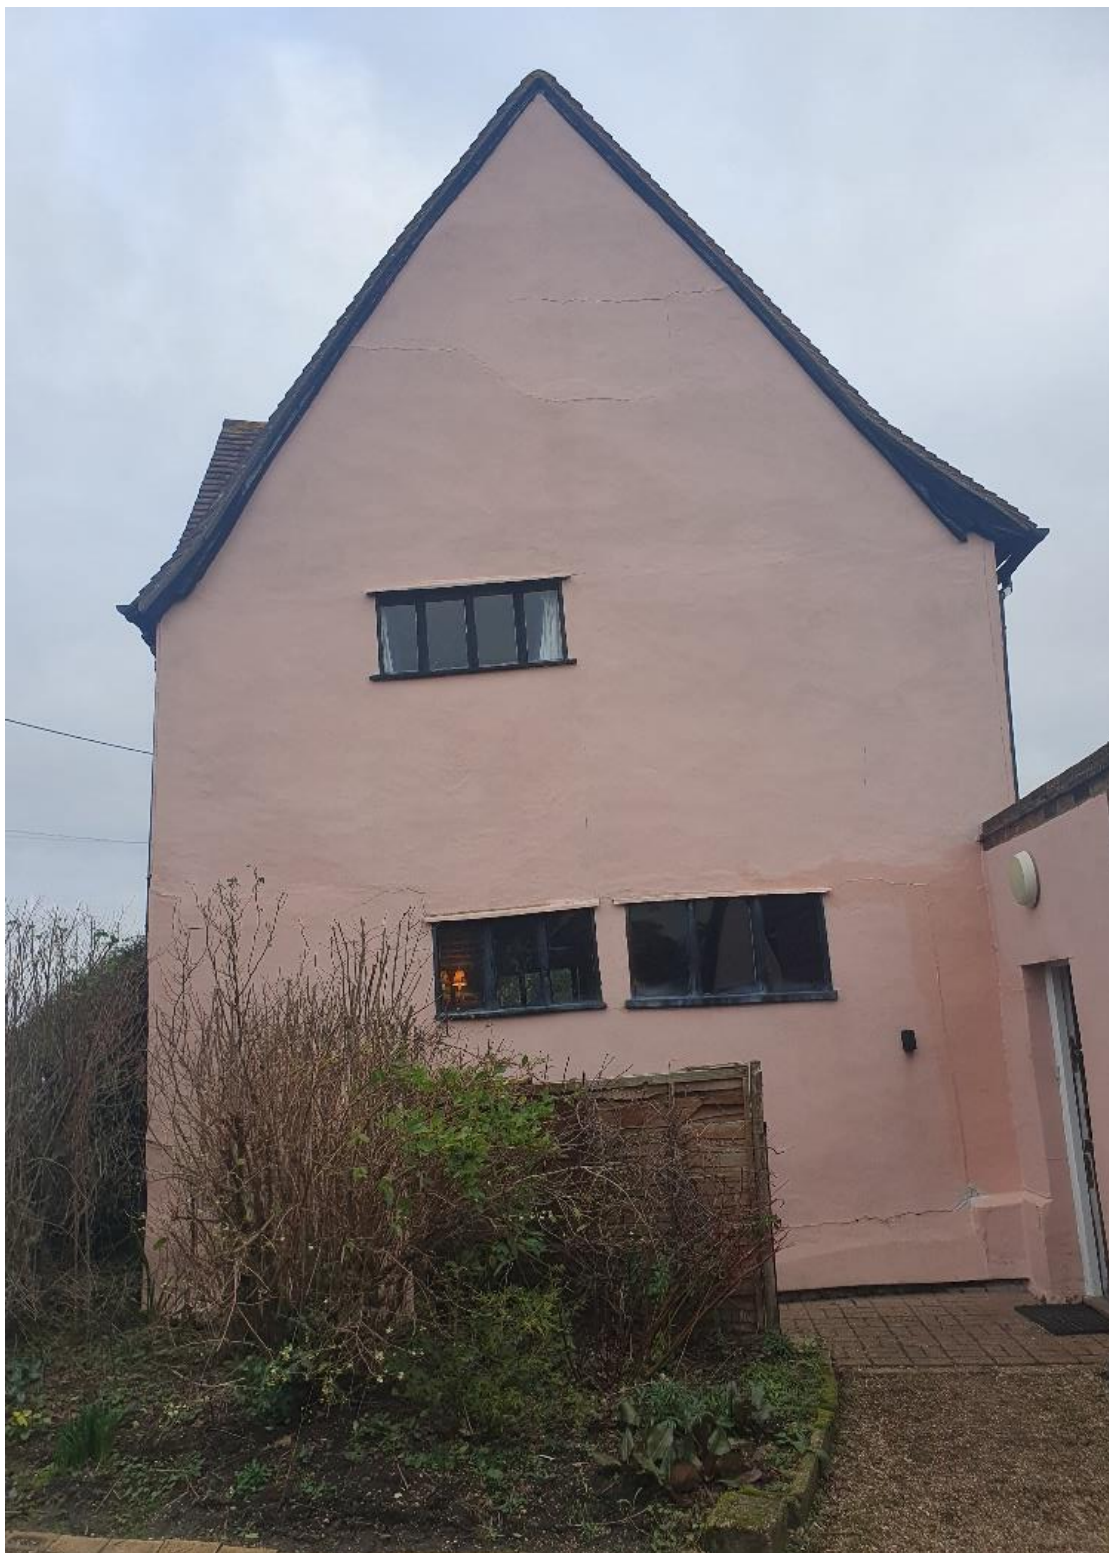
Right Flank (South) Elevation:

The right-hand flank wall at low level has had a new bell drip detail installed. It has been done in cement-based render rather than lime based and this can increase the risk of moisture getting trapped behind the render works causing damage to the sole plate. In August 2022 elevated moisture readings were taken from the sole plate in the dining room.

Since then, we have noticed several large cracks spread across this wall and we have also been concerned at the level of damp on the wall internally and externally.

Erect scaffolding and remove the existing render, apply sheep wool insulation in-between the beams. Cover with breathable savolit board then render with lime putty, float up and sponge to a finish. Leave the site clean and tidy.

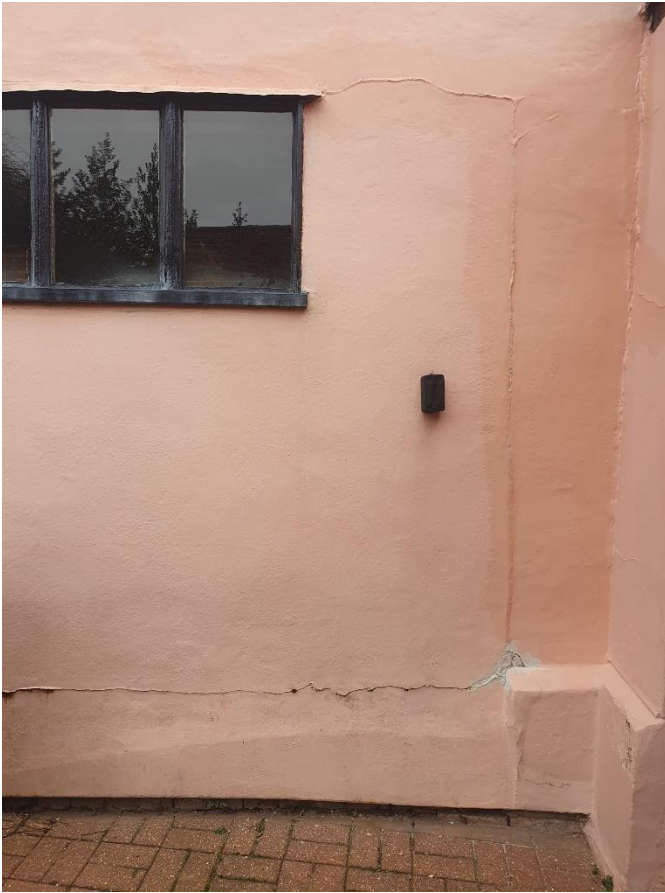
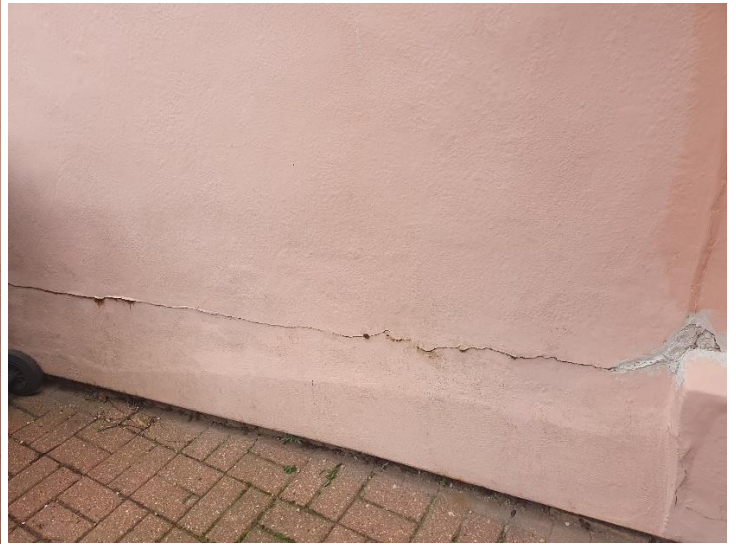
Details of the cracks on the exterior wall of the Right flank (South) elevation:

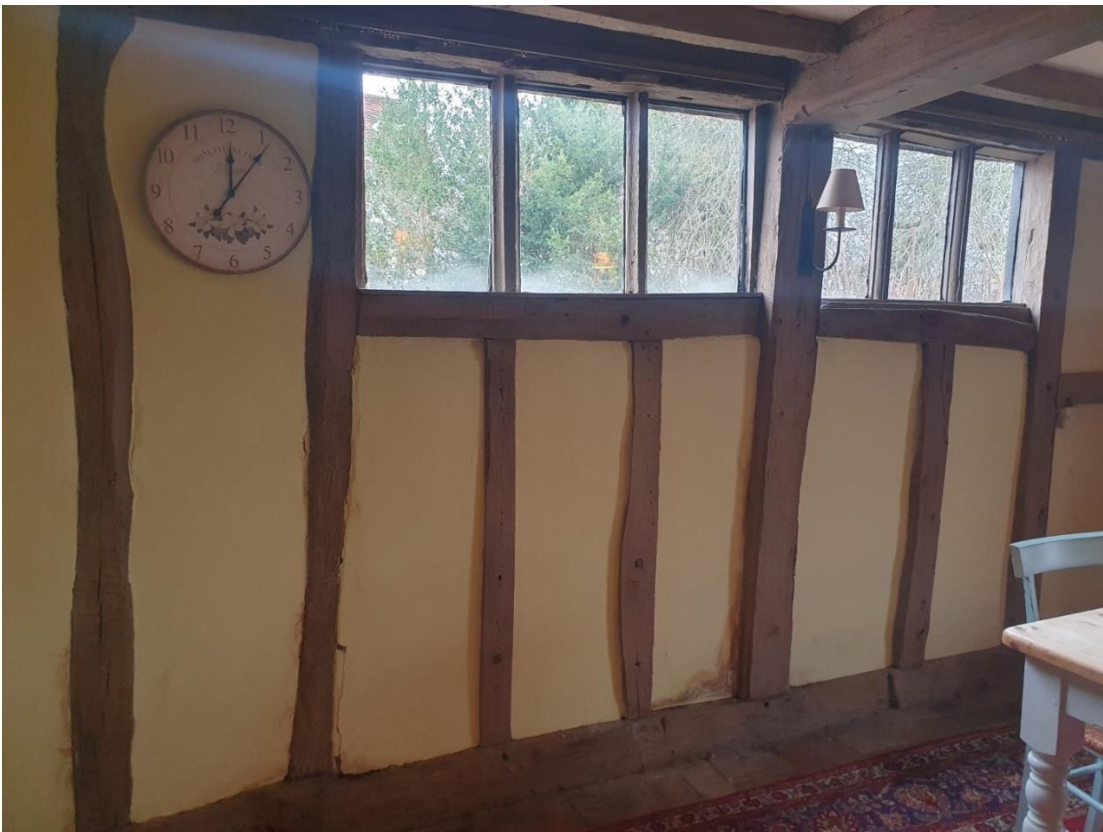
The interior of the right-hand flank wall:

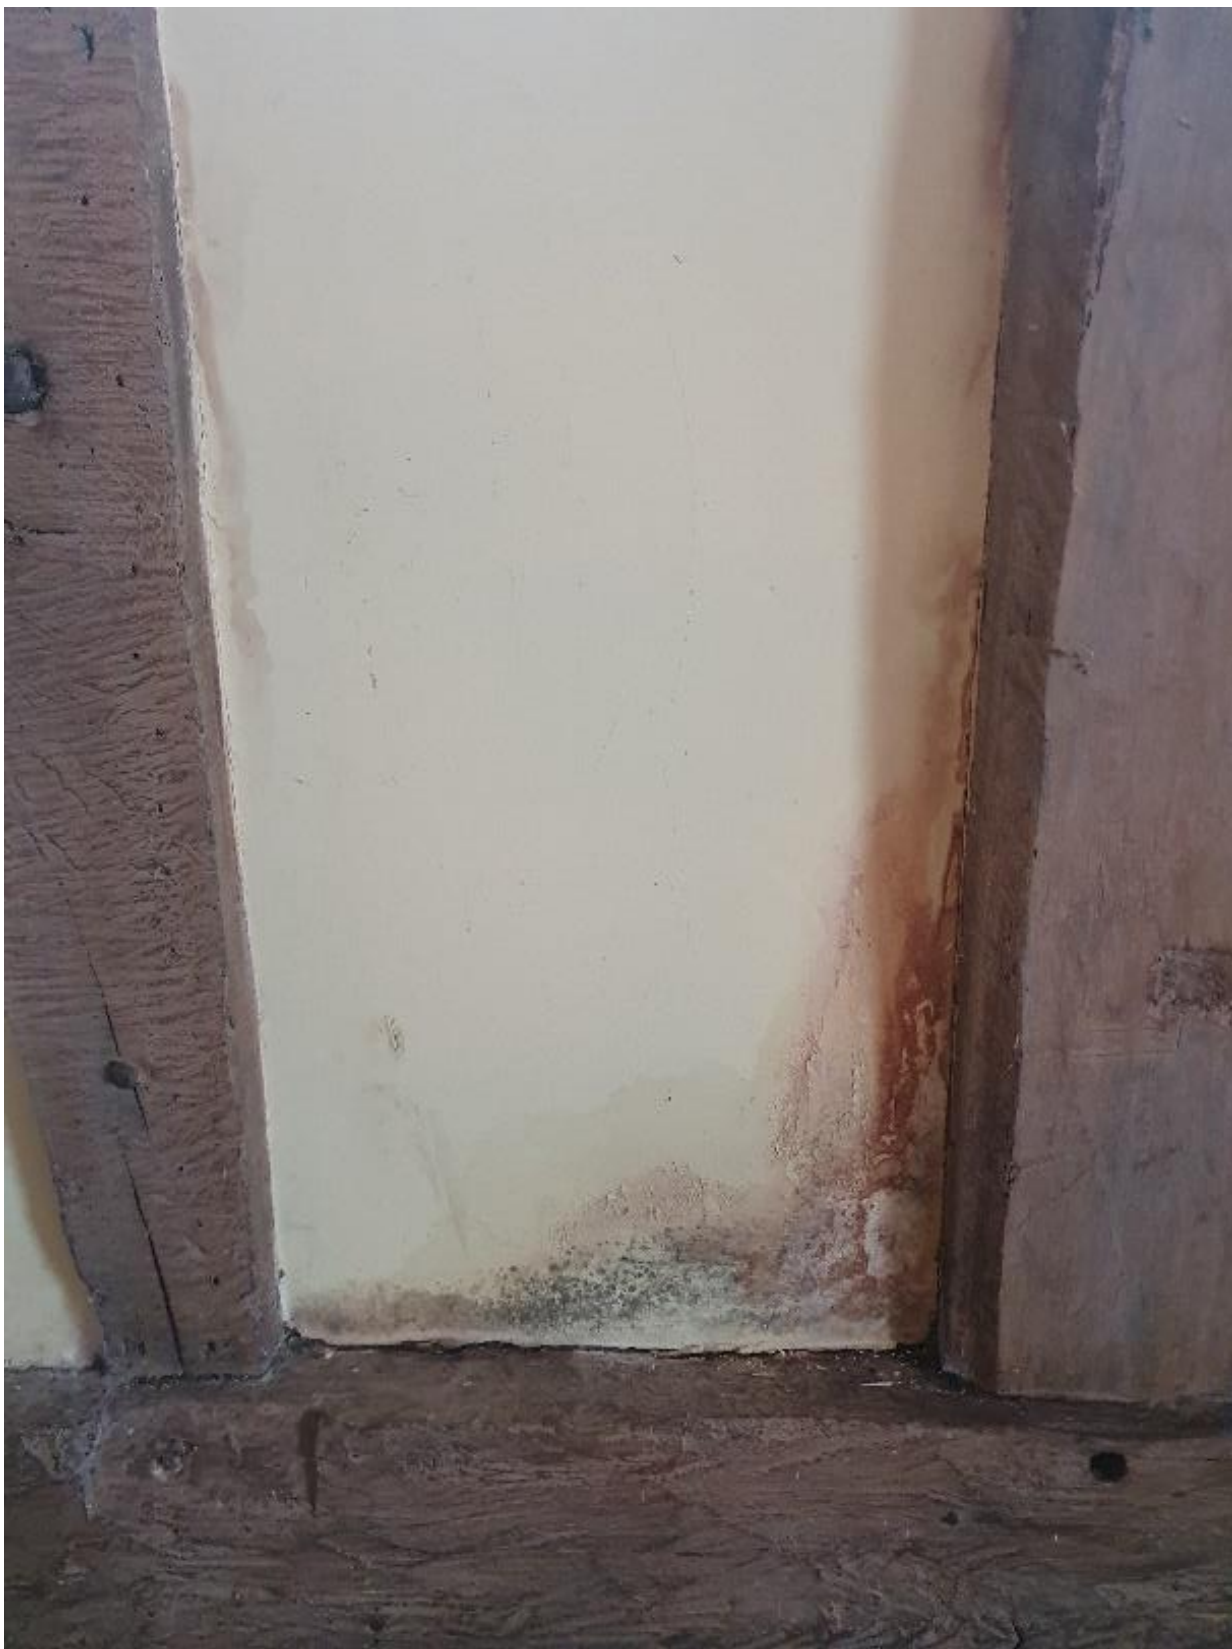
A close up showing an example of the damp occurring on this wall internally:

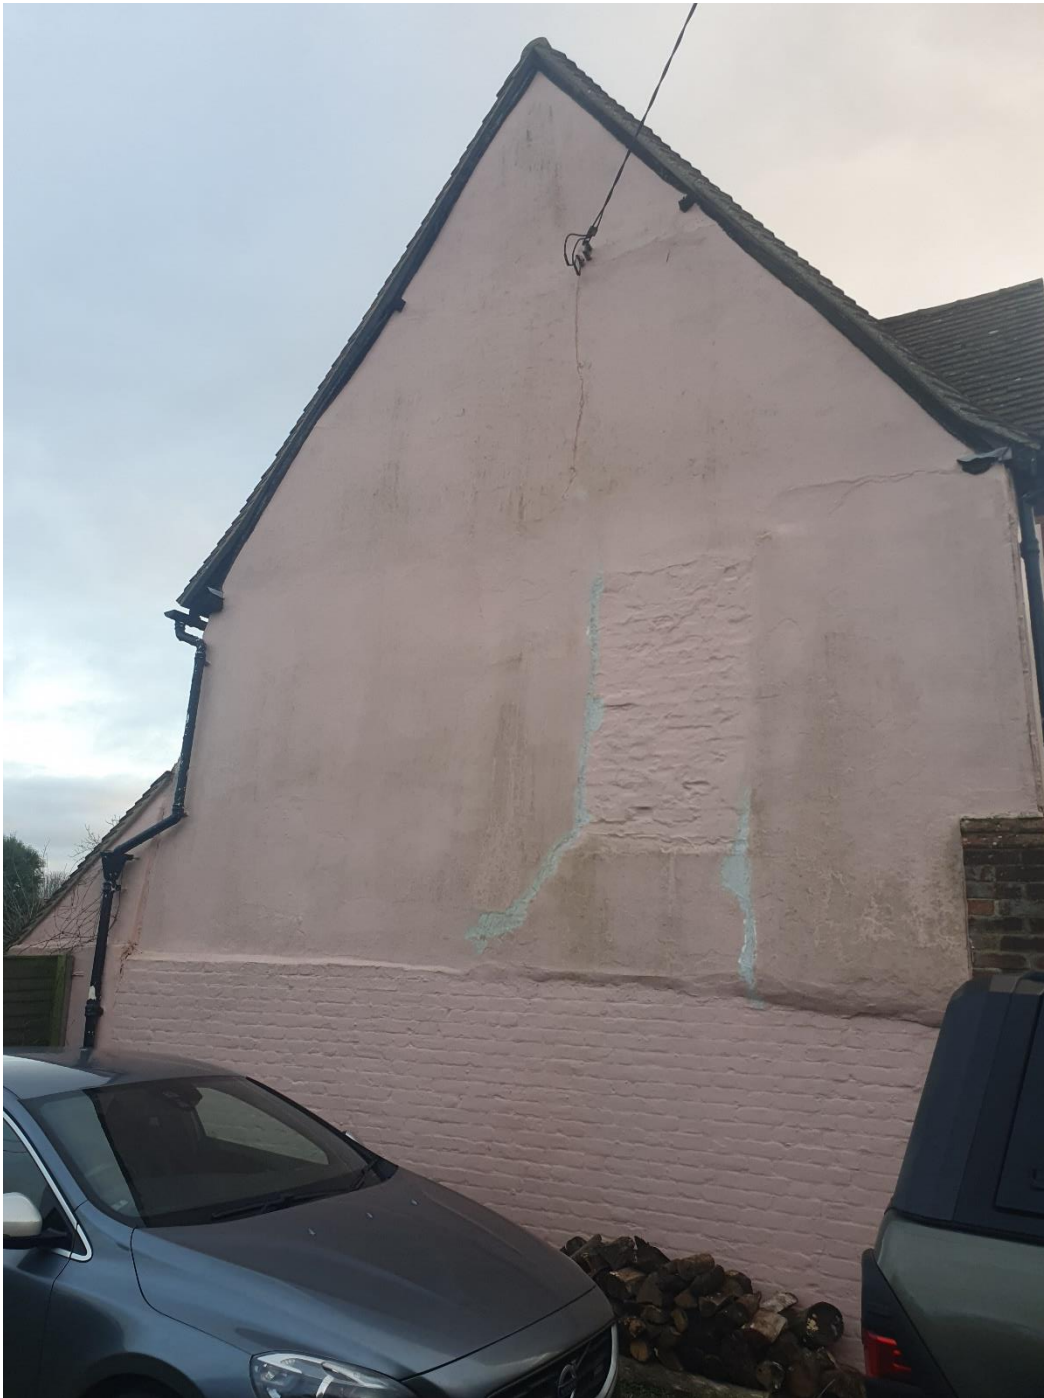
Left Flank (North) Elevation:

In addition, the North flank wall, which is of brick construction to first floor level and then timber-framed and lime plastered above, is also showing signs of wear, there are several large cracks and the plaster has blown in places.

This has led to water penetrating into the interior of the building and we have needed to repair large patches of plaster internally in the bedroom.

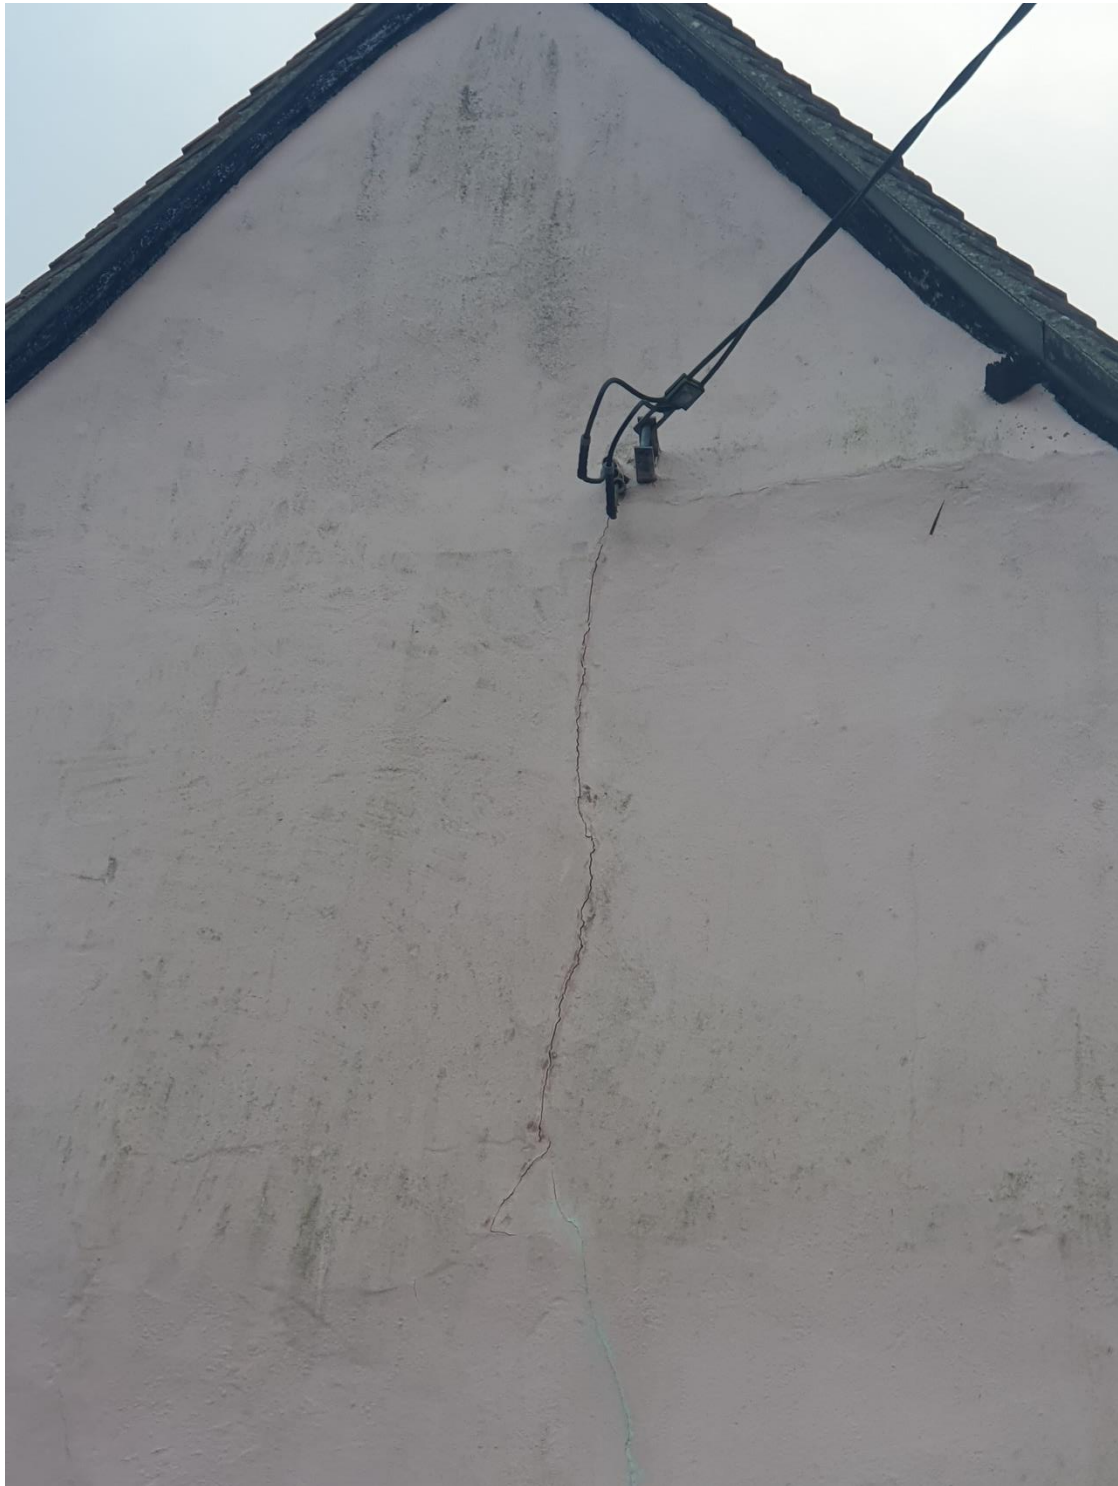
Details of the cracks on the exterior wall of the Left flank (North) elevation:

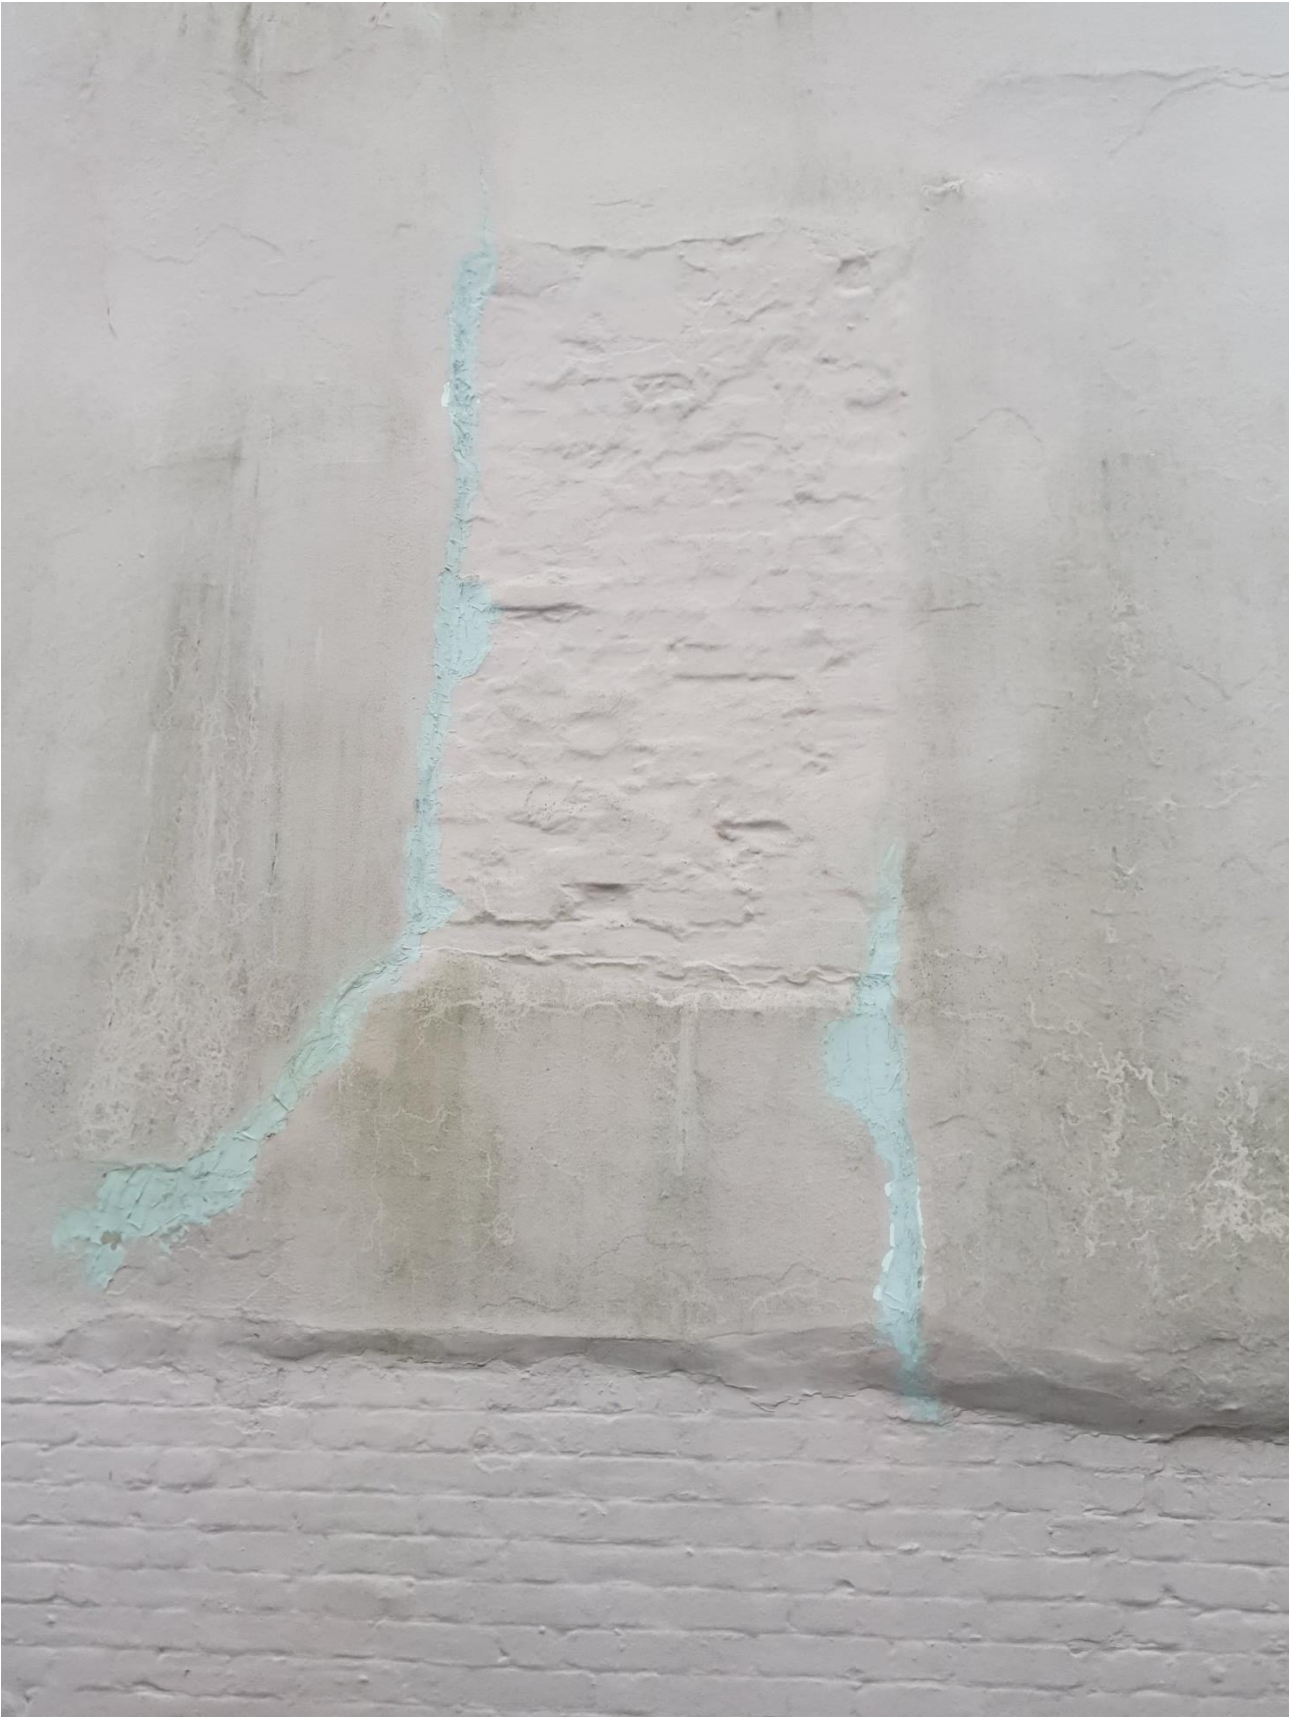
Further detail of the cracks on the Left flank (South) Wall
