# Land Contamination Report

### PHASE I – LAND CONTAMINATION DESK STUDY

**Site:** 8 Nancevallon, Higher Brea, Camborne, Cornwall, TR14 9DE

**Date:** 08 September 2023

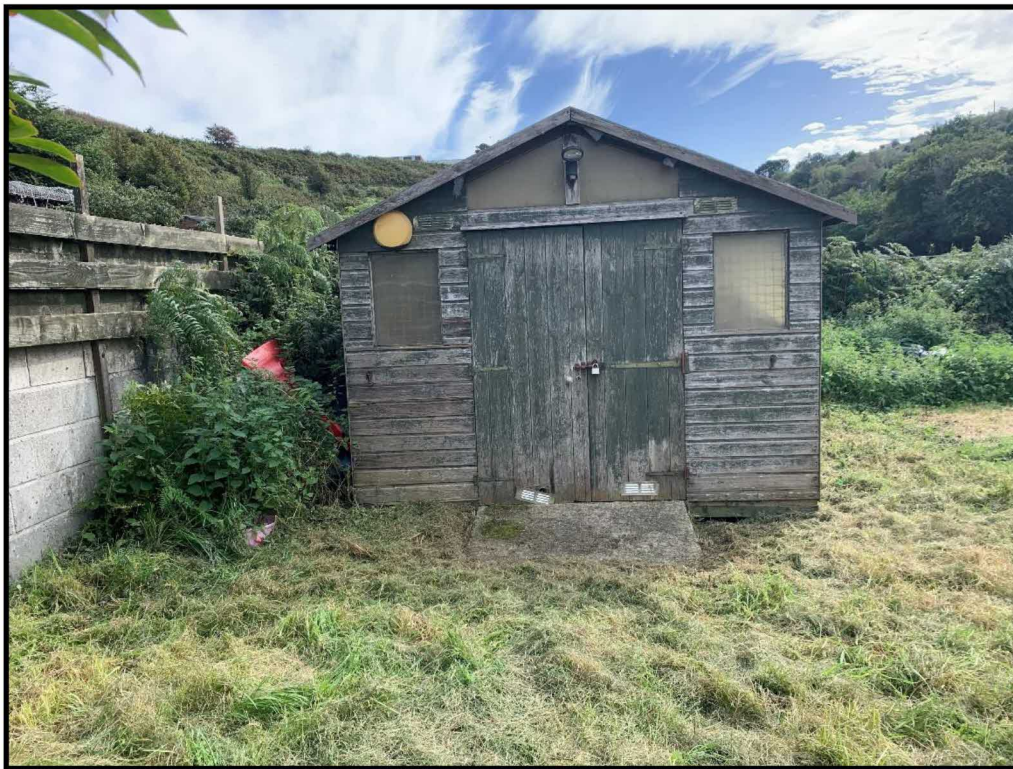
A wooden shed was situated in the southeastern corner of the garden. Cornwall Mining Consultants were not able to access the shed however the client confirmed that the contents included office items. Either side of the shed, various inert gardening related items were observed including plastic pots and sheets.

Photograph 9 - View of the shed in the southeastern corner of the site.

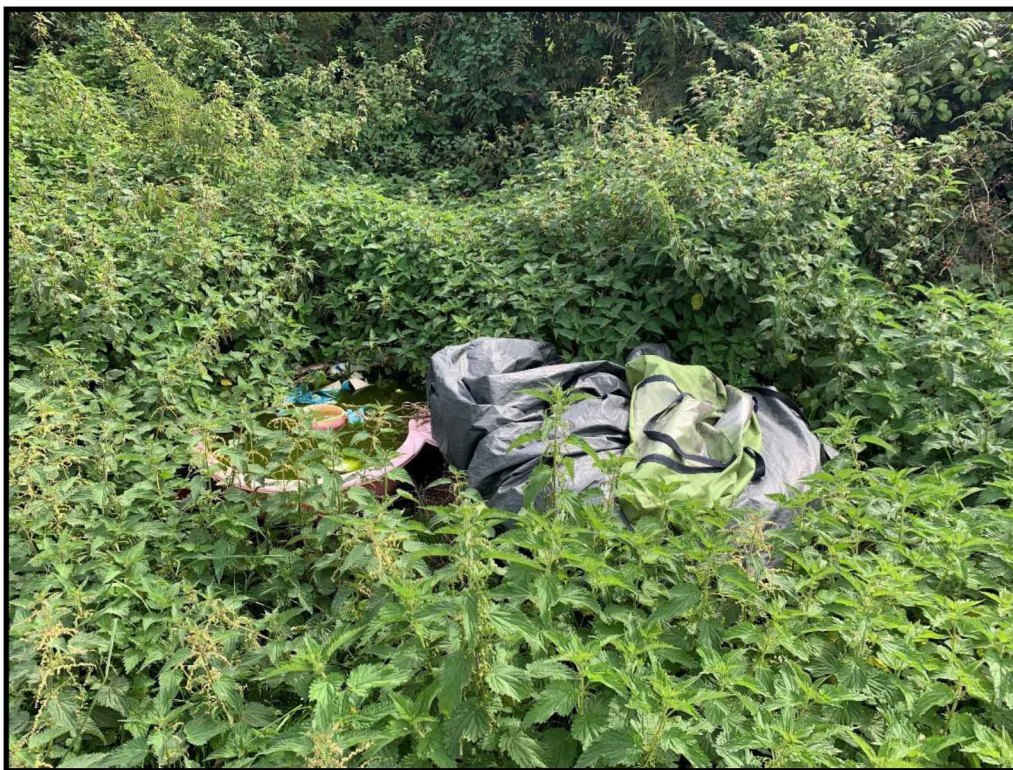
Photograph 10 - View of various gardening-related items including plastic sheeting and plastic pots, west of the shed.
