A BUILDING SURVEY AND PRELIMINARY ECOLOGICAL ASSESSMENT CARRIED OUT AT

> 24 ST GEORGE'S VIEW CULLOMPTON, DEVON EX15 1BA

ON THE 12[™] JANUARY 2024

A report prepared by

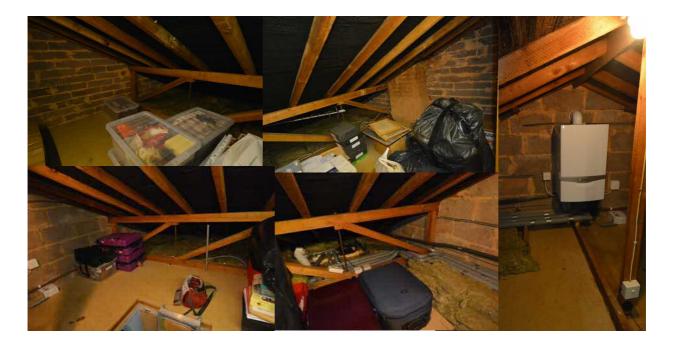
The main house is inhabited and there are no potential roosting/nesting options within the ground and first floor of the property. Access was gained into the loft void through a loft hatch, and the void itself was underfelted throughout with bitumastic felt, well insulated, partially boarded and used for storage. The pitch of the roof is very shallow, and the loft itself spans the width of the property and measures c. 1.5m high. Figure 4, below, gives a very good overview of the state of the loft and, as can be seen in the photographs, it is in regular use for storage.

No signs of use by bats or birds were encountered during the survey.

Figure 4:- Series of photographs illustrating the condition of the loft and its current use.

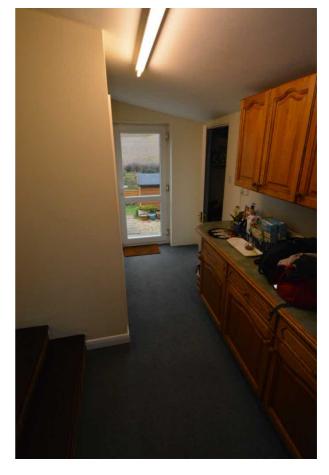
The garage consists of a single storey structure capped by a flat bitumastic roof, which is connected to the main property by an enclosed single-storey entrance/walkway area (please refer to the architect's drawings for further details). It is in constant use on a daily basis. Photos of this part of the building can be seen in Figure 5 overleaf.

No signs of use by bats or birds were encountered during the survey.

Figure 5 (right):- Internal photographs of the connecting walkway/entrance area.

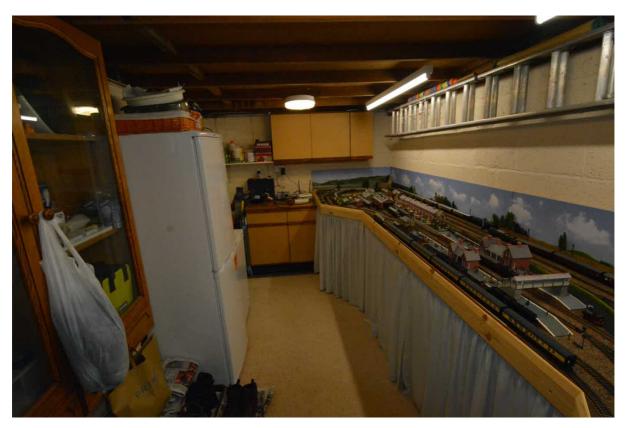
The garage is currently used partly as a utility room and as an area for a model train layout, as can be seen in Figure 6 overleaf.

Figure 6 (below):- Internal photographs of the single-storey garage.

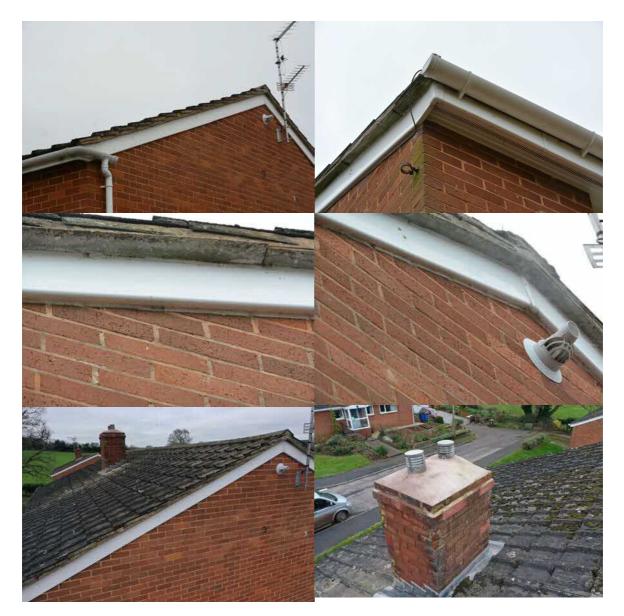
Given the good state of repairs of the property, well dressed leadwork, and sealed/caulked gaps around and below the fascias and soffits, as can be seen in the photographs in Figure 7 below, there were NO likely entry/exit points that we could identify on the main building.

Figure 7:- Photographs illustrating the good state of repair of the features mentioned above in the text.

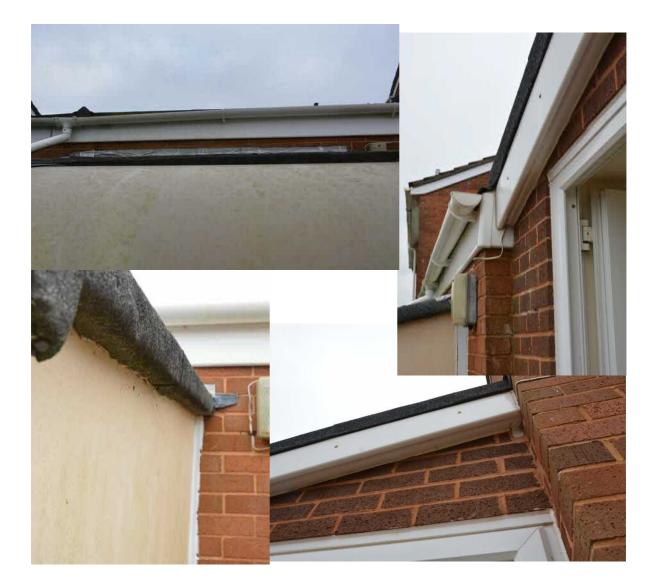
As for the main property, areas where bats and/or birds might usually find potential access points into structures were also very well maintained, as can be seen in Figure 8 below and, as a result, we could not find any potential access points for bats (or birds) to exploit.

Figure 8:- Photographs illustrating the good state of repair of the features surrounding the garage and linking structure, which might usually offer potential access locations, to wildlife, into the buildings.
