**STRUCTURAL ASSESSMENT**

**PROPOSED ROOF MOUNTED PV INSTALLATION**

**MORRISONS, WESTON SUPERMARE**

CPA Project No: 2209-86

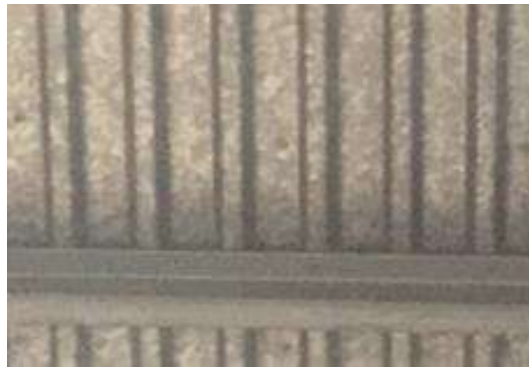
The profile of the bottom sheet seen above the ceiling in the main store and measured in the warehouse area appears to correlate with SMD SR30+ Steel Deck profile. We have carried out our analysis using SMD SR30+, 0.7 mm steel load tables.

**Figure 2 view on the underside of the roof deck in the warehouse**

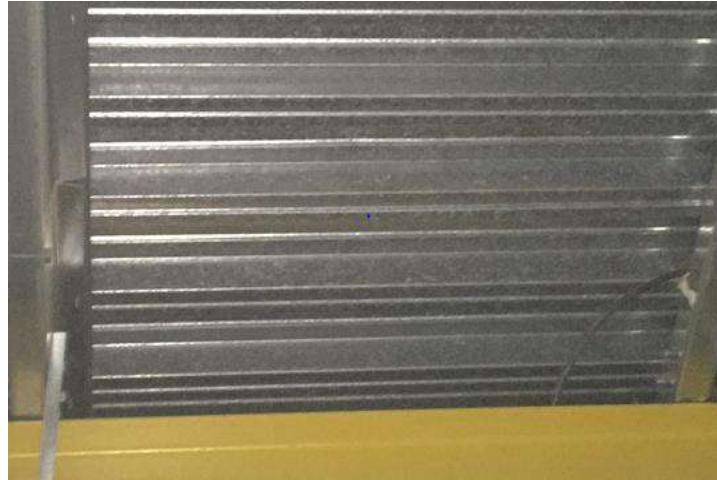
The profile of the bottom sheet in the store extension area indicated on archive drawings is a PMF D60 – 0.7 mm steel deck. We have carried out our analysis using RoofDek D60, 0.7 mm steel load tables.

**Figure 4 view on the underside of the roof deck in the store extension**

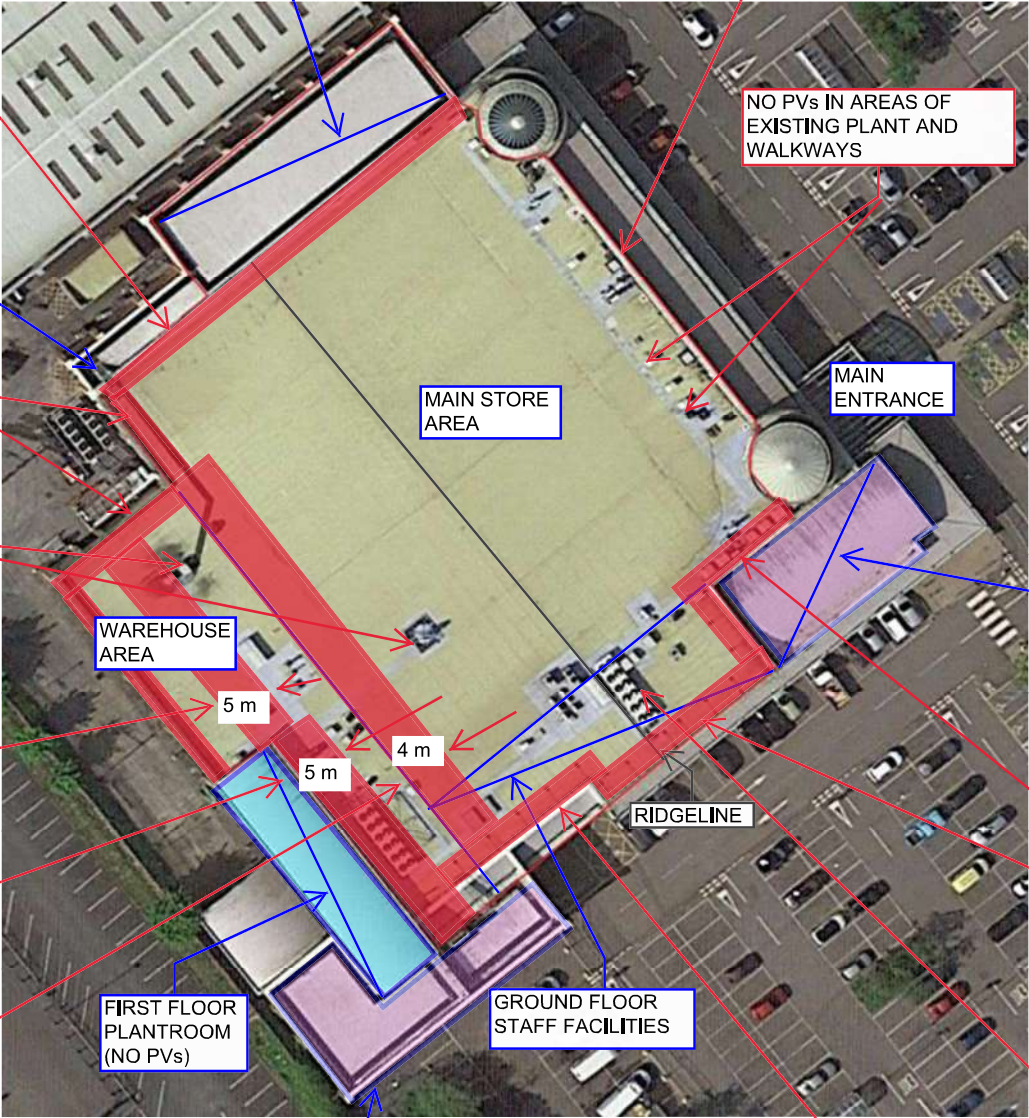
**ROOF PLAN INDICATING AREAS OF ROOF WHERE PV INSTALLATION IS  
RECOMMENDED**

Addition of PV panels not acceptable within areas of significant snow drift on the main store roof due to exceedance of purlin capacities. Refer to Appendix 1.

PV panels cannot be added to the main store roof parallel to the West elevation as indicated on Appendix 1. This is due to the presence of bulkheads and the presence of dividing walls without a suitable deflection head detail. This is to protect against the PV loading causing the roof to deflect and impose forces into the partition walls, potentially leading to cracking of the walls.

NO PVs FOR A MINIMUM DISTANCE, TBC PRINCIPAL DESIGNER, FROM THE EDGE OF THE ROOF AREA DUE TO LOW PARAPET HEIGHT

NO PVs IN AREAS OF EXISTING PLANT AND WALKWAYS

NO PVs FOR 5 m AT 5 m FROM THE REAR OF THE PARAPET

NO PVs FOR 5 m FROM THE REAR FACE OF THE FIRST FLOOR PLANTROOM

NO PVs FOR 2 m FROM THE EDGE OF THE ROOF AREA DUE TO EXISTING EDGE PROTECTION HANDRAILS AND BASES

NO PVs FOR 4 m AT A DISTANCE OF 8 m FROM THE REAR FACE OF THE FIRST FLOOR PLANTROOM, ACROSS THE WIDTH OF THE ROOF

**NOTE**  
 1. KEEP CLEAR OF PENETRATIONS & EXISTING SERVICES.  
 2. ACTUAL SETTING OUT OF PV PANELS TO BE CONFIRMED BY PV SPECIALIST.  
 3. PROVISION OF SAFE ACCESS/EDGE PROTECTION MUST BE CONSIDERED.

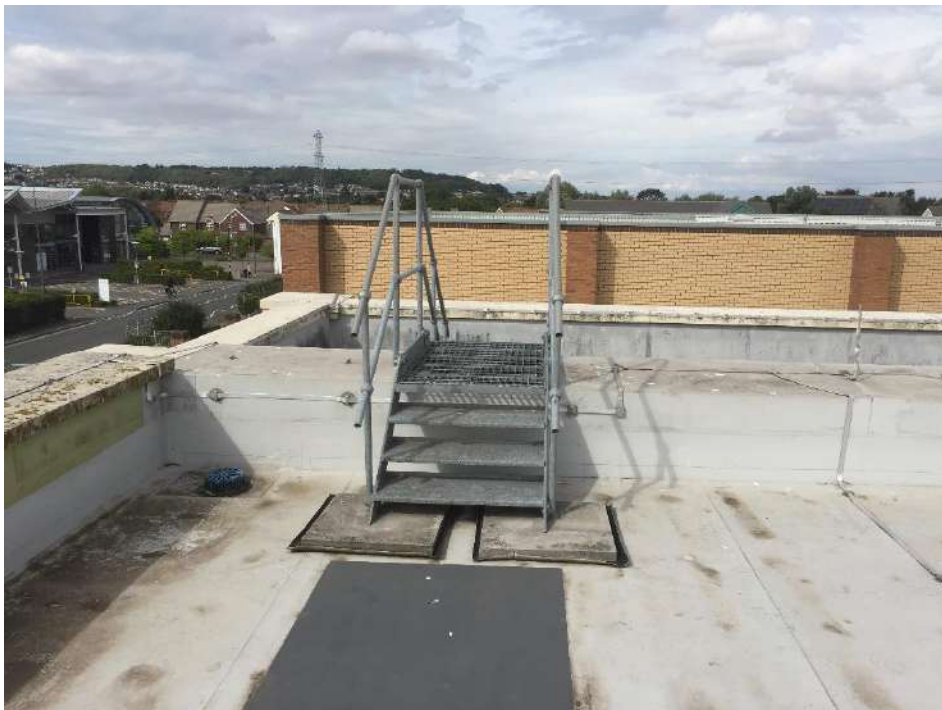
The store extension roof area is accessed via steel stairs/ladders, this should be taken into consideration from an access perspective when installing PVs.

**Steel stair access to the store extension roof**

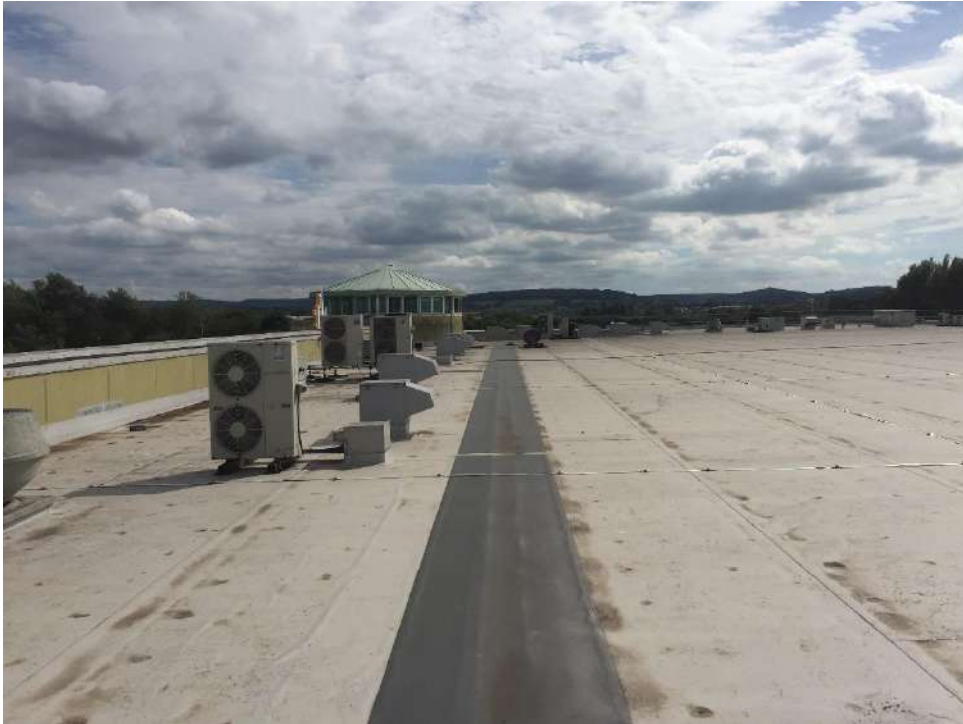
We noted that the upstand to the roof perimeter was low (less than 900 mm) in several areas with no other edge protection provided. The client may wish to consider the provision of additional edge protection prior to the installation of any PV panels.

**View along the rear of the North East parapet looking towards the Main Entrance area**

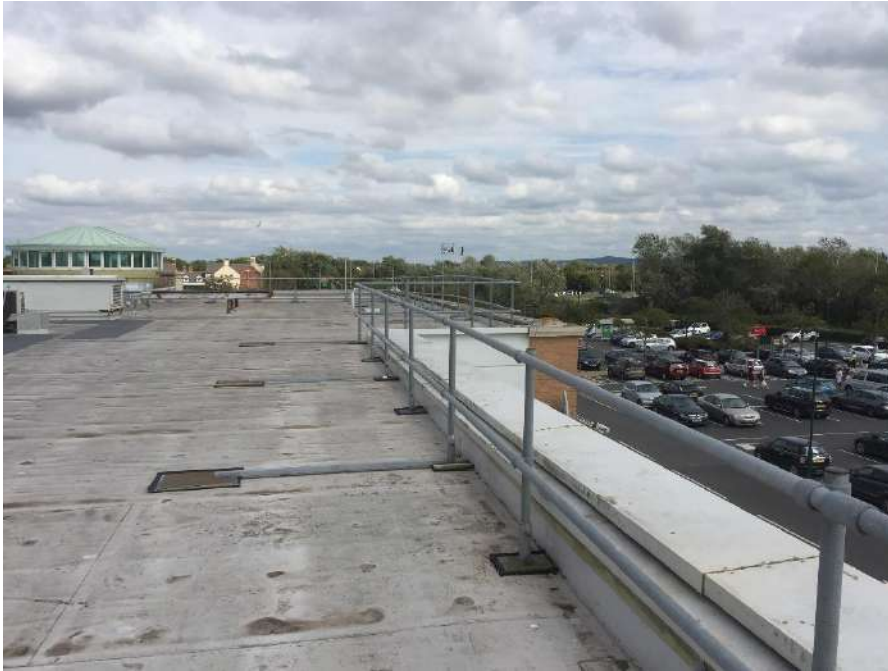
**View looking North East along the rear of the South East parapet.**

**Note the extended bases to the handrail support posts**

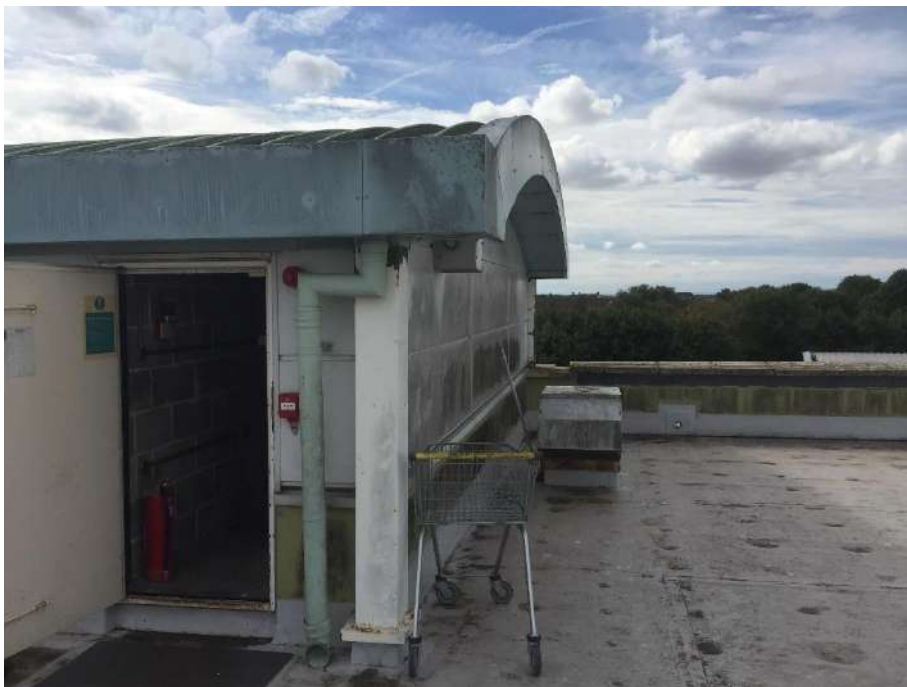
A shopping trolley had been left on the roof which should be removed.

**Shopping trolley left on the roof**

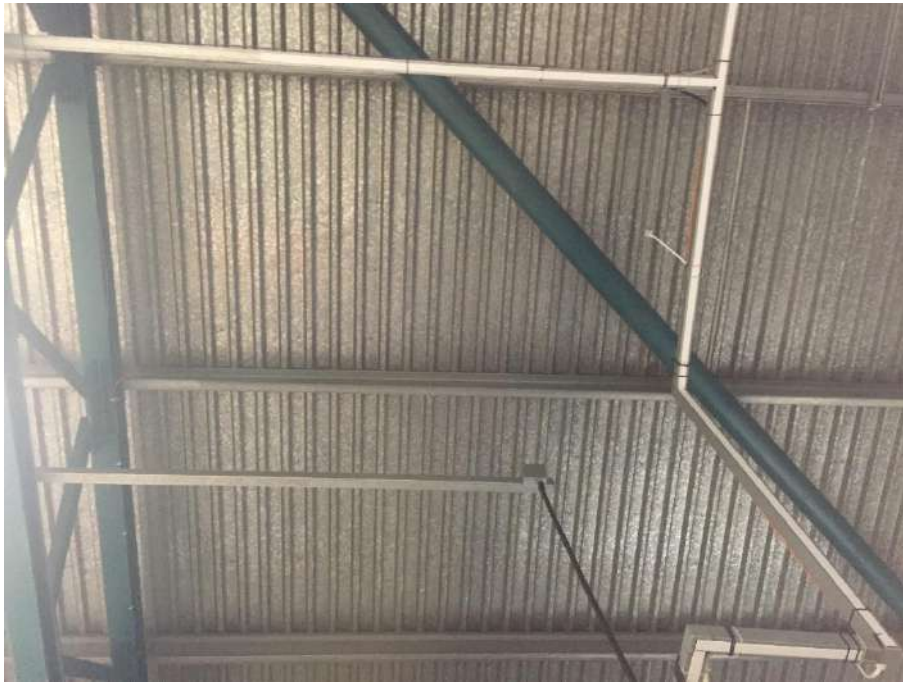
**View on the underside of the roof decking and secondary lattice truss to the warehouse area**

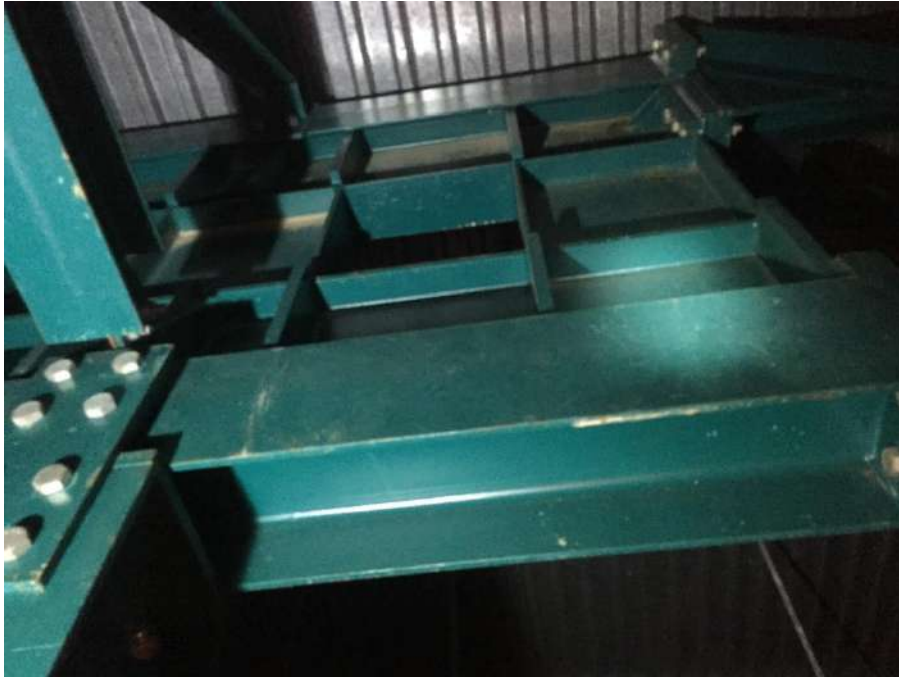
Fully plated end to a spine truss at the column connection,  
seen above the ceiling in the store area

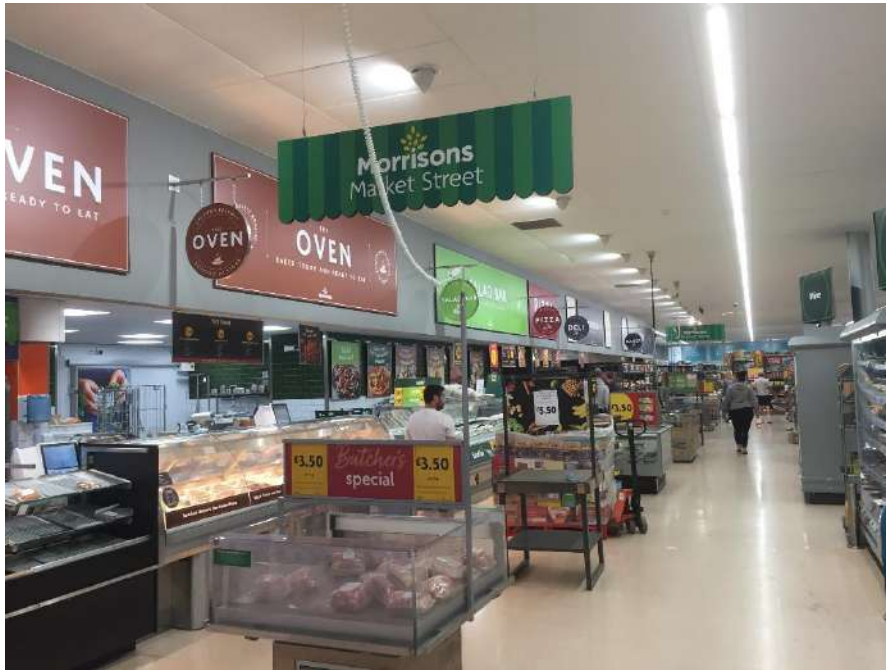
**View along the bulkheads to front of the Prep Areas  
(parallel to the spine beams and South West elevation)**
