Decay Diagnostic Survey

'The Hey Way', High Street, Dadford, Bucks.

Robert C Yates
2-1-2023

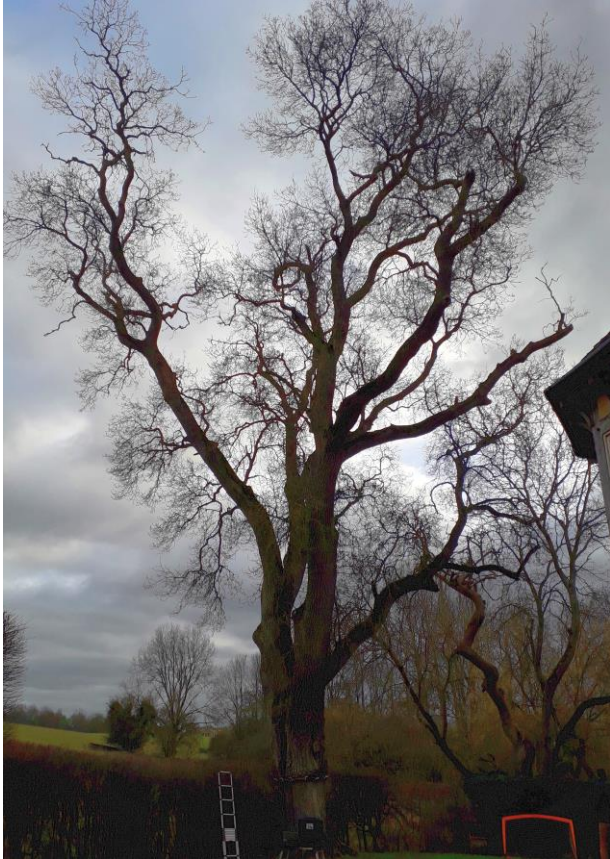
Tree No. T1	Species: Narrow leaved Ash (<i>Fraxinus angustifolia</i>)	Comments: Large (26m), over-mature, grafted, co-dominant specimen tree with pronounced crown dieback (not thought to be the result of <i>Chalara</i> 'Ash Dieback', but more general decline). East stem also bifurcates at approx. 6 metres
TPO? YES Ref. 1996 No.20	Location: Rear garden / within falling distance of house

Photo 1: Overview of subject tree (looking southeast)

Recommend a reduction in the overall height of the tree to 18 metres, plus removal of any remaining deadwood (all in accordance with current industry best practice and guidance ref. BS3998 (2010) and subject to formal LPA approval) – Re-assess in 5 years' time.

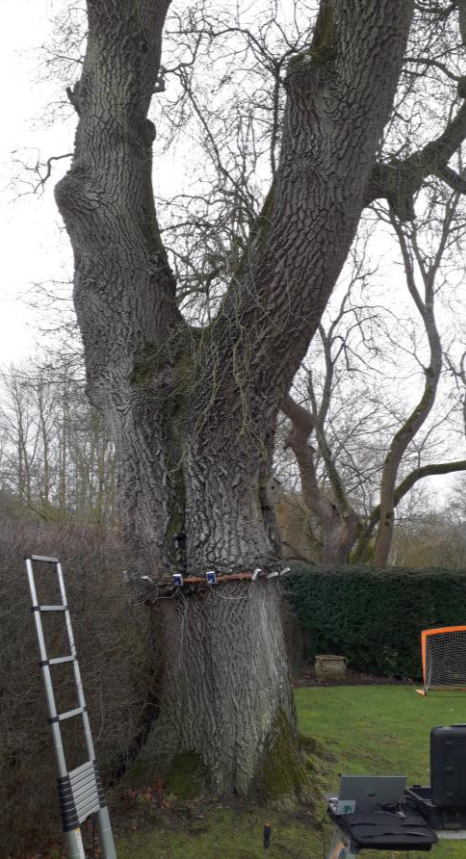
Photo 2: Sonic device in-situ

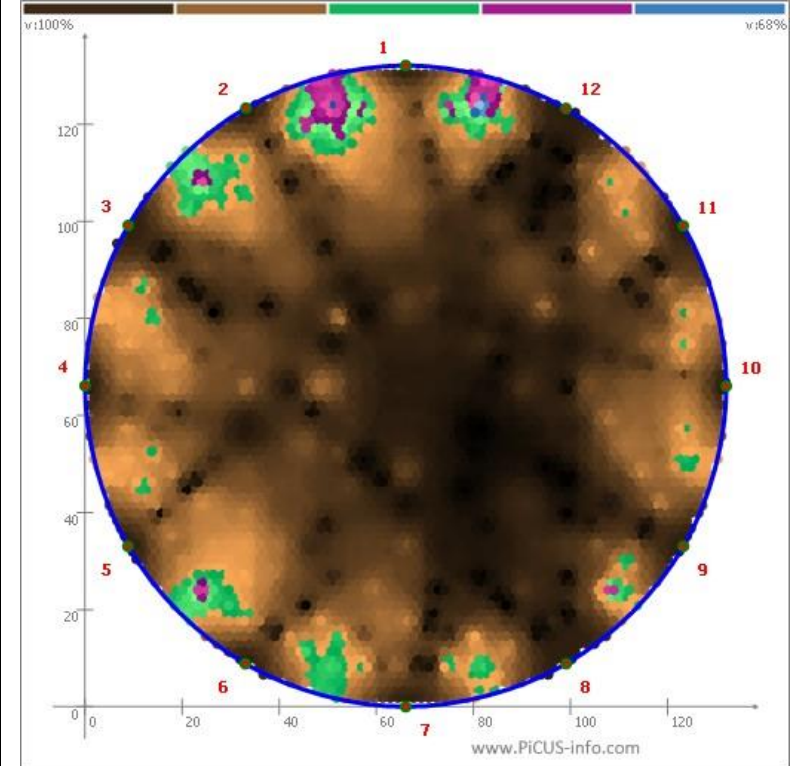
Sonic test carried out at 2.0m above ground level – See image below (North to top)

Conclusion/Recommendations: No detectable decay in main stem at point of graft union. General dieback and presence of major deadwood poses a risk to those resident at the property, and potentially to the building – pre-emptive remedial action required
