U321 Land East of High Road, High Cross, Hertfordshire: Stage 1 Road Safety Audit Response For M Scott Properties
November 2023

# Stage 1 Road Safety Audit Sutes Farm, Ermine Street, Ware Residential Access Arrangements

Date: 03/11/2023

Report Title Stage 1 Road Safety Audit

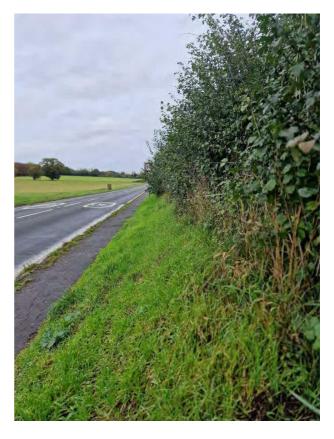
#### 3.1.1. **Problem**

Location: Ermine Street, at the

development access

Summary: Reduced side road

visibility may lead to failure to give way type collisions

It is acknowledged that a 2.4m x 160m visibility splay to the right is proposed at the junction (this appears to be appropriate for the measured vehicle speeds provided), however, it is unclear whether the banking and existing vegetation will reduce the available visibility to the right for emerging users. Reduced side road visibility may lead to failure to give way type collisions.

#### **Recommendation:**

It is recommended that adequate side road visibility to the right is provided, consistent with free flow 85<sup>th</sup> percentile approach speeds; this may require the re-profiling of the banking and removal of some vegetation.

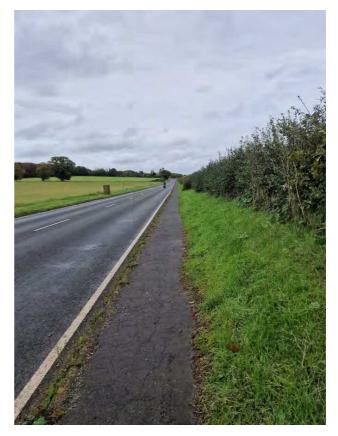
#### 3.1.2. **Problem**

Location: Ermine Street, at the

development access

Summary: Side road downhill

gradient may increase the likely of overshoot failure to give way type

collisions

At the junction, the adjacent ground levels are higher than the carriageway channel level. This may lead to a downhill gradient to the give way line. A downhill approach to the junction may lead to overshoot failure to give way type collisions, particularly in wet or icy conditions.

#### **Recommendation:**

It is recommended that a flat dwell area is provided on the development arm of the junction on the approach to the give way line, consistent with current best practice.

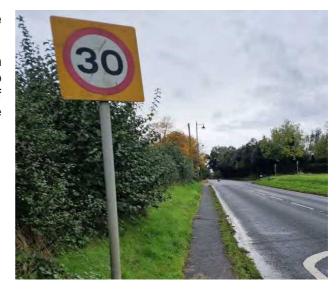
#### 3.3.1. **Problem**

Location: Ermine Street, at the

development access

Summary: Reduced illumination

levels may lead to increased likelihood of collisions during the hours of darkness

The existing street lighting provision terminates at the junction with Pest House Lane. The proposed access is to be located to the north of the Pest House Lane junction and this may mean that the proposed development access junction is in shadow. Reduced illumination levels at, and on the approach to, the junction may lead to increased likelihood of collisions during the hours of darkness.

#### **Recommendation:**

It is recommended that adequate illumination levels are provided, to highlight the presence of the proposed junction area and the main road approach. An extension to street lighting to the north of the proposed access area may require the relocation of the existing speed limit terminal – see also Observation 4.1 below.

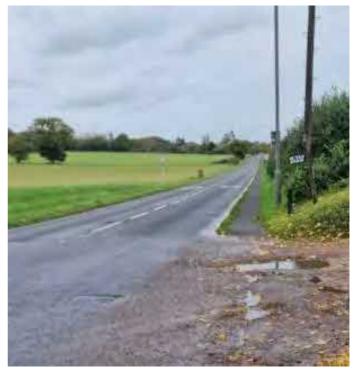
## 4.1. Observation

Location: Ermine Street at the

development access

The proposed development access will effectively extend the village envelope and built-up area. As such, it may be appropriate to relocate the existing location of the speed limit terminal to provide a gateway / buffer prior to the built-up area – see also Problem 3.3.1 above.

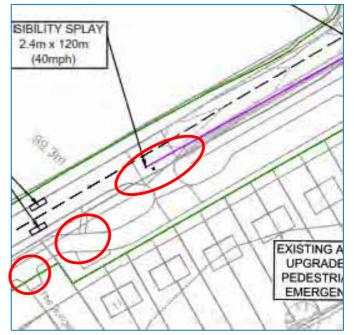
#### 4.2. Observation

Location: High Road at the

existing service road entry and footway

At the access and footpath link to / from the southbound bus stop, the existing footway has kerb upstands. These may present trip hazards or not be negotiated by mobility impaired users. This is an existing issue, but the likely increased pedestrian activity induced by the proposed development to / from local attractors, such as the bus stops and other village facilities, may increase the likelihood of trips or falls. The need for dropped kerb crossovers at these locations should be discussed with the highway authority.

There appears to be an opportunity to provide an alternative vulnerable user route via the footway on the service road, although the extent of the public highway is unclear. There are also upstand kerbs on the service road, in the vicinity of 'The Bungalow' and these present similar issue to the above.

The need for a dropped kerb crossover at these locations should be discussed with the highway authority.

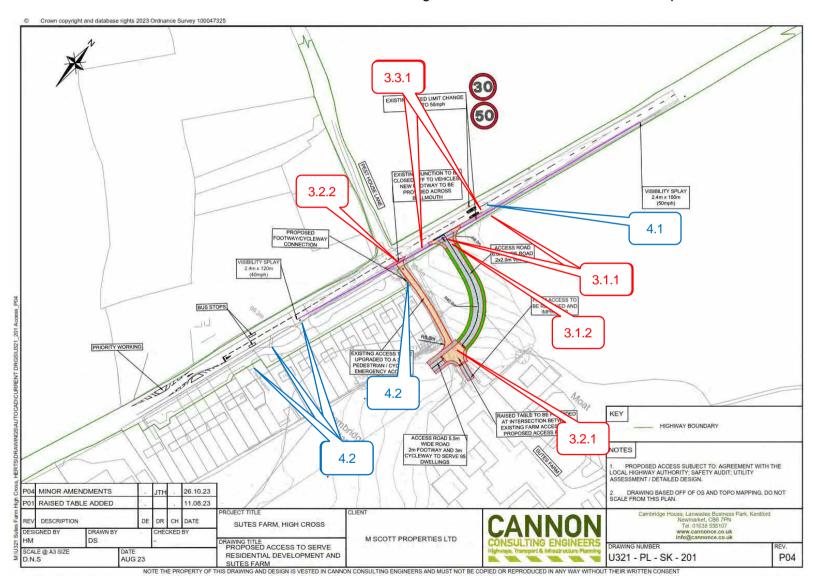
# **APPENDIX B: Drawing Showing Problem Locations**

Problem numbers shown on the attached drawing refer to Problem numbers within the report.
