## ARBORICULTURAL ASSESSMENT - SPORT WALES NATIONAL CENTRE

<b>Location:</b>	Sport Wales National Centre, Sophia Gardens, Cardiff CF11 9SW		
<b>Client:</b>	Sport Wales	<b>Reference:</b>	S240102.2
<b>Author:</b>	John Mitchener	<b>Report Date:</b>	12 January 2024
<b>Surveyor:</b>	John Mitchener	<b>Survey Date:</b>	05 January 2024

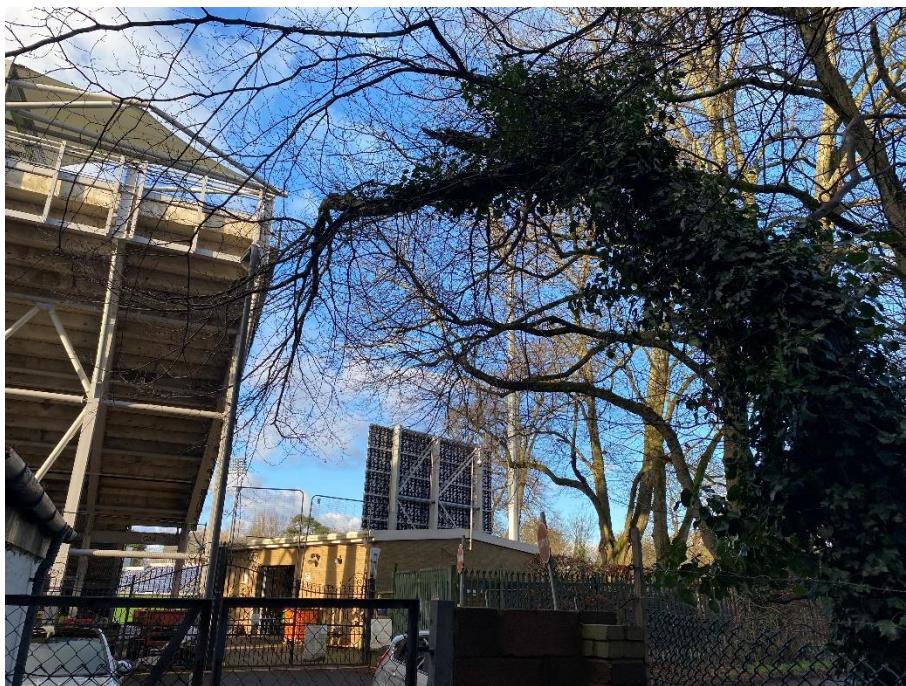
- One 'not tagged' common beech tree *Fagus sylvatica* whose crown is obstructing a nearby lighting column. This tree is within the ownership of Cardiff Council but, due to being suppressed by larger neighbouring trees, has developed a crown which extends across the property boundary and into the Site. The crown of this tree is obstructing a lighting column which is also at risk of damage from swaying branches.

***Photograph 1: Not tagged common beech obstructing lighting column***

The crown of this tree should be pruned back to obtain a 1-2m separation distance from the lighting column.

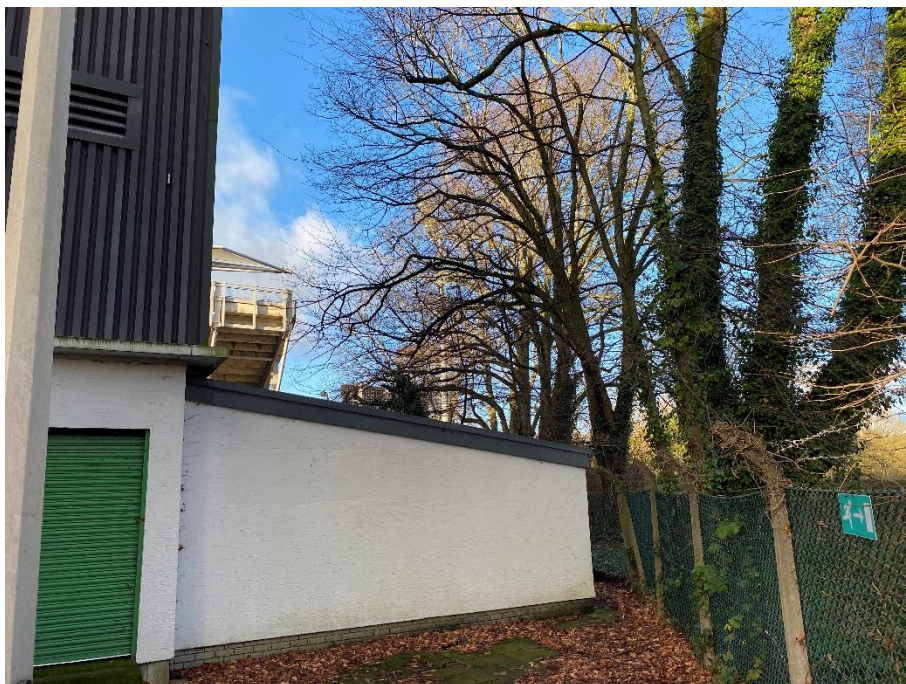
- One 'not tagged' tree group includes a number of young/semi-mature common beech trees with branches which are either low over the car park or unreasonably encroach towards the building located in the north-eastern corner of the Site. Also included are several larger mature lime trees with lower branches which have been previously pruned and which have subsequently regrown.

***Photograph 2: Not tagged tree group – branches encroaching on building***

Where practicable, this tree group should be crown lifted to 5.2m over the car park. Where older trees have substantial branches below this height then they should be retained and trimmed back to the previous pruning points. Trees near the building in the north-eastern corner should have their branches pruned to obtain 3m clearance from the building roof and

sides. This work will ensure that the car park can accommodate the movement of high-sided vehicles such as skip lorries and that the possibility of future building damage is avoided.

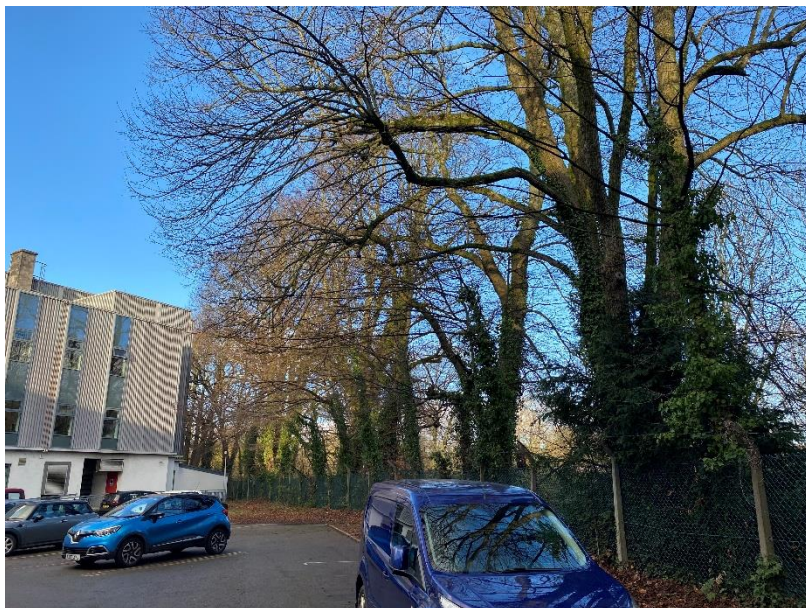
**Photograph 3: Not tagged tree group – low branches over car park**

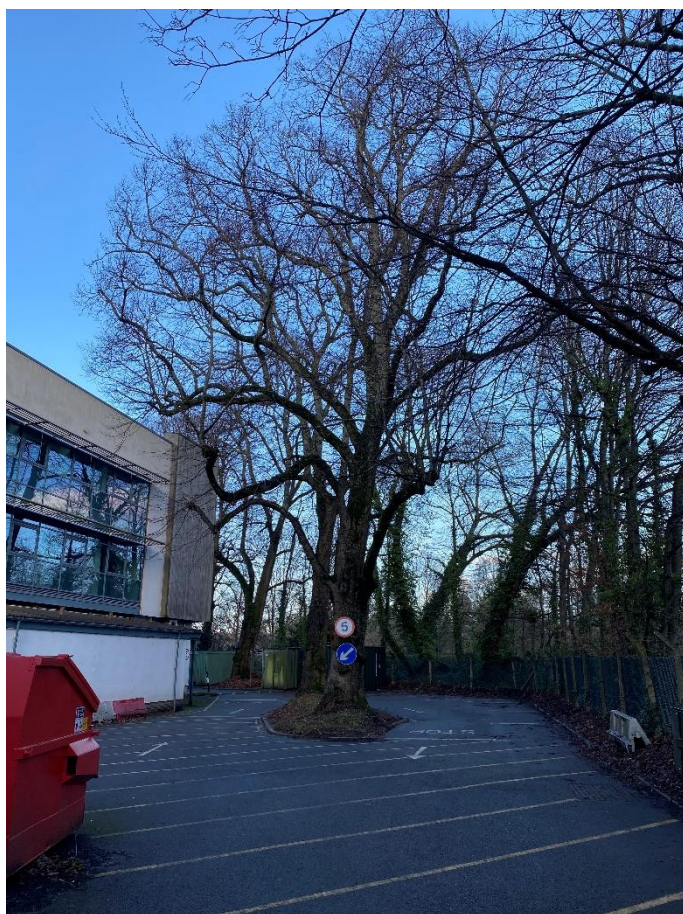
**Photograph 4: Tree 538**

- Trees 536, 537 and 538 are mature limes. All trees exhibit a degree of deadwood within their crowns with trees 537 and 538 also having epicormic growth the either their stem and/or branches.

Trees 537 and 538 are located within an island in the middle of the access road to the car park. These trees have been historically crown lifted to prevent them obstructing the passage of vehicles but now exhibit a degree of regenerative growth in the form of epicormic shoots and small branches. These shoots and small branches are starting to restrict the access of high-sided vehicles and should preferentially be removed. Removal is only required at, or below, the height to which they have been historically crown lifted.

All trees should have deadwood over 25mm diameter removed from their crowns. This is necessary to prevent deadwood falling onto buildings, an access road and nearby structures. Although the risk of falling deadwood causing substantial damage is low the possibility cannot be entirely discounted, and pre-emptive removal is advised.
