**LISTED BARN REPORT  
OF  
GRANARY COTTAGE  
MULBERRY GREEN  
OLD HARLOW  
ESSEX**

**FOR  
MR JOHN FOSH**

Our ref: HD23010  
Date of Issue: 29<sup>th</sup> June 2023  
Prepared by: Chris Jennison B.Tech., C.Eng., MIStructE

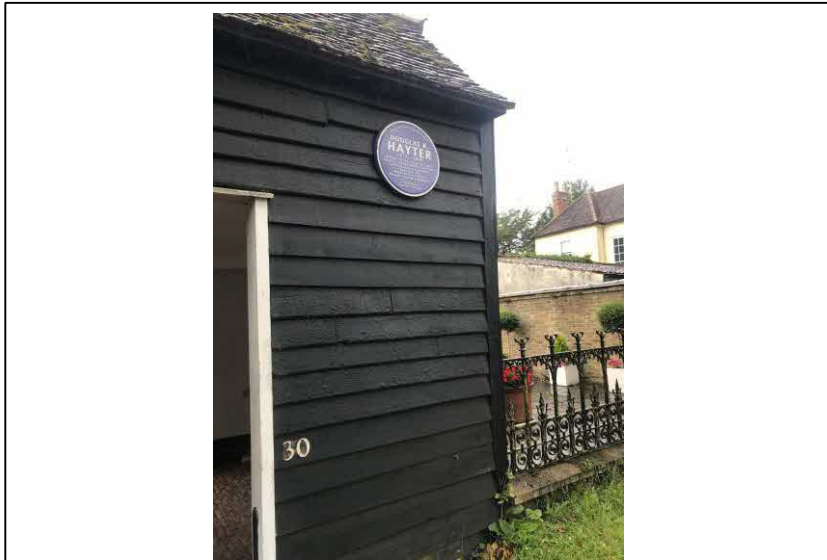
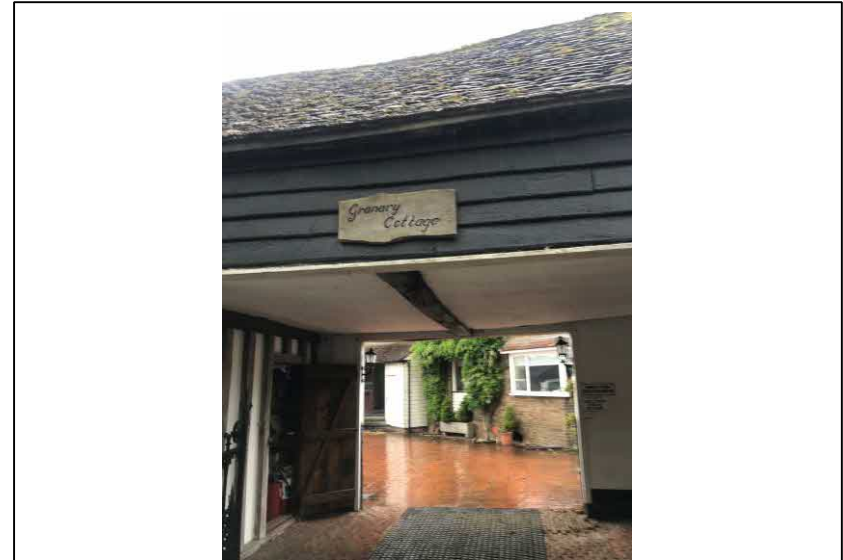
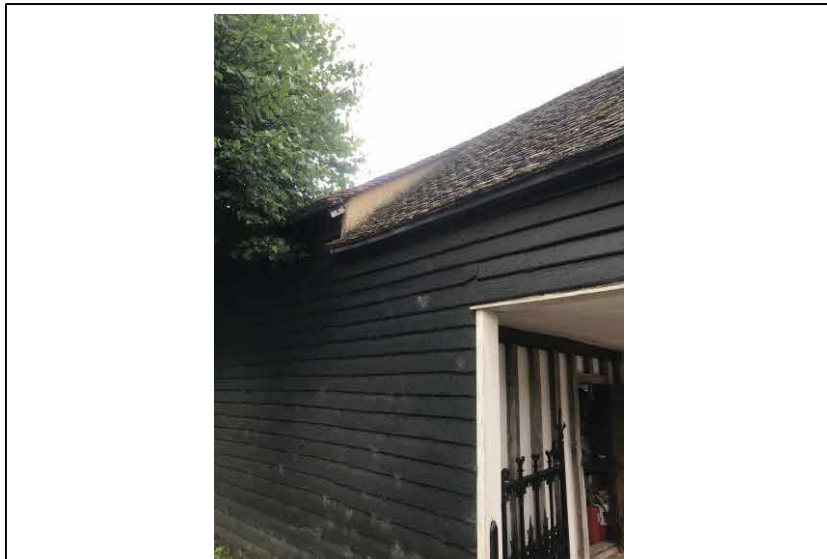
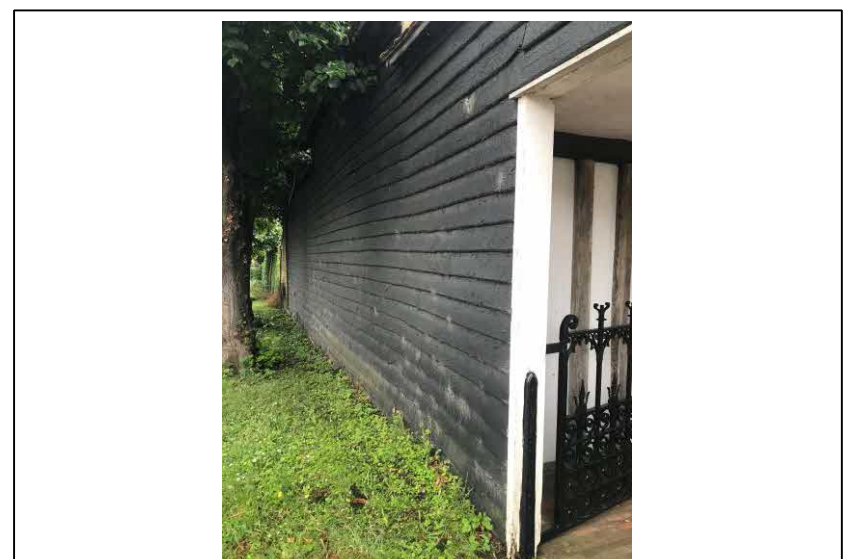
- 1.2. A considerable amount of alteration and adaption has been undertaken throughout the life of the building to meet the changes in use required and vehicle access through the building to reach Granary Cottage. (Photos 1A-1D)

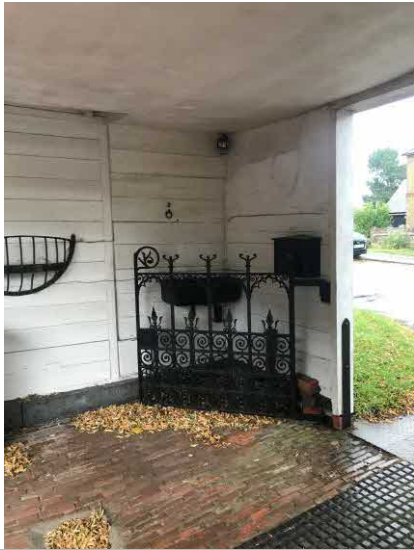
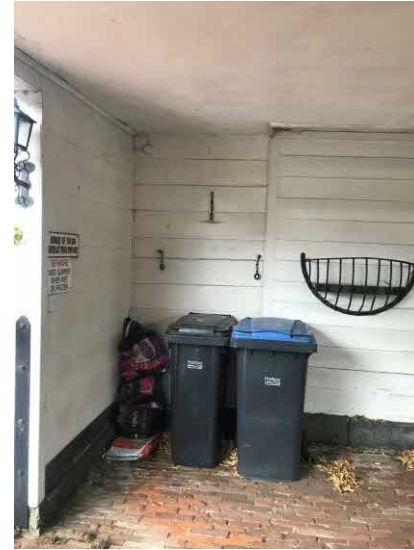
- 1.5. The remains of a hay rack, tethering rings and a drained paved floor at the west end of the building suggests it has been used as a stables which would seem in keeping with the building size and layout and original division into bays. (Photos 2A & 2B)

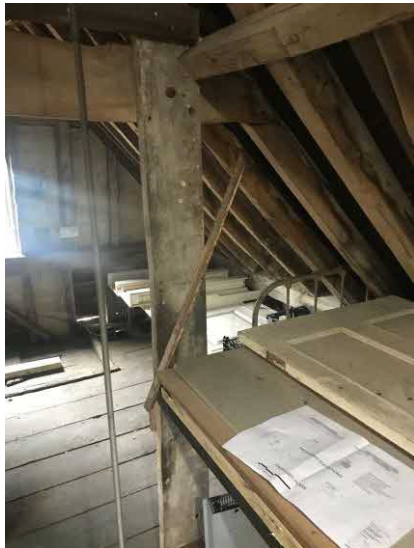
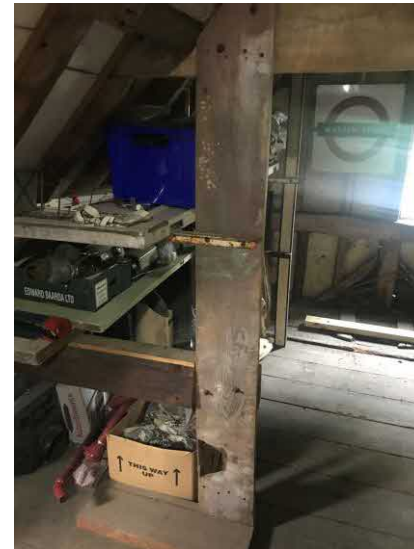
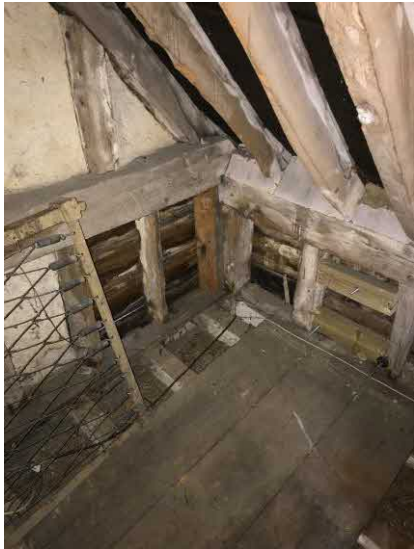
- 1.6. The internal remnants of areas of close boarding with upper levels of the studwork infilled with lath and lime render would indicate a use requiring enhanced protection from the weather consistent with more intensive use than storage. (Photos 3A-3C)

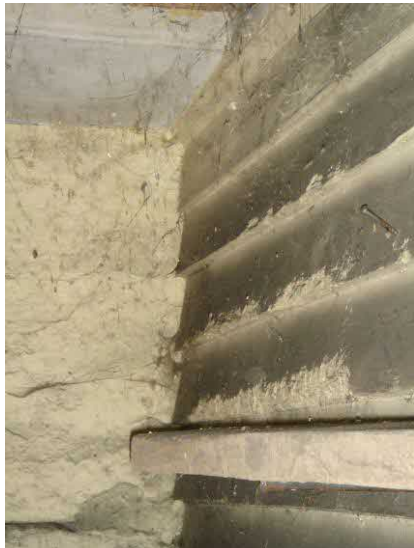
Photo 4

- 1.8. Irregular spacing of the main frame posts and ties coupled with the remains of weather boarding on two of the internal crosswalls suggests the building was sectioned off or could have been extended each end. (Photo 4)

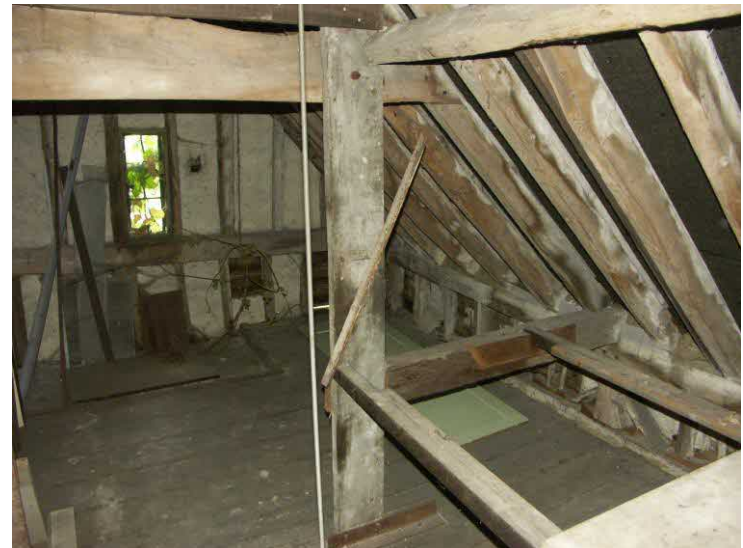
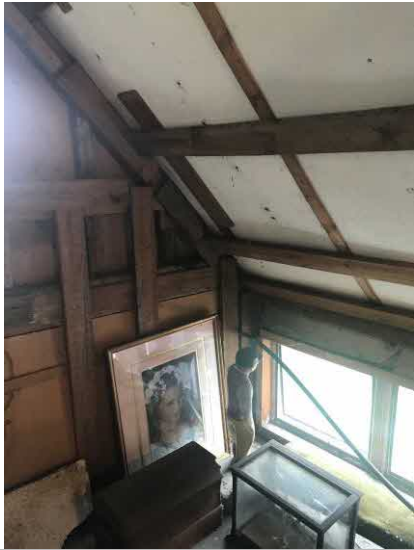
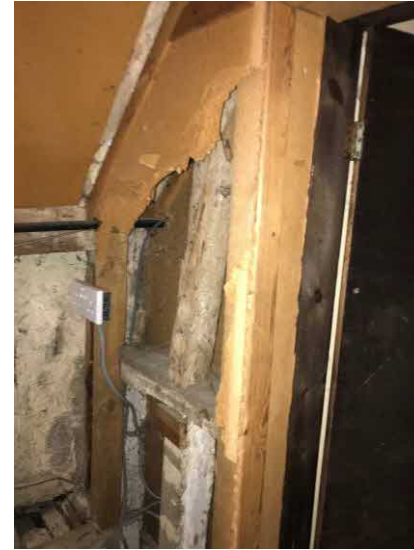
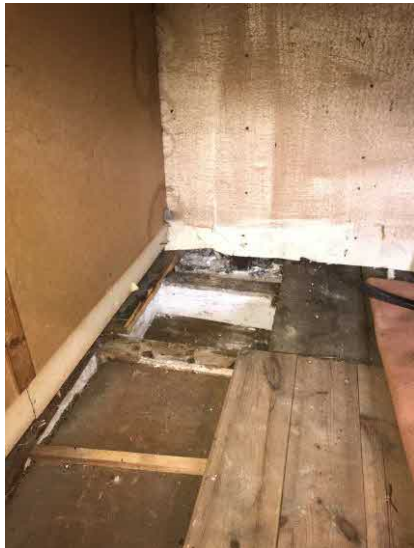
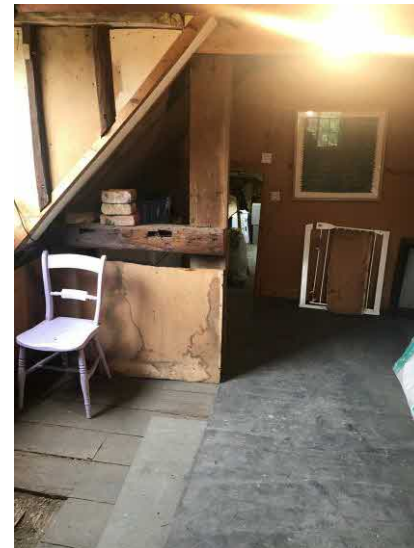
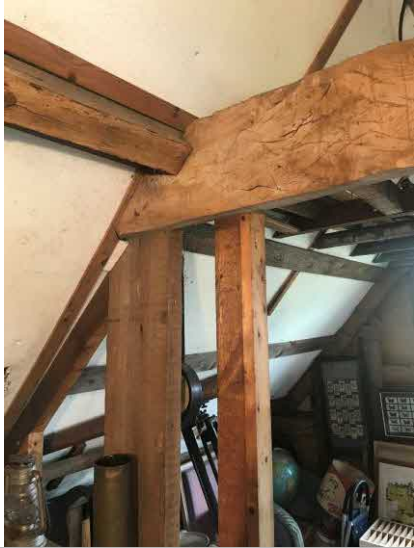
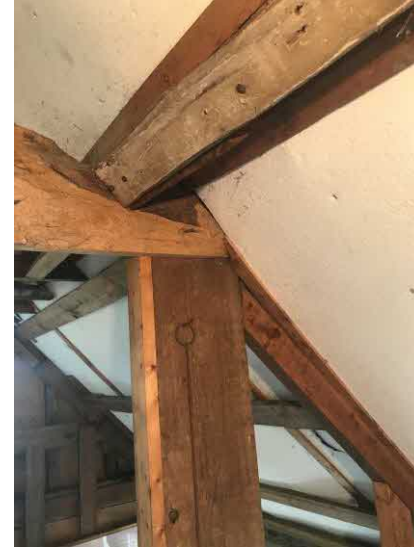
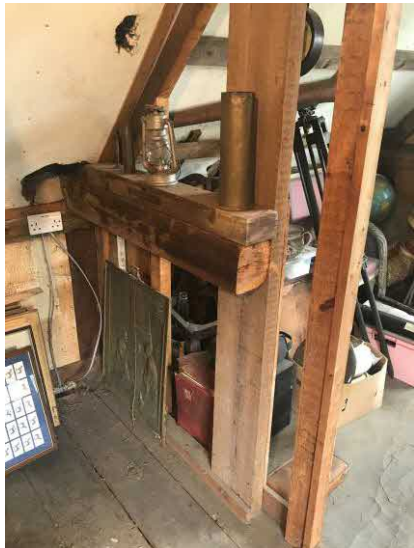
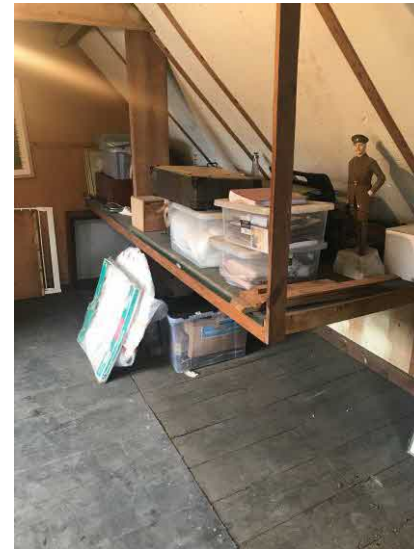
- 1.11 The early parts of the first floor at each end of the building appear to have been introduced as a loft store constructed with regular sized softwood joists and prepared softwood timber boarding fixed below eaves level to maximise the loft headroom. (Photos 5 & 6A-6H)

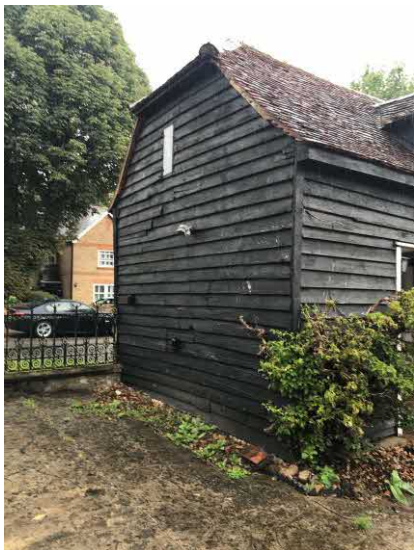
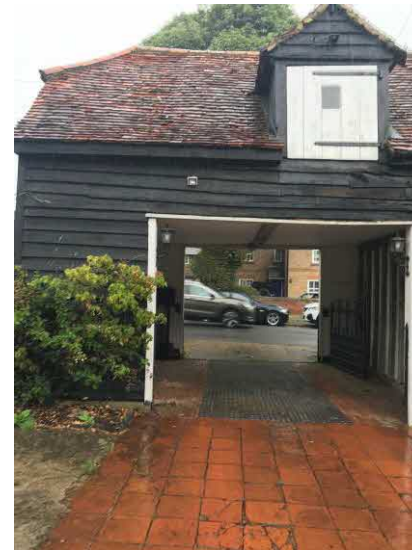
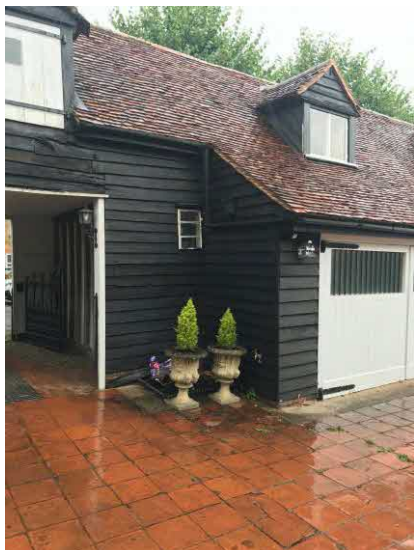
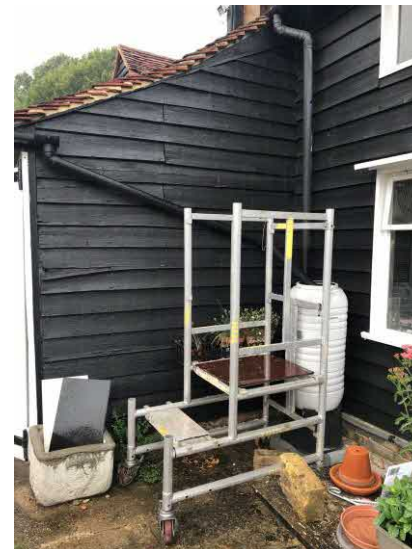
- 1.12. The three roof dormers on the south roof slope were probably added at the same time to provide loft access through the ledged and braced doors. (Photos 7A-7D)

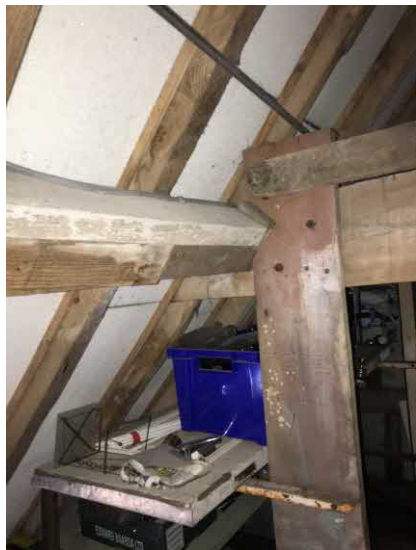
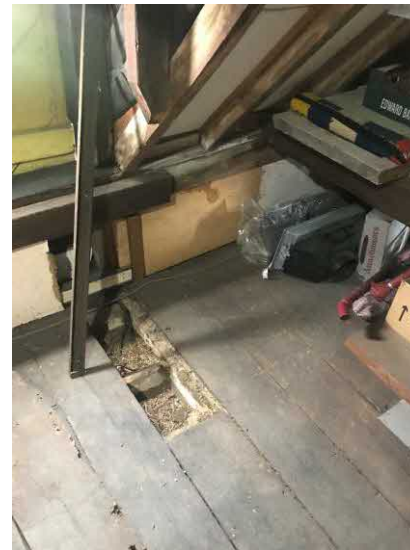
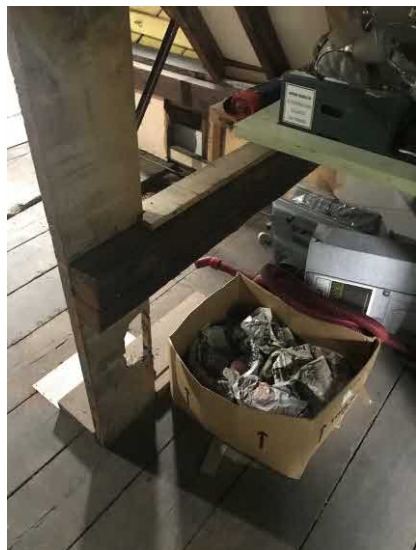
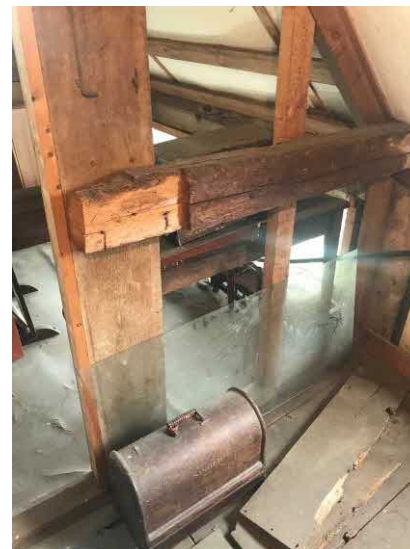
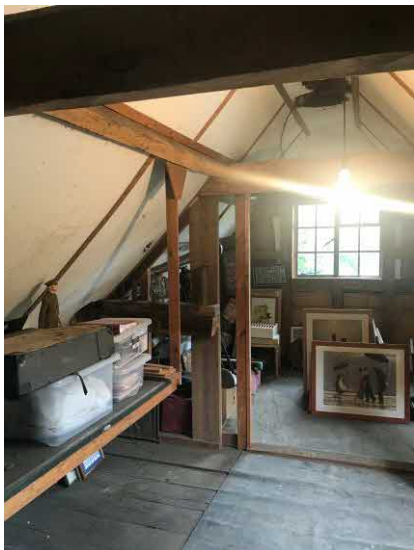
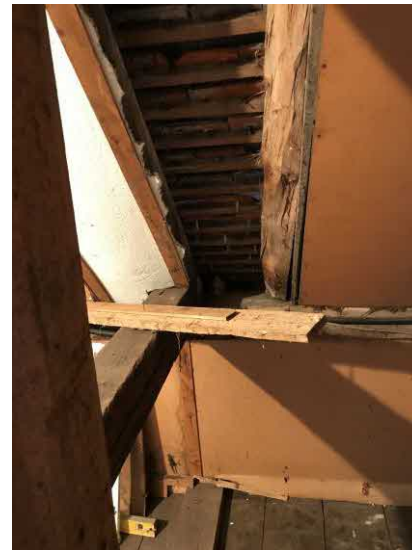
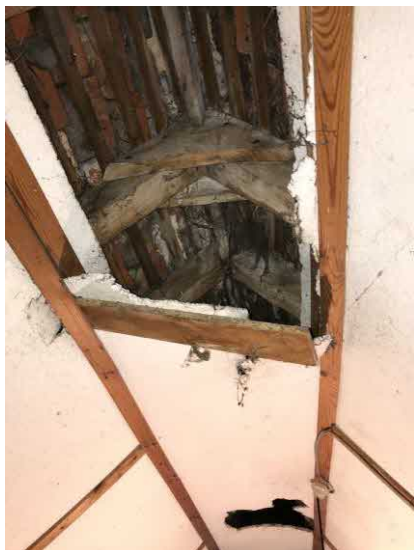
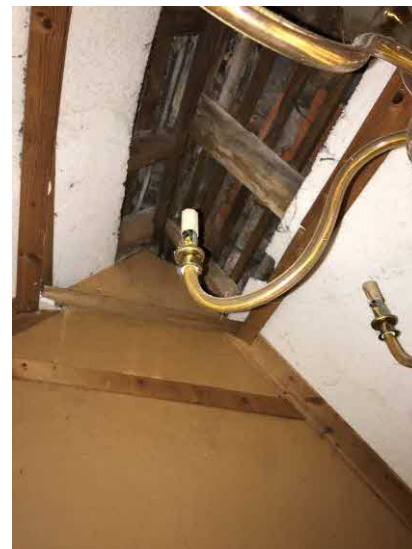
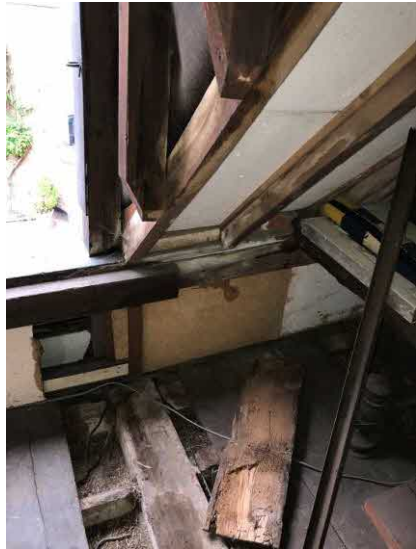
- 1.13. Access between the bays was clearly restricted by the original eaves ties across the building width so these were cut through and partly removed and replaced by an arrangement of timber struts used to transfer the load to the introduced floor. (Photos 8, 9A-9D & 10A-10D)

- 1.14 While the arrangement has worked, it is crude and of questionable reliability.
- 1.15 The central section of the first floor has been constructed more recently and may have been carried out in conjunction with repitching the roof above this area to increase loft space and incorporate a staircase and new first floor. The louvered glazing to the central dormer, the addition of lean to projections on the south side to widen the building in steps of 1.5m and 2.0m, and installation of the double part glazed doors to form garaging for the cars, are clearly contemporary adaptations. (Photo 11A-11D)

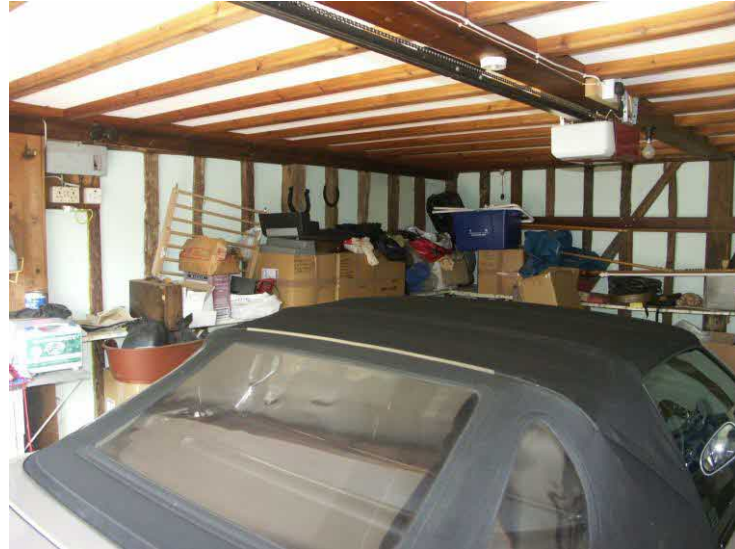
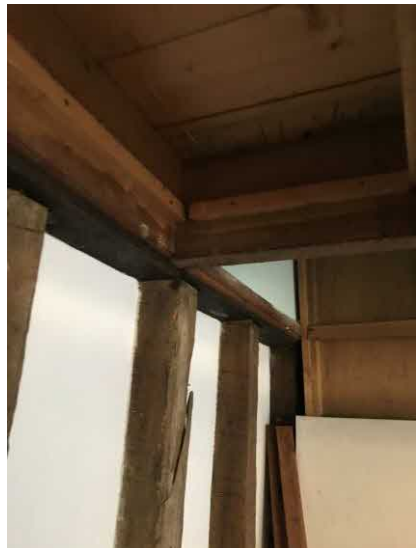
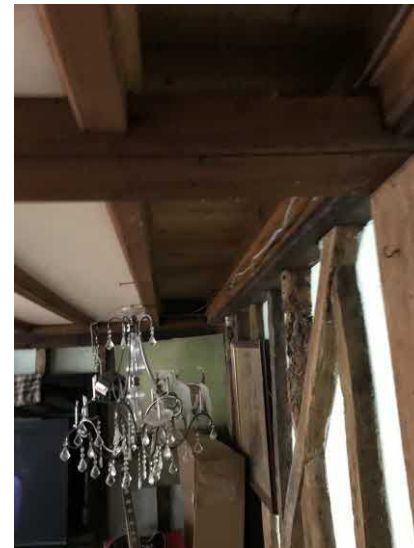
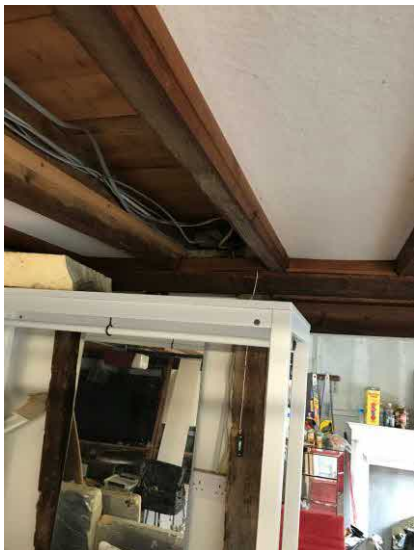
2.5.2 The floors in the central section and staircase are of comparatively recent construction and this area is to be replaced under the proposals with the staircase relocated to improve access. (Photos 11A-11D)

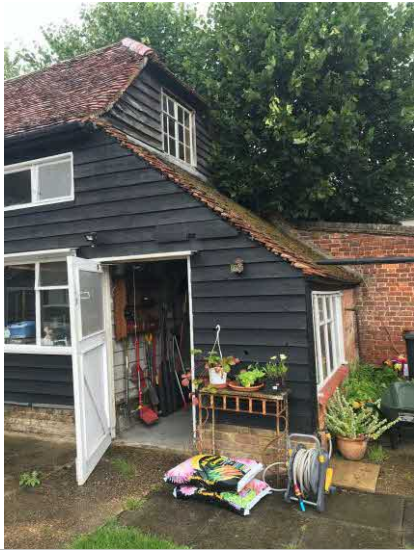
Photo 13

- 1.16 The lean to addition at the east end of the building is probably the most recent alteration extending the building length by approximately 2.0m constructed against the listed boundary wall using reclaimed materials; bricks tiles, steel and timber window frames. (Photo 13)

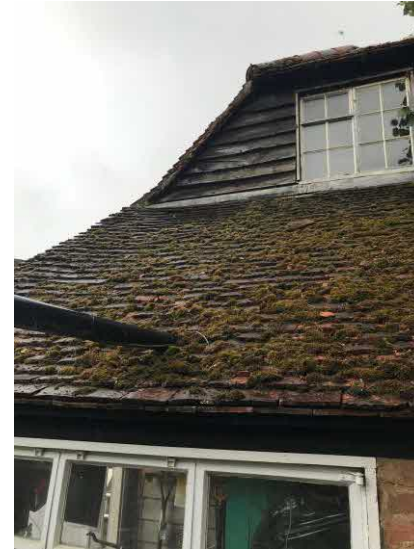
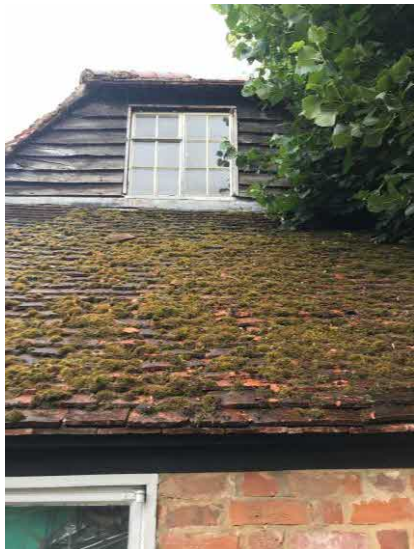
- 1.17 The east end of the building was apparently adapted to cultivate plants with heating, also serving the nearby greenhouse. (Photos 14A-14B)
- 1.18 The resulting mismatch of styles and treatment, coupled with the poor execution of the alteration work, severely detracts from the rustic origins of the building appearance. (Photo 15)

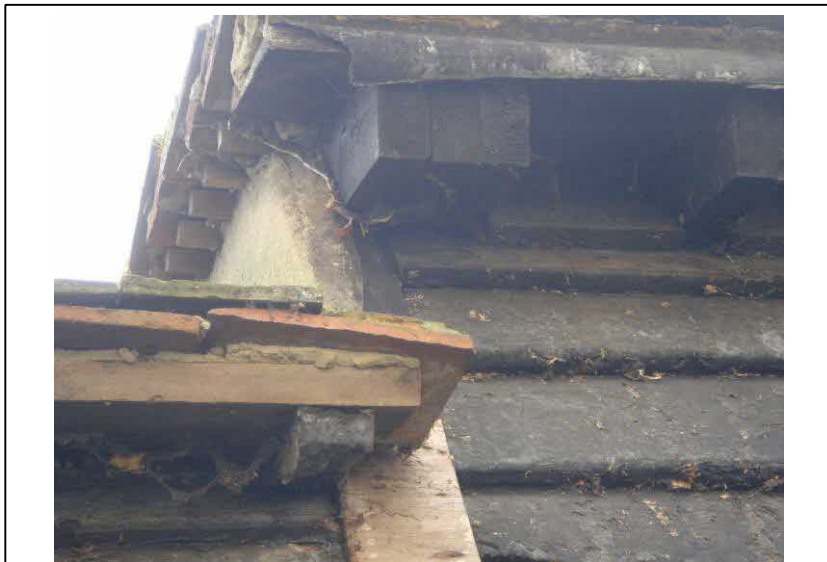
Photo 16

- 2.3.1 The roof tiles on the pitched roof are clay peg type, the central section and areas around the dormers have been refixed on sarking felt and modern machine sawn tile battens & rafters (Photo 16)

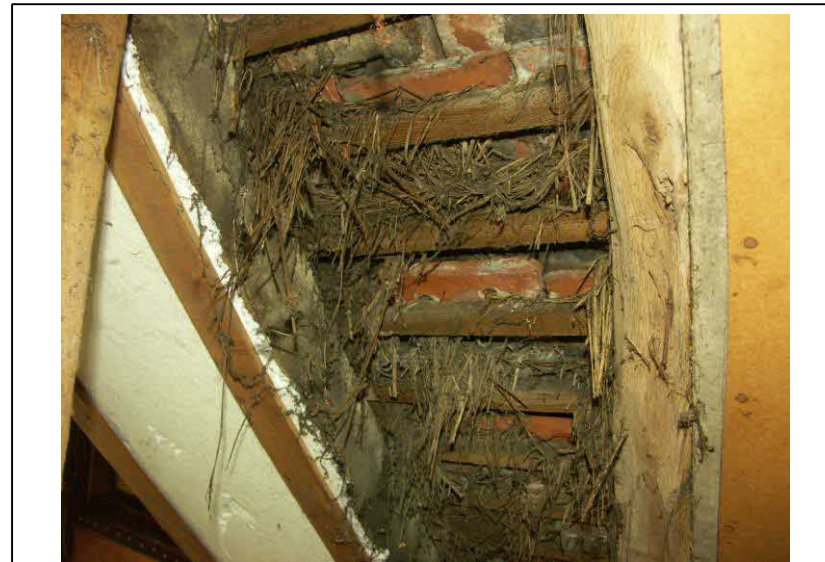
Photo 17

- 2.3.2 The remains of straw underlay on the other slopes and eroded state of the mortar pointing to the roof verges indicates tiles in these areas are as laid. The nails and fixings are therefore in a suspect condition. (Photo 17)

- 2.3.3 Some loft space areas are lined with thin boarding of very little insulation value. (Photo 18)
- 2.3.4 The roof needs to be fully stripped, the tiles set aside for reuse on new treated battens with sarking felt. This operation would provide an opportunity to deal with defects in the existing rafters by strengthening and supplementing inadequate members and replacing defective construction and flashings along the dormer cheeks. (Photo 19)

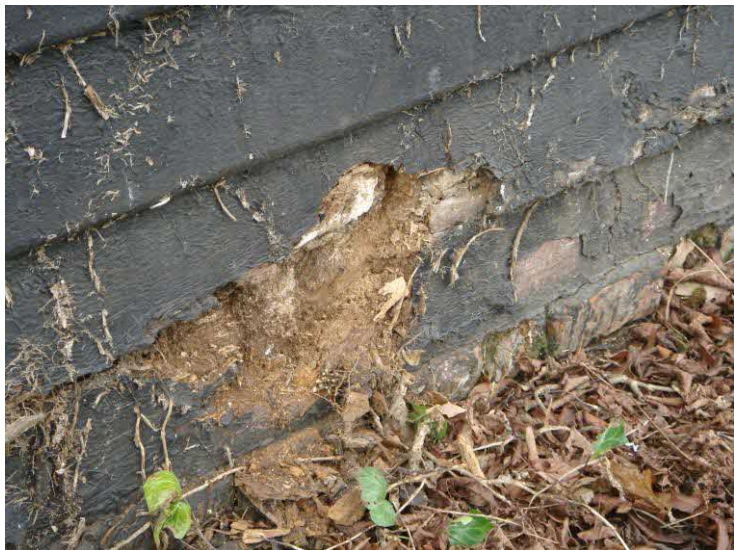
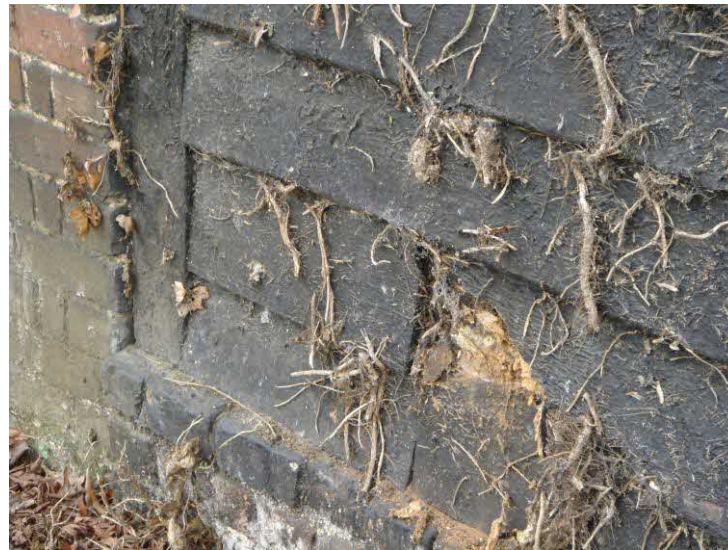
- 2.3.5 Insulation and an internal lining would be introduced to make the first floor space habitable.
- 2.3.6 There is no gutter along the eaves of the north roof slope, in driving rain conditions this results in wetting of the weather boarding and wall plate which has contributed to the rotten condition. (Photos 20 & 21)

- 2.3.7 Cast iron gutters will be provided along all roof verges.

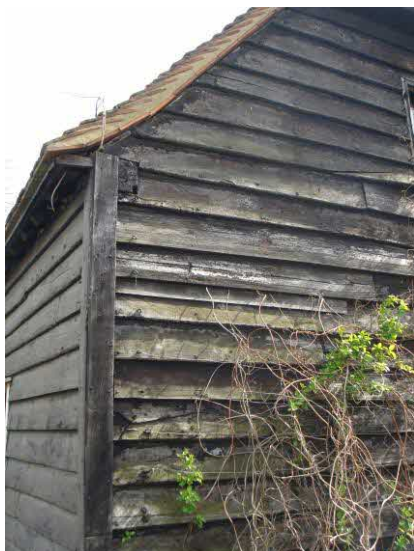
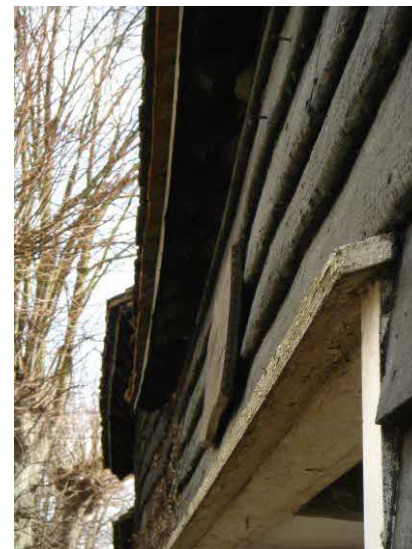
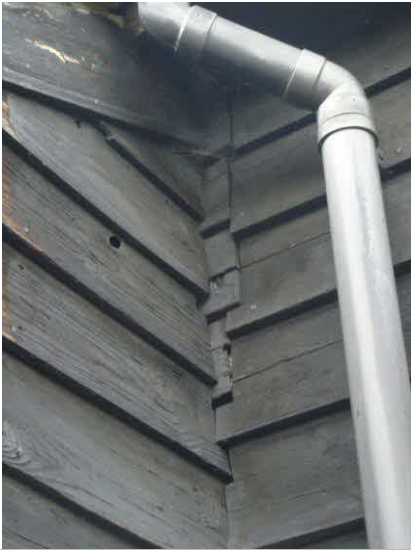
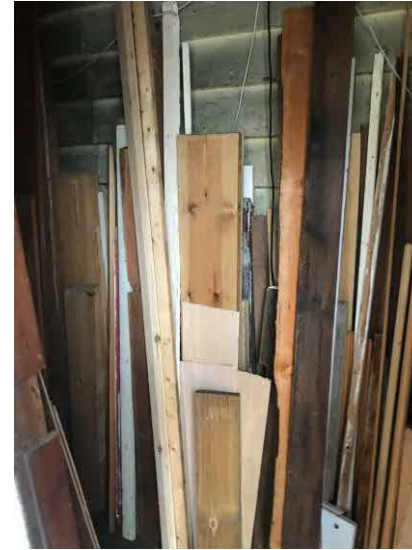
- 2.4.1 The feather edged weather boarding on the north elevation is heavily tarred and largely original. Most of the boarding on the other elevations is more recent and contemporary with the alterations. (Photos 22, 22a, 23 & 24)

- 2.4.3 In order to treat the stud framing and supplement weakened members, the boarding will be removed and set aside for reuse. A multi layer insulation will be fixed over the studs before over-boarding with WPB ply vapour barrier and counter battening to receive the salvaged weather boarding.

- 2.4.4 As far as possible any new replacement weather boarding will be used on the south elevation. New timber material will be the same type and profile as the original.

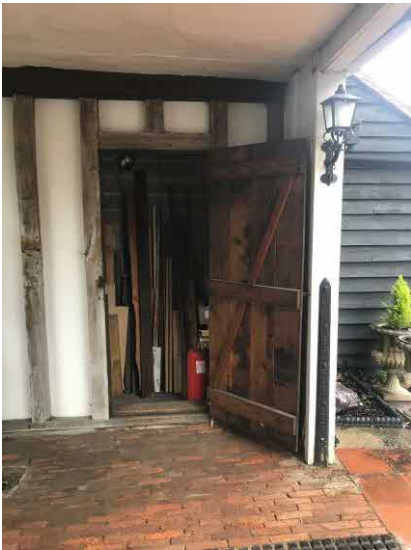
Photo 25

- 2.4.2 The internal bead and butt boarded low level lining and remains of mud and straw lime washed infill above are original. The boarding may be salvageable in places, but the condition of the infill is too deteriorated to save. (Photo 25)

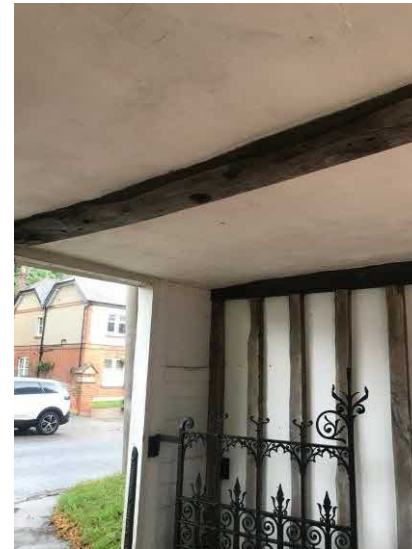
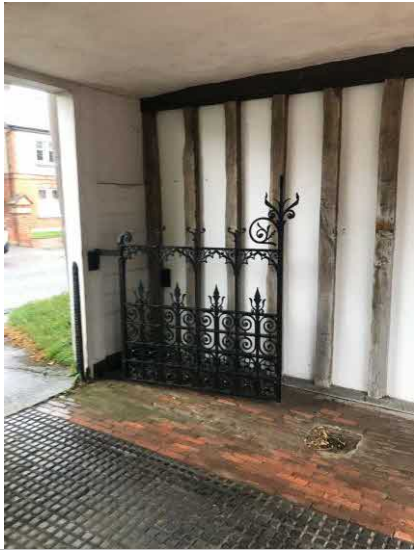
2.4.6 The alteration proposals do not entail removal of any of the original internal loadbearing studwork. The exposed studwork is principally of recent introduction & non load bearing. (Photo 26 & 26A)

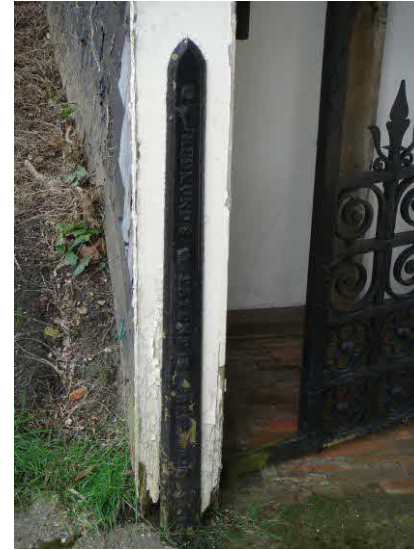
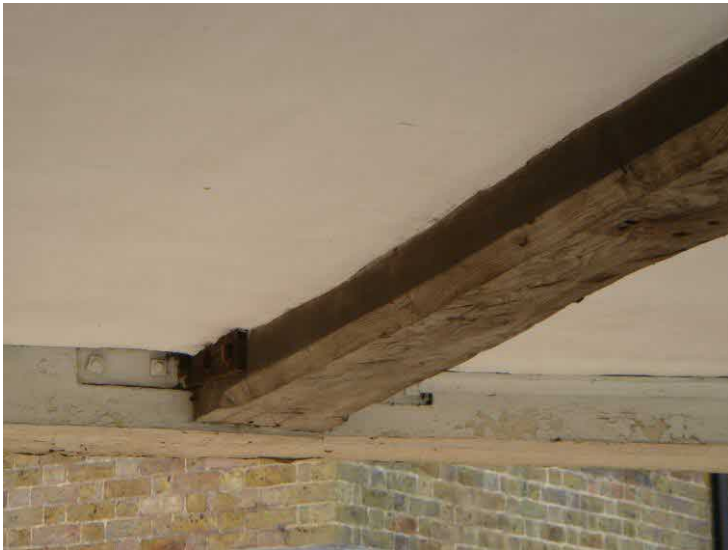
2.5.3 At the west end a supplementary arrangement of timber trimming beams has been introduced to provide support to the floor and roof allowing the creation of a vehicle access way through the building.

2.5.4 The use of metal angle cleats and coach screws to connect the beams and cast iron hinge parts to anchor the support posts typifies the improvised approach toward the building adaptations. (Photos 27 & 28)

2.5.6 These ad hoc adaptations are clearly suspect. In order to develop a reliable long term solution, the whole frame needs to be fully exposed and appraised.

2.5.7 New hardwood timber framing traditionally jointed will be incorporated into the alteration work to strengthen the floor, tie the side walls and strut the purlins.

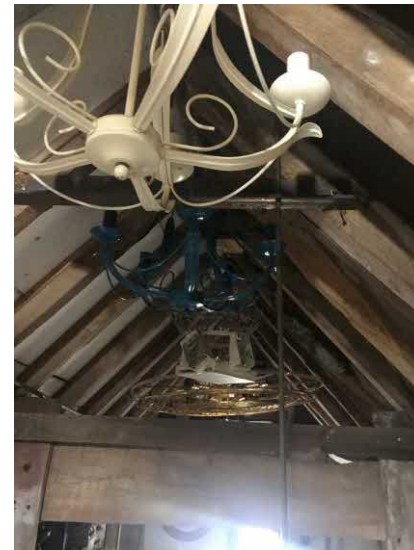
Photo 30

2.5.5 Evidently more recent concern over the strength of the floor and support beam has prompted the installation of a steel threaded stud hanger fixed to the roof apex from an angle hanger. (Photo 30)

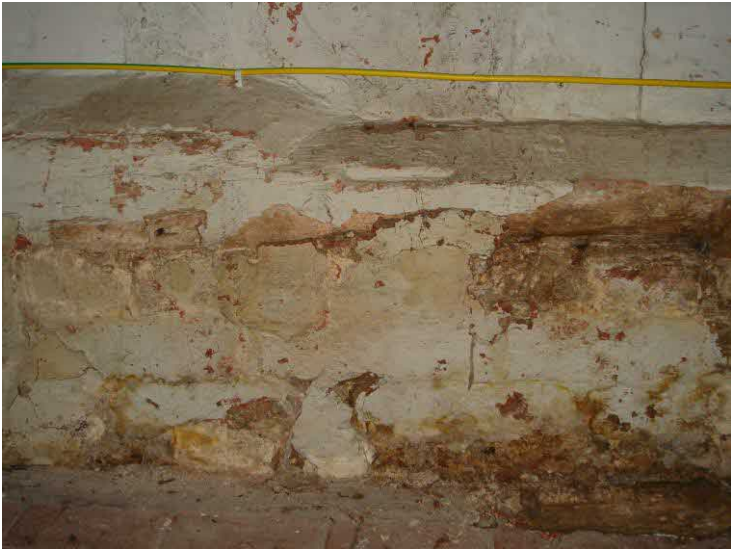
Photo 31

2.7.1 The base plate of the stud walls is raised above floor level by approximately 330mm bedded on a solid 215mm thick brick plinth. Subject to exploration this is likely to have a shallow founded corbel spread base. (Photo 31)

- 2.7.2 To ensure that the superstructure is not subject to seasonal movement and has the reliability of a current building conversion all loadbearing walls will be underpinned.
- 2.7.3 The soil level against the external surfaces will be reduced to avoid moisture transfer and a dpm will be introduced.
