Erection of Two Houses at Site at Craigrory, Artafallie, North Kessock

TREE SURVEY, PROTECTION PLAN, ARBORICULTURAL METHOD STATEMENT AND LANDSCAPE PLAN AS PER BS 5837:2012

Compiled by:
Dietrich Pannwitz FICFor
Sylvestrus Ltd.
Inverness
December 2023

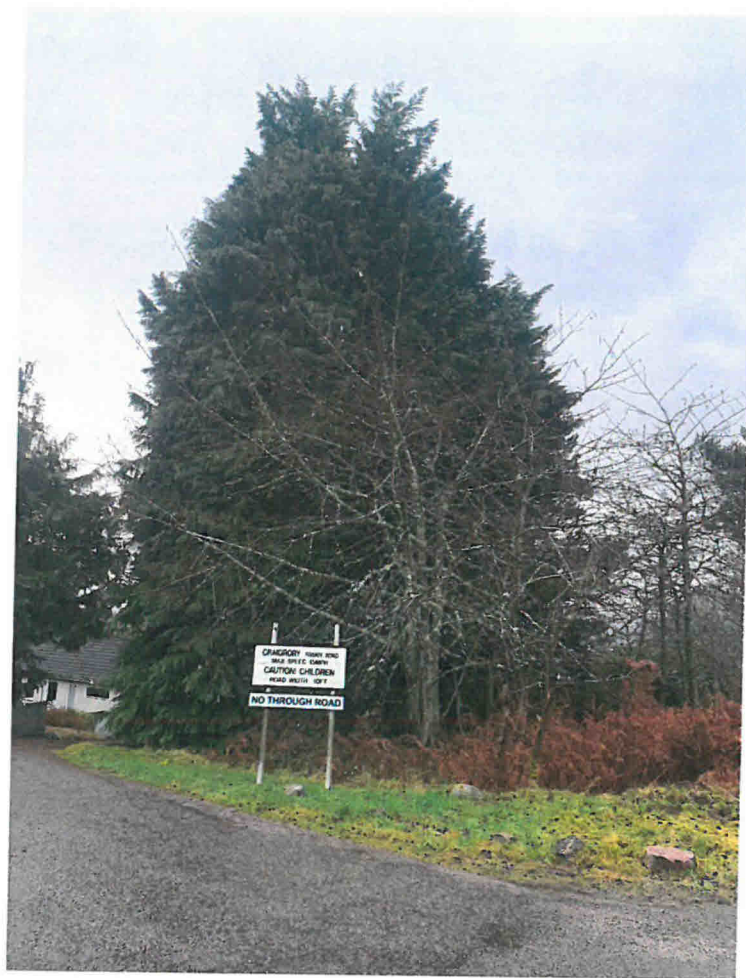
View from Public Road (North) onto Project Area - Showing Extend of Mature Non Native Hedging "Out of Control"

All the Leylandii (including a hedge to the East of the existing building) and some other minor trees can be removed as they have low or no amenity of landscape value.

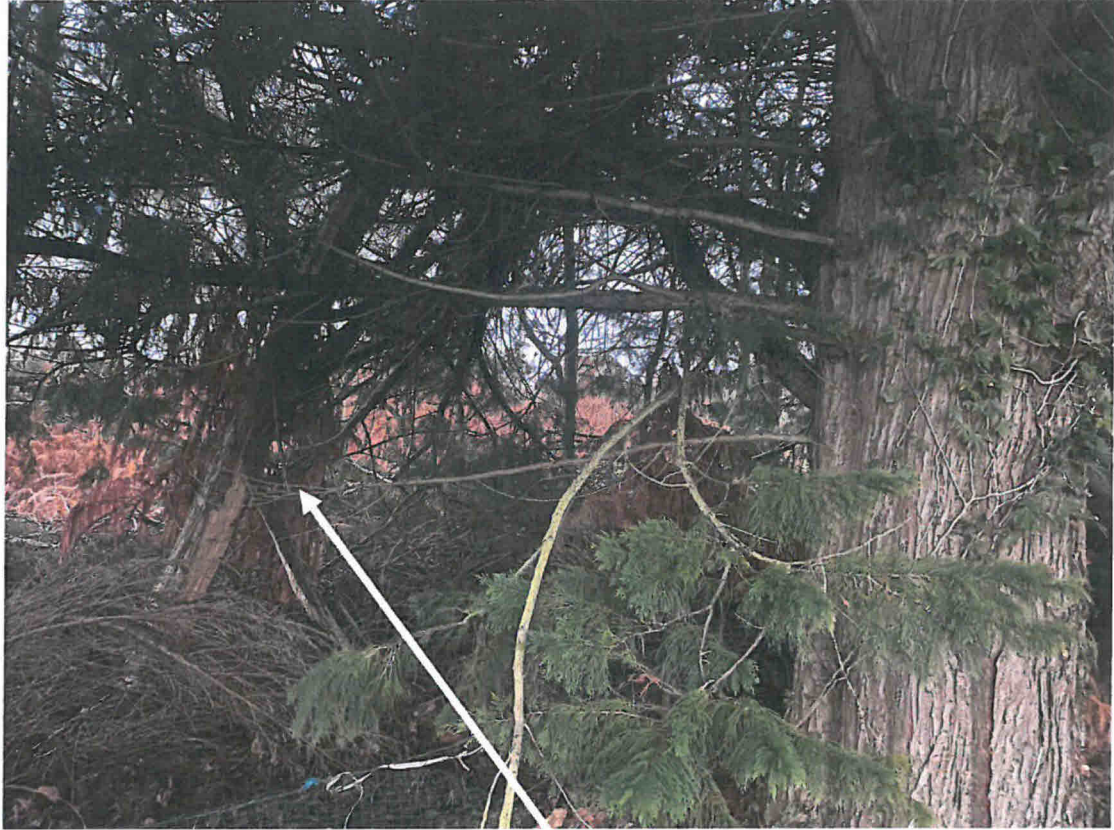
No fungal fruit bodies were noted on the trees. But there are some broken tops in the Leylandii, some have been "topped" before, one is dead, a dead elm is present and the group of Birch to the East is leaning very heavily towards the East over a stock fence (exposure?). T15 (Beech) shows damage to the trunk possibly by machine impact.

Broken Top of Tree No. 6
