Prepared by:	Maplebeck Tree Care
Address:	Clay Barn, Southwell NG22 0BS
Work Package:	St John's Church, Mansfield, NG18 1QH
Site Name/Order No:	<input type="text" value="St John's Church, Mansfield, NG18 1QH"/>
Inspector's Name:	<input type="text" value="Andrew Fairhurst"/>
Date of Report:	<input type="text" value="16-10-2023"/>

Executive Summary:

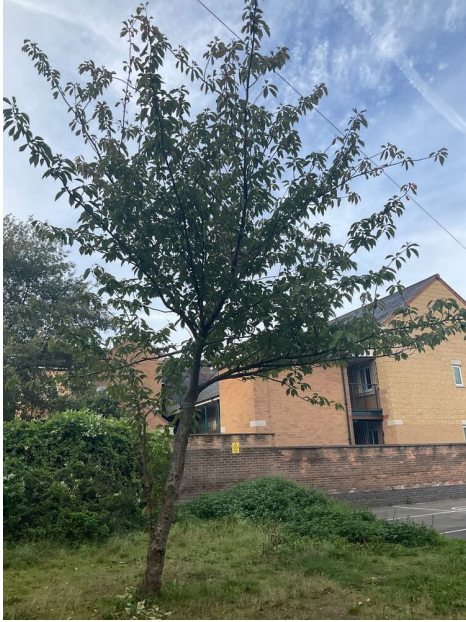
MapNo: T1 KTIId: 110126940
Date: 2023-10-16

No	Species	Height (m)	Age Class	Next Inspection	Priority	Est. Duration
T1	Prunus avium (Wild Cherry)	6	EarlyMature	16-10-2028		0
	GENERAL OBSERVATIONS Multiple wounds on the stem from 0.5m to 2.5m which have accluded well biased towards the north most likely due to neighbouring tree being removed at some point. Phone line just in contact with outer canopy of no concern. PHYSICAL_CONDITION Good ; STRUCTURAL_CONDITION Fair ; KT ASSET ID 110126940 ; STEM DIAMETERS 21cm ; CAVAT FUNCTIONAL VALUE 75% ; CAVAT CASH VALUE - ; USER NAME Maplebeck Tree Care ; LAST INSPECTED 16-10-2023		NO WORKS REQUIRED AT THE TIME OF INSPECTION			
T2	Fraxinus excelsior (Common Ash)	20	Mature	16-10-2026	4	0
	GENERAL OBSERVATIONS Moderate deadwood in canopy as to be expected with the species with some over the footpaths, canopy within 1m of the hall. No signs of ash die back. PHYSICAL_CONDITION Good ; STRUCTURAL_CONDITION Good ; KT ASSET ID 110126941 ; STEM DIAMETERS 80cm ; CAVAT FUNCTIONAL VALUE 75% ; CAVAT CASH VALUE - ; USER NAME Maplebeck Tree Care ; LAST INSPECTED 16-10-2023		PRELIMINARY RECOMMENDATIONS Remove Deadwood (Degree Moderate) (Remove deadwood over 30mm diameter which over hangs footpaths) Priority 4; Cut back from property (Prune to give 3m clearance of hall) Priority 4

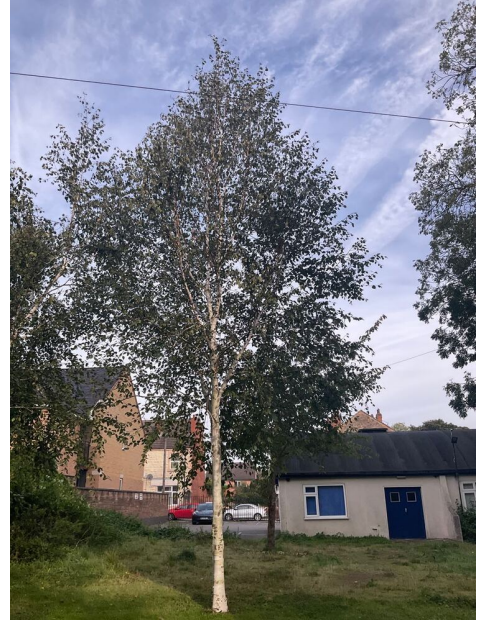
MapNo: T3 KTIId: 110126942
Date: 2023-10-16

T3	Betula papyrifera (Paper-bark Birch)	8	SemiMature	16-10-2028		0
	GENERAL OBSERVATIONS PHYSICAL_CONDITION Good ; STRUCTURAL_CONDITION Good ; KT ASSET ID 110126942 ; STEM DIAMETERS 19cm ; CAVAT FUNCTIONAL VALUE 75% ; CAVAT CASH VALUE - ; USER NAME Maplebeck Tree Care ; LAST INSPECTED 16-10-2023		NO WORKS REQUIRED AT THE TIME OF INSPECTION			
T4	Betula papyrifera (Paper-bark Birch)	7	SemiMature	16-10-2028		0
	GENERAL OBSERVATIONS PHYSICAL_CONDITION Good ; STRUCTURAL_CONDITION Good ; KT ASSET ID 110126943 ; STEM DIAMETERS 18cm ; CAVAT FUNCTIONAL VALUE 75% ; CAVAT CASH VALUE - ; USER NAME Maplebeck Tree Care ; LAST INSPECTED 16-10-2023		NO WORKS REQUIRED AT THE TIME OF INSPECTION			
T5	Laburnum anagyroides (Laburnum)	7	Mature	16-10-2027	4	0
	GENERAL OBSERVATIONS Phoneline running through canopy and being redirected by growth requires pruning to free up wire. PHYSICAL_CONDITION Good ; STRUCTURAL_CONDITION Good ; KT ASSET ID 110126944 ; STEM DIAMETERS 13cm ; CAVAT FUNCTIONAL VALUE 75% ; CAVAT CASH VALUE - ; USER NAME Maplebeck Tree Care ; LAST INSPECTED 16-10-2023		PRELIMINARY RECOMMENDATIONS Clear street lamp (Prune to free up phoneline giving as much clearance as possible 0.2m if possible.) Priority 4

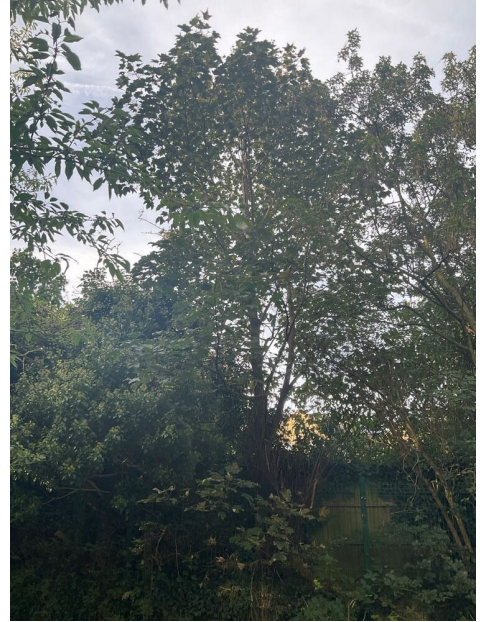
MapNo: T6 KTIId: 110126945
Date: 2023-10-16

T6	Acer pseudoplatanus (Sycamore)	8	SemiMature	16-10-2028		0
	GENERAL OBSERVATIONS Most likely a self set tree may cause damage to fences but in the future but of no concern currently PHYSICAL_CONDITION Good ; STRUCTURAL_CONDITION Good ; KT ASSET ID 110126945 ; STEM DIAMETERS 12cm ; COMMENT In between fence line owner unclear ; CAVAT FUNCTIONAL VALUE 75% ; CAVAT CASH VALUE - ; USER NAME Maplebeck Tree Care ; LAST INSPECTED 16-10-2023		NO WORKS REQUIRED AT THE TIME OF INSPECTION			
T7	Prunus avium (Wild Cherry)	11	Mature	16-10-2028	3	0
	GENERAL OBSERVATIONS Minor root girdling of no concern, canopy below 2m over path and within 1m of church PHYSICAL_CONDITION Good ; STRUCTURAL_CONDITION Good ; KT ASSET ID 110126946 ; STEM DIAMETERS 41cm ; CAVAT FUNCTIONAL VALUE 75% ; CAVAT CASH VALUE - ; USER NAME Maplebeck Tree Care ; LAST INSPECTED 16-10-2023		PRELIMINARY RECOMMENDATIONS Cut back from property (Prune to give 2m clearance from chirch) Priority 4; Raise Crown (Raise canopy to 3m all around.) Priority 3

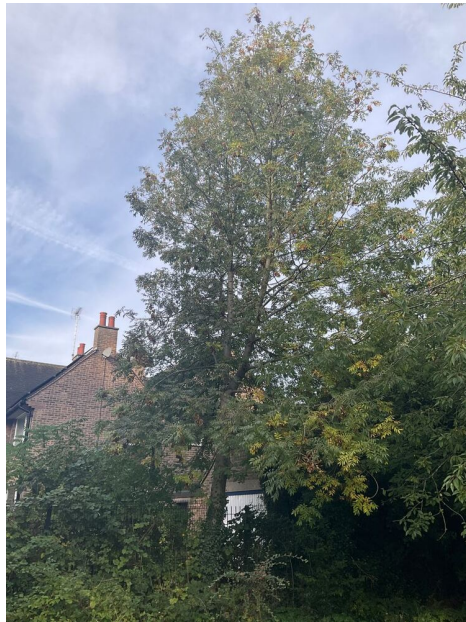
MapNo: T8 KTIId: 110126947
Date: 2023-10-16

T8	Fraxinus excelsior (Common Ash)	11	EarlyMature	16-10-2028	4	0
	GENERAL OBSERVATIONS Biased towards neighbouring property, not in contact with fence yet. PHYSICAL_CONDITION Good ; STRUCTURAL_CONDITION Good ; KT ASSET ID 110126947 ; STEM DIAMETERS 29cm ; CAVAT FUNCTIONAL VALUE 75% ; CAVAT CASH VALUE - ; USER NAME Maplebeck Tree Care ; LAST INSPECTED 16-10-2023		PRELIMINARY RECOMMENDATIONS Cut back from property (Prune to give 2m clearance from neighbours garage) Priority 4			
T9	Fraxinus excelsior (Common Ash)	10	EarlyMature	16-10-2028		0
	GENERAL OBSERVATIONS Multi stemmed species, with ivy establishing on the tree PHYSICAL_CONDITION Good ; STRUCTURAL_CONDITION Good ; KT ASSET ID 110126948 ; STEM DIAMETERS 21cm, 18cm, 19cm ; CAVAT FUNCTIONAL VALUE 75% ; CAVAT CASH VALUE - ; USER NAME Maplebeck Tree Care ; LAST INSPECTED 16-10-2023		NO WORKS REQUIRED AT THE TIME OF INSPECTION			
T10	Prunus laurocerasus (Cherry Laurel)	6	Mature	16-10-2028		0

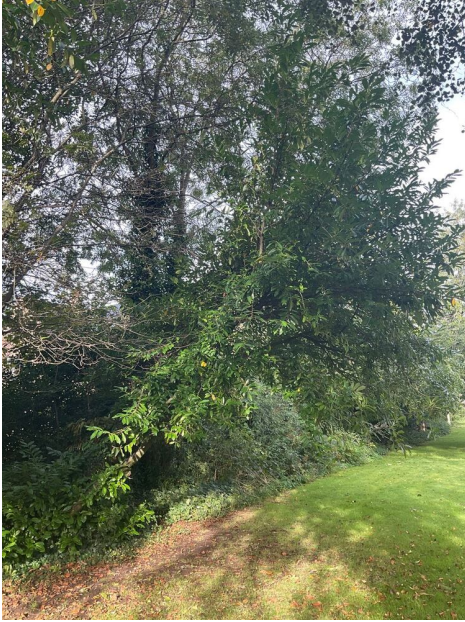
MapNo: T10 KTId: 110126949
Date: 2023-10-16

GENERAL OBSERVATIONS Heavily biased over grassed area due to competition. PHYSICAL_CONDITION Good ; STRUCTURAL_CONDITION Good ; KT ASSET ID 110126949 ; STEM DIAMETERS 12cm, 13cm ; CAVAT FUNCTIONAL VALUE 75% ; CAVAT CASH VALUE - ; USER NAME Maplebeck Tree Care ; LAST INSPECTED 16-10-2023		NO WORKS REQUIRED AT THE TIME OF INSPECTION			
T11	Prunus laurocerasus (Cherry Laurel)	5	Mature	16-10-2028		0
	GENERAL OBSERVATIONS Heavily biased over grassed area due to competition. Pruned clear of the path PHYSICAL_CONDITION Good ; STRUCTURAL_CONDITION Good ; KT ASSET ID 110126950 ; STEM DIAMETERS 12cm, 13cm, 17cm ; CAVAT FUNCTIONAL VALUE 75% ; CAVAT CASH VALUE - ; USER NAME Maplebeck Tree Care ; LAST INSPECTED 16-10-2023		NO WORKS REQUIRED AT THE TIME OF INSPECTION			
T12	Sorbus aucuparia (Rowan)	9	Mature	16-10-2028		0
	GENERAL OBSERVATIONS Minor deadwood in canopy of no concern. PHYSICAL_CONDITION Good ; STRUCTURAL_CONDITION Good ; KT ASSET ID 110126951 ; STEM DIAMETERS 19cm, 6cm ; CAVAT FUNCTIONAL VALUE 75% ; CAVAT CASH VALUE - ; USER NAME Maplebeck Tree Care ; LAST INSPECTED 16-10-2023		NO WORKS REQUIRED AT THE TIME OF INSPECTION

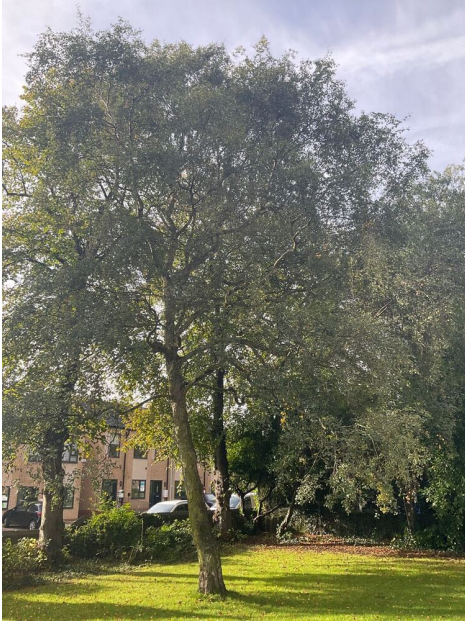
MapNo: T13 KTId: 110126952
Date: 2023-10-16

T13	Betula pendula (Silver Birch)	9	Mature	16-10-2028		0

No	Species	Height (m)	Age Class	Next Inspection	Priority	Est. Duration
	GENERAL OBSERVATIONS Minor deadwood in canopy of no concern PHYSICAL_CONDITION Good ; STRUCTURAL_CONDITION Good ; KT ASSET ID 110126952 ; CAVAT FUNCTIONAL VALUE 75% ; CAVAT CASH VALUE - ; USER NAME Maplebeck Tree Care ; LAST INSPECTED 16-10-2023					NO WORKS REQUIRED AT THE TIME OF INSPECTION
T14	Tilia cordata (Small-leaved Lime)	12	Mature	16-10-2028	3	0
	GENERAL OBSERVATIONS Moderate deadwood in canopy over path, canopy encroaching onto carriageway. PHYSICAL_CONDITION Good ; STRUCTURAL_CONDITION Good ; KT ASSET ID 110126953 ; STEM DIAMETERS 55cm ; CAVAT FUNCTIONAL VALUE 75% ; CAVAT CASH VALUE - ; USER NAME Maplebeck Tree Care ; LAST INSPECTED 16-10-2023					PRELIMINARY RECOMMENDATIONS Raise Crown (Raise canopy to 5.2m over carriageway) Priority 3; Remove Deadwood (Degree Moderate) (Remove deadwood over 30mm diameter over footway side only) Priority 3

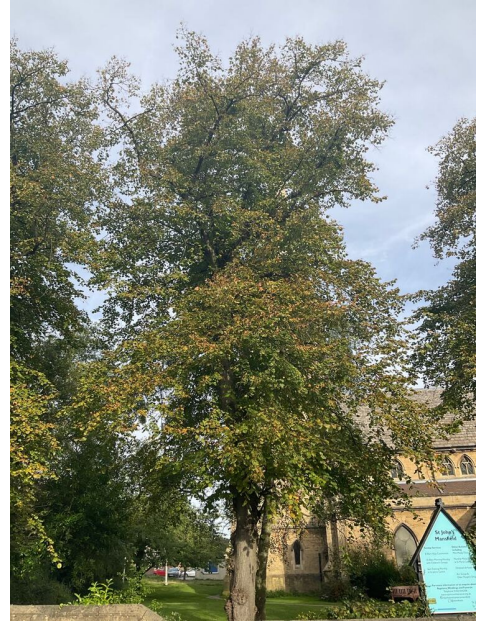
MapNo: T15 KTId: 110126954
Date: 2023-10-16

T15	Tilia cordata (Small-leaved Lime)	12	Mature	16-10-2028	3	0
	GENERAL OBSERVATIONS canopy encroaching onto carriageway. Minor deadwood over footway PHYSICAL_CONDITION Good ; STRUCTURAL_CONDITION Good ; KT ASSET ID 110126954 ; STEM DIAMETERS 50cm ; CAVAT FUNCTIONAL VALUE 75% ; CAVAT CASH VALUE - ; USER NAME Maplebeck Tree Care ; LAST INSPECTED 16-10-2023					PRELIMINARY RECOMMENDATIONS Raise Crown (Raise canopy to 5.2m over carriageway.) Priority 3; Remove Deadwood (Degree Minor) (Remove deadwood over 30mm diameter over footway side only) Priority 3
T16	Tilia cordata (Small-leaved Lime)	12	Mature	16-10-2028	3	0
	GENERAL OBSERVATIONS canopy encroaching onto carriageway. PHYSICAL_CONDITION Good ; STRUCTURAL_CONDITION Good ; KT ASSET ID 110126955 ; STEM DIAMETERS 52cm ; CAVAT FUNCTIONAL VALUE 75% ; CAVAT CASH VALUE - ; USER NAME Maplebeck Tree Care ; LAST INSPECTED 16-10-2023					PRELIMINARY RECOMMENDATIONS Raise Crown (Raise canopy to 5.2m over carriageway.) Priority 3

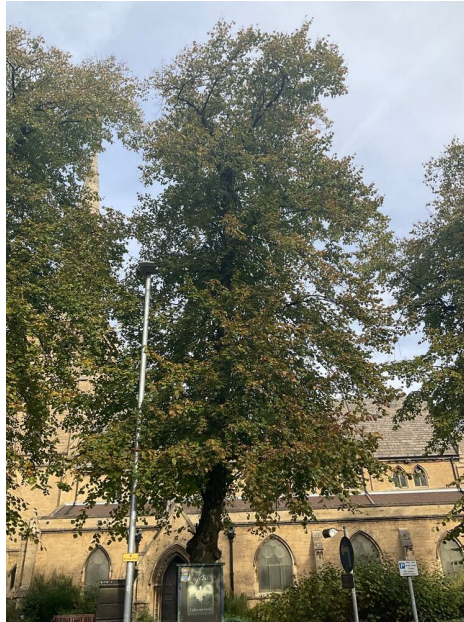
MapNo: T17 KTId: 110126956
Date: 2023-10-16

T17	Tilia cordata (Small-leaved Lime)	12	Mature	16-10-2028	3	0
	GENERAL OBSERVATIONS canopy encroaching onto carriageway. And requires clearing around streetlight. PHYSICAL_CONDITION Good ; STRUCTURAL_CONDITION Good ; KT ASSET ID 110126956 ; STEM DIAMETERS 52cm ; CAVAT FUNCTIONAL VALUE 75% ; CAVAT CASH VALUE - ; USER NAME Maplebeck Tree Care ; LAST INSPECTED 16-10-2023					PRELIMINARY RECOMMENDATIONS Clear street lamp (Prune to give 1.5m clearance from streetlight) Priority 3; Raise Crown (Raise canopy to 5.2m over carriageway.) Priority 3
T18	Tilia cordata (Small-leaved Lime)	12	Mature	16-10-2028	3	0
	GENERAL OBSERVATIONS canopy encroaching onto carriageway. Moderate deadwood over footway. PHYSICAL_CONDITION Good ; STRUCTURAL_CONDITION Good ; KT ASSET ID 110126957 ; STEM DIAMETERS 52cm ; CAVAT FUNCTIONAL VALUE 75% ; CAVAT CASH VALUE - ; USER NAME Maplebeck Tree Care ; LAST INSPECTED 16-10-2023					PRELIMINARY RECOMMENDATIONS Remove Deadwood (Degree Moderate) (Remove deadwood over 30mm diameter over footway) Priority 3; Raise Crown (Raise canopy to 5.2m over carriageway.) Priority 3

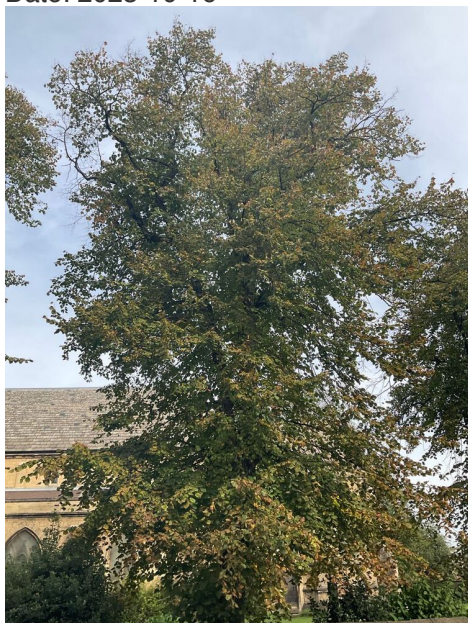
MapNo: T19 KTId: 110126958
Date: 2023-10-16

T19	Tilia cordata (Small-leaved Lime)	12	Mature	16-10-2028	3	0
	GENERAL OBSERVATIONS canopy encroaching onto carriageway. Minor deadwood over carriageway. PHYSICAL_CONDITION Good ; STRUCTURAL_CONDITION Good ; KT ASSET ID 110126958 ; STEM DIAMETERS 52cm ; CAVAT FUNCTIONAL VALUE 75% ; CAVAT CASH VALUE - ; USER NAME Maplebeck Tree Care ; LAST INSPECTED 16-10-2023					PRELIMINARY RECOMMENDATIONS Remove Basal Suckers Priority 4; Remove Deadwood (Degree Minor) (Remove deadwood over 30mm diameter over footway) Priority 3; Raise Crown (Raise canopy to 5.2m over carriageway.) Priority 3
T20	Tilia cordata (Small-leaved Lime)	11	Mature	16-10-2028	3	0
	GENERAL OBSERVATIONS canopy encroaching onto carriageway. Moderate deadwood over carriageway. Basal epicormic growth. PHYSICAL_CONDITION Good ; STRUCTURAL_CONDITION Good ; KT ASSET ID 110126959 ; STEM DIAMETERS 48cm ; CAVAT FUNCTIONAL VALUE 75% ; CAVAT CASH VALUE - ; USER NAME Maplebeck Tree Care ; LAST INSPECTED 16-10-2023					PRELIMINARY RECOMMENDATIONS Remove Basal Suckers Priority 4; Remove Deadwood (Degree Moderate) (Remove deadwood over 30mm diameter over footway and footpath in church grounds.) Priority 3; Raise Crown (Raise canopy to 5.2m over carriageway.) Priority 3

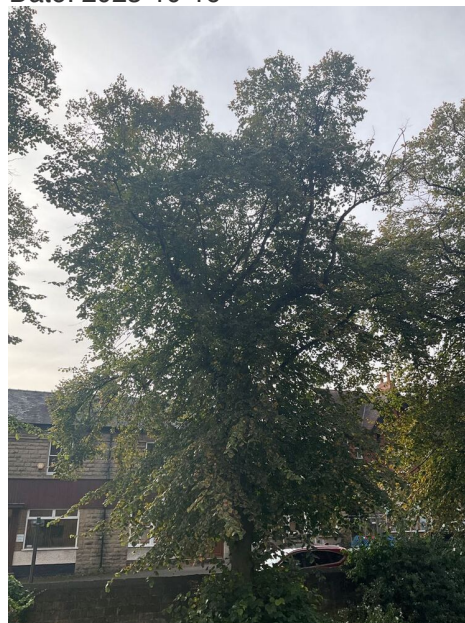
MapNo: T21 KTId: 110126960
Date: 2023-10-16

T21	Tilia cordata (Small-leaved Lime)	11	Mature	16-10-2028	3	0
	GENERAL OBSERVATIONS canopy encroaching onto carriageway. Moderate deadwood over carriageway and folate inside church grounds. Basal epicormic growth. PHYSICAL_CONDITION Good ; STRUCTURAL_CONDITION Good ; KT ASSET ID 110126960 ; STEM DIAMETERS 48cm ; CAVAT FUNCTIONAL VALUE 75% ; CAVAT CASH VALUE - ; USER NAME Maplebeck Tree Care ; LAST INSPECTED 16-10-2023					PRELIMINARY RECOMMENDATIONS Remove Basal Suckers Priority 4; Remove Deadwood (Degree Minor) (Remove deadwood over 30mm diameter over carriageway way and footpath inside church grounds.) Priority 3; Raise Crown (Raise canopy to 5.2m over carriageway.) Priority 3
T22	Tilia cordata (Small-leaved Lime)	12	Mature	16-10-2028	3	0
	GENERAL OBSERVATIONS Basal epicormic growth. PHYSICAL_CONDITION Good ; STRUCTURAL_CONDITION Good ; KT ASSET ID 110126961 ; STEM DIAMETERS 60cm ; CAVAT FUNCTIONAL VALUE 75% ; CAVAT CASH VALUE - ; USER NAME Maplebeck Tree Care ; LAST INSPECTED 16-10-2023					PRELIMINARY RECOMMENDATIONS Raise Crown (Raise canopy for future clearance and to keep the aesthetics down the run of limes the same.) Priority 3; Remove Basal Suckers Priority 4

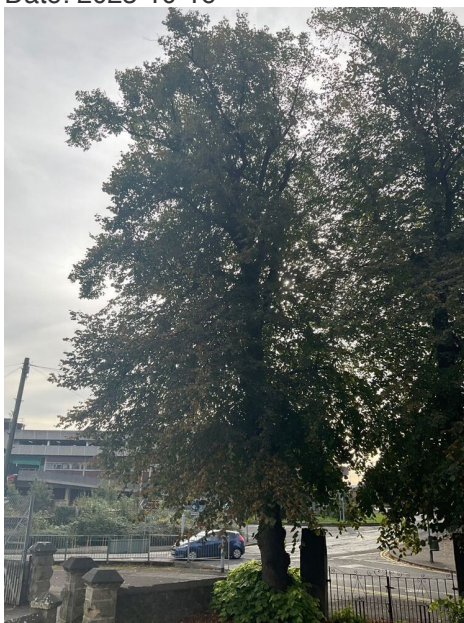
MapNo: T23 KTId: 110126962
Date: 2023-10-16

T23	Tilia cordata (Small-leaved Lime)	12	Mature	16-10-2028	3	0
	GENERAL OBSERVATIONS Basal epicormic growth. PHYSICAL_CONDITION Good ; STRUCTURAL_CONDITION Good ; KT ASSET ID 110126962 ; STEM DIAMETERS 60cm ; CAVAT FUNCTIONAL VALUE 75% ; CAVAT CASH VALUE - ; USER NAME Maplebeck Tree Care ; LAST INSPECTED 16-10-2023					PRELIMINARY RECOMMENDATIONS Raise Crown (Raise canopy for future clearance and to keep the aesthetics down the run of limes the same.) Priority 3; Remove Basal Suckers Priority 4
T24	Tilia cordata (Small-leaved Lime)	12	Mature	16-10-2028	4	0
	GENERAL OBSERVATIONS Basal epicormic growth, restricting inspection of the base of the tree, minor dieback in the upper canopy of no concern due to no targets. PHYSICAL_CONDITION Good ; STRUCTURAL_CONDITION Good ; KT ASSET ID 110126963 ; STEM DIAMETERS 60cm ; CAVAT FUNCTIONAL VALUE 75% ; CAVAT CASH VALUE - ; USER NAME Maplebeck Tree Care ; LAST INSPECTED 16-10-2023					PRELIMINARY RECOMMENDATIONS Remove Basal Suckers Priority 4

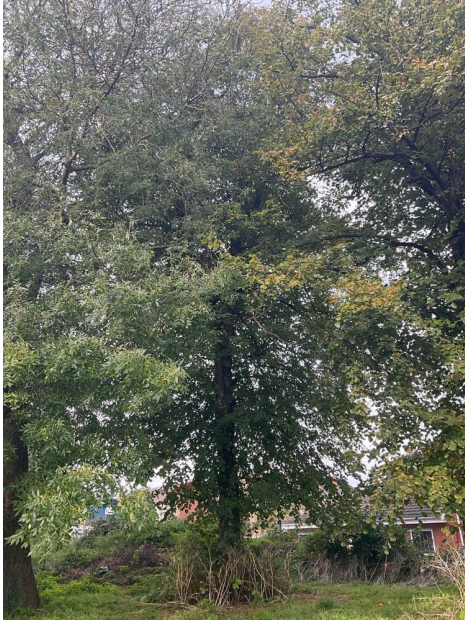
MapNo: T25 KTId: 110126964
Date: 2023-10-16

T25	Tilia cordata (Small-leaved Lime)	14	Mature	16-10-2028	4	0

No	Species	Height (m)	Age Class	Next Inspection	Priority	Est. Duration
	<p>GENERAL OBSERVATIONS Basal epicormic growth, restricting inspection of the base of the tree.</p> <p>PHYSICAL_CONDITION Good; STRUCTURAL_CONDITION Good; KT ASSET ID 110126964; STEM DIAMETERS 52cm; CAVAT FUNCTIONAL VALUE 75%; CAVAT CASH VALUE -; USER NAME Maplebeck Tree Care; LAST INSPECTED 16-10-2023</p>					
			<p>PRELIMINARY RECOMMENDATIONS Remove Basal Suckers Priority 4</p>			
T26	Acer pseudoplatanus (Sycamore)	11	EarlyMature	16-10-2027		0
	<p>GENERAL OBSERVATIONS</p> <p>PHYSICAL_CONDITION Good; STRUCTURAL_CONDITION Good; KT ASSET ID 110126965; STEM DIAMETERS 28cm; CAVAT FUNCTIONAL VALUE 75%; CAVAT CASH VALUE -; USER NAME Maplebeck Tree Care; LAST INSPECTED 16-10-2023</p>		<p>NO WORKS REQUIRED AT THE TIME OF INSPECTION</p>			
T27	Sambucus nigra (Elder)	6	Mature	16-10-2028		0
	<p>GENERAL OBSERVATIONS Heavily biased over neighbouring fence line.</p> <p>PHYSICAL_CONDITION Good; STRUCTURAL_CONDITION Fair; KT ASSET ID 110126966; STEM DIAMETERS 15cm; CAVAT FUNCTIONAL VALUE 75%; CAVAT CASH VALUE -; USER NAME Maplebeck Tree Care; LAST INSPECTED 16-10-2023</p>		<p>NO WORKS REQUIRED AT THE TIME OF INSPECTION</p>

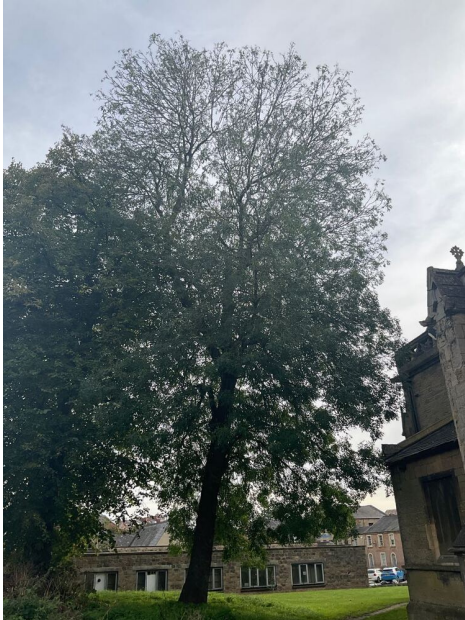
MapNo: T28 KTId: 110126967
Date: 2023-10-16

T28	Fraxinus excelsior (Ash)	19	Mature	16-10-2026	3	0
	<p>GENERAL OBSERVATIONS Canopy encroaching towards church, canopy below 3m over path. Limb at 8m in height to the west over the footpath is overextending the natural canopy line.</p> <p>PHYSICAL_CONDITION Good; STRUCTURAL_CONDITION Good; KT ASSET ID 110126967; STEM DIAMETERS 66cm; CAVAT FUNCTIONAL VALUE 75%; CAVAT CASH VALUE -; USER NAME Maplebeck Tree Care; LAST INSPECTED 16-10-2023</p>		<p>PRELIMINARY RECOMMENDATIONS Reduce Crown (Meters 3m) (Reduce limb to the west at 8m in height back to within the natural canopy line by 3m) Priority 4; Cut back from property (Prune to give 3m clearance from church) Priority 4; Raise Crown (Raise crown to 4m all around) Priority 3</p>
