**0/1 73 West Princes Street, Glasgow, G4 9BY**

We propose replacing the existing sash and case window with newly manufactured timber sash and case windows that will be manufactured in a like for like formation. Horn detail would be lifted from the existing windows to preserve the established style.

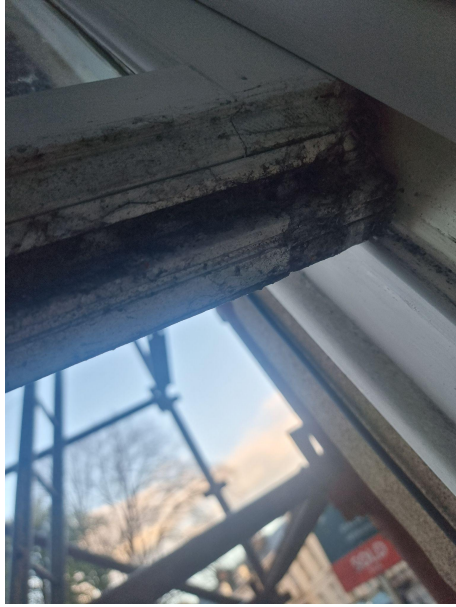
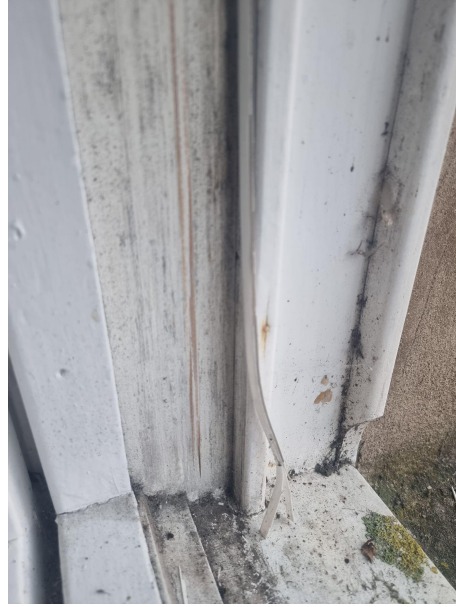
Seals have been installed to the windows around the parting bead and on top of the bottom rail. This has been done due to wind and water entering the property. Usually this would be checked into the bottom rail and the seal would be added to the sash rather than the parting bead on the casement which shows these were added as a temporary fix due to the issues. The cut out section on the outside baton rod is also something only seen on modern windows to allow the water to not be trapped on the sill and trickle out, this is not something that is seen on original windows.

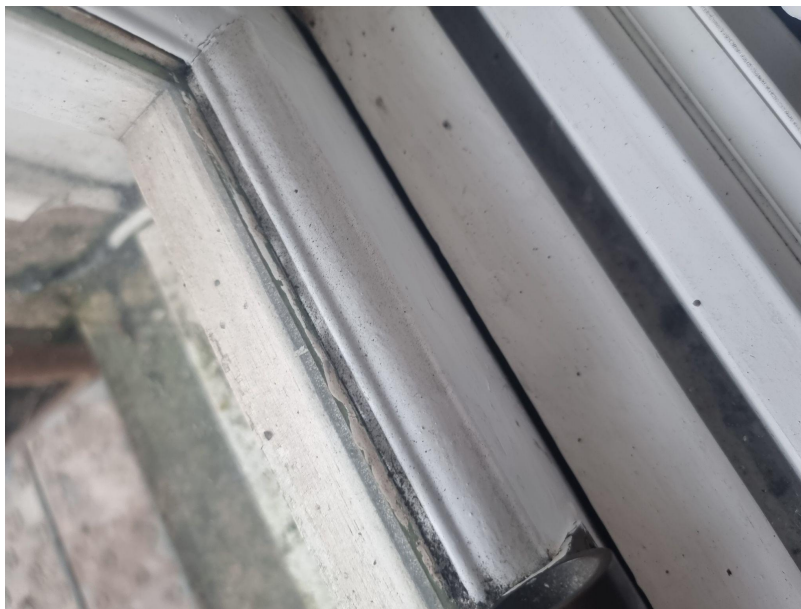
Seals around the glass have come away, allowing wind to enter the property. The glass is not original and the curved bevel on the moldings around the windows show that they are not original and therefore not historically relevant.

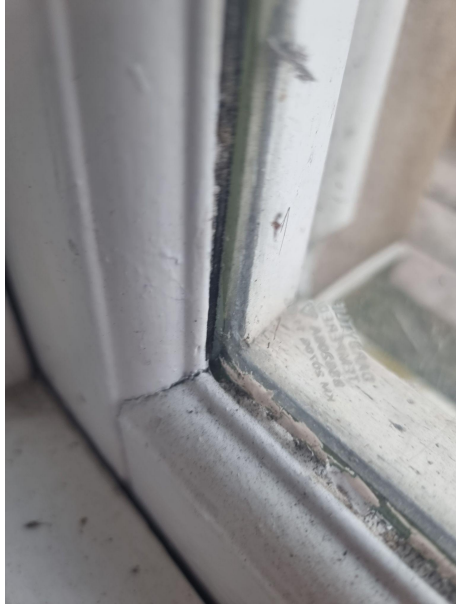
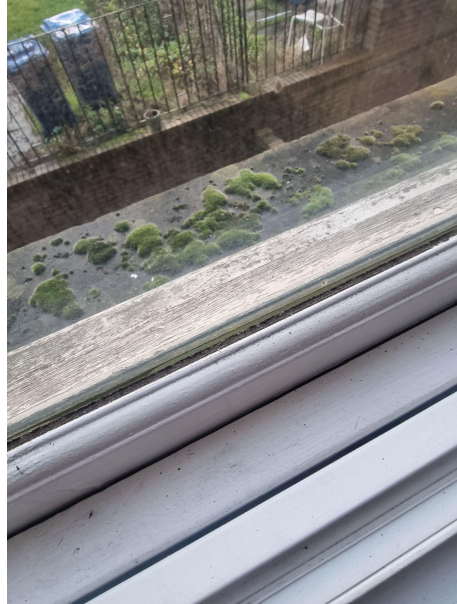
The seals around the glass internally and externally have deteriorated and therefore the glass is no longer sitting properly within the sash. This is allowing wind to channel through the windows.

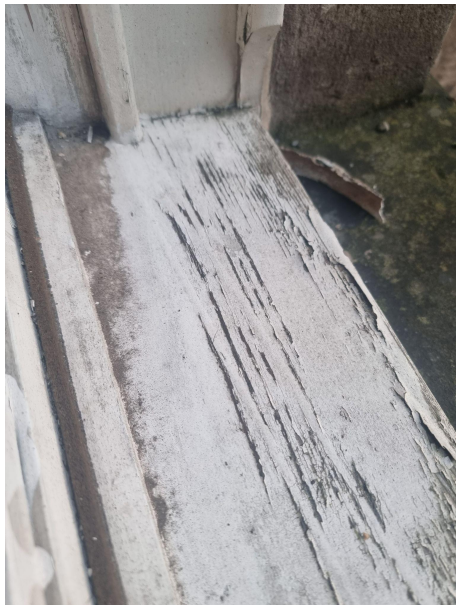
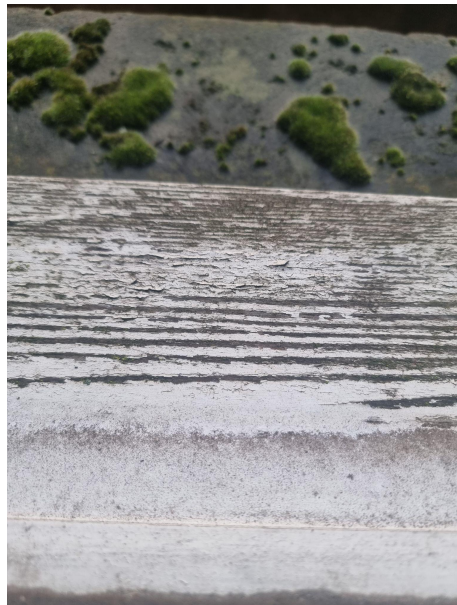
The sills to all windows are water damaged and starting to show signs of rot. The mastic has also come away from the windows which is allowing water to enter the casement.

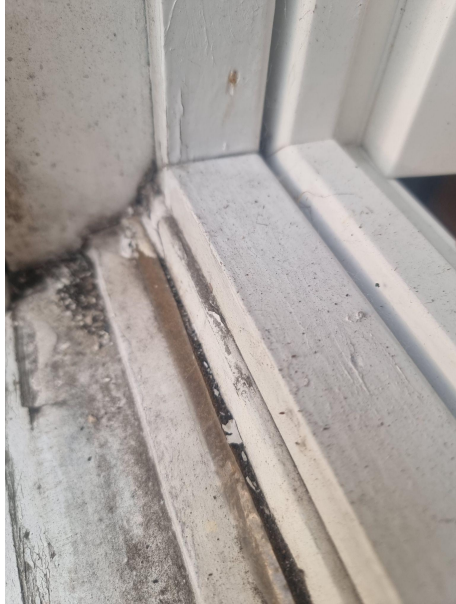
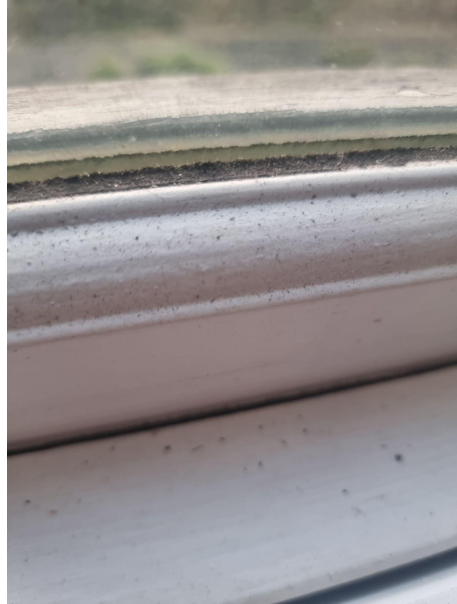
Additional plates have been added to the casement to reduce draughts. The second photo shows the sharp moldings to the windows and the seals that have deteriorated internally.

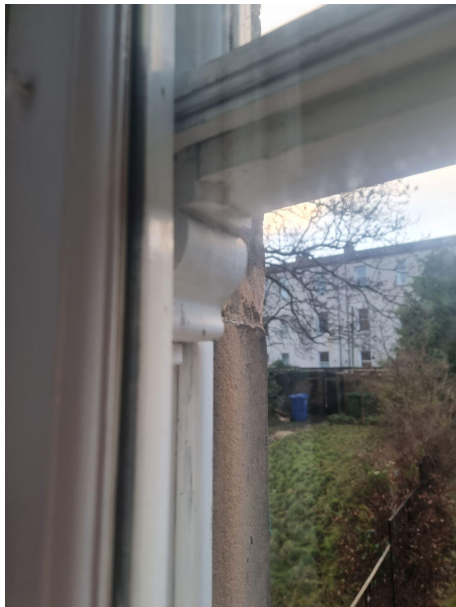
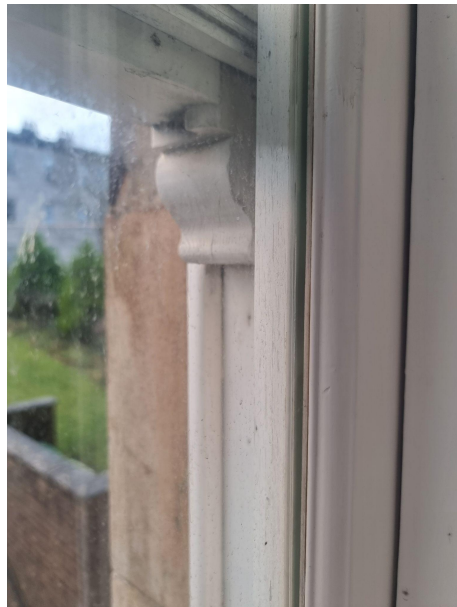
The molding on the horn shows that these windows are not original. This is known as the curvature on top groove nearest the glass is a follow-on of the bevel of the sash. This is something that is only seen on modern windows.

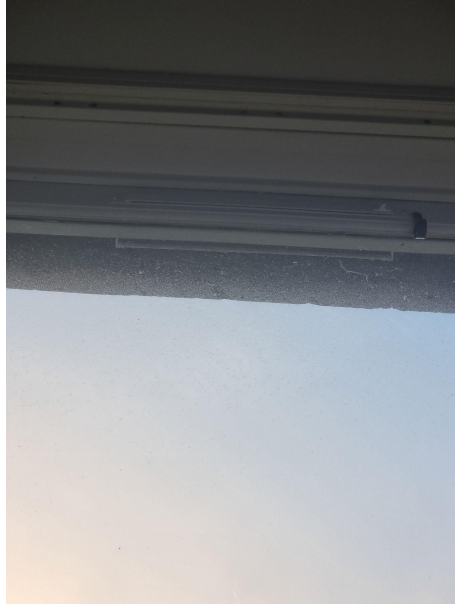
Trickle vents are not seen on modern windows. This has been checked out at manufacturing and is not something that has been retro-fitted.
