3818-05/AS

12<sup>th</sup> January 2024

## PHASE 1 GEO-ENVIRONMENTAL INVESTIGATION FOR LINNEY LANE MOTORS, SHAW

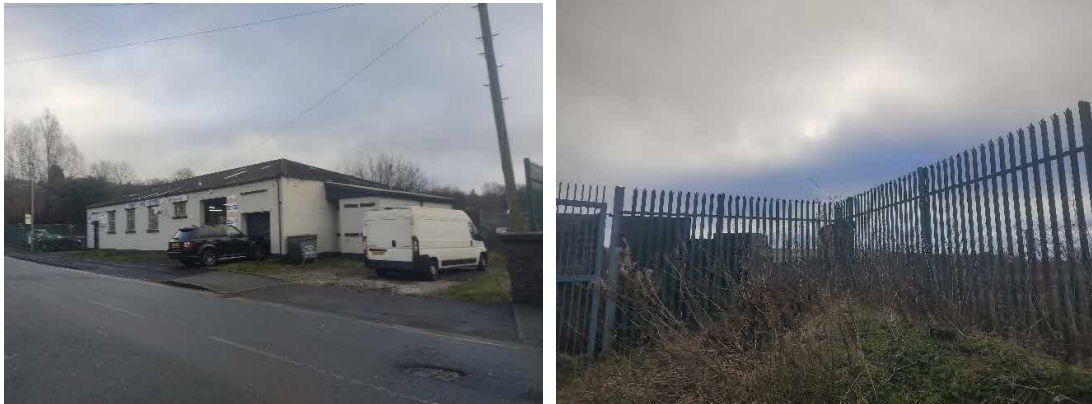
Figure 3: The site as seen from Linney Lane, looking south-east (left) and the south-western site corner with a locked access gate into the Shaw Distribution Centre and the off-site River Beal located on the opposite side of the boundary fence (right).

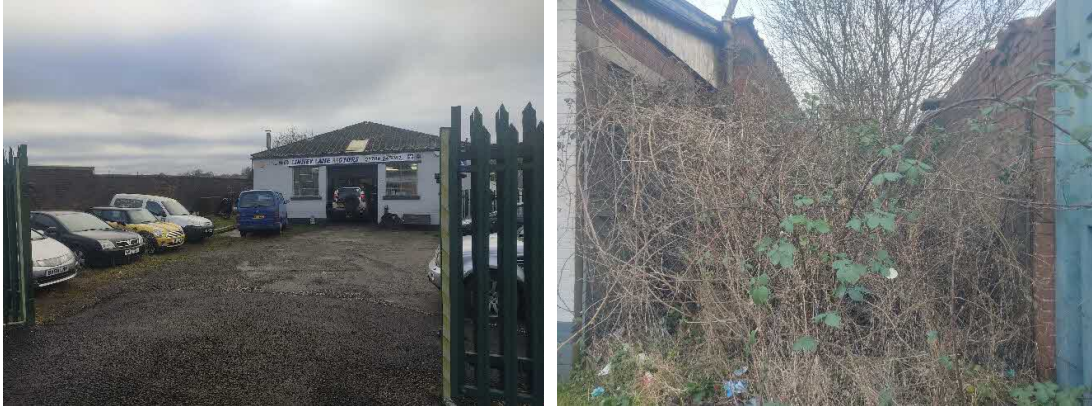
Storage drums and discarded tyres were noted along the southern site boundary adjacent to the building.

Figure 4: The Linney Lane Motors car park (left) and the southern site boundary with dense vegetation along the back of the garage building (right).
