VERIFICATION REPORT

30 Radford Way,
Billericay,
CM12 0DA

Job No: P2647J1906/SEJ

Date: 18 December 2023

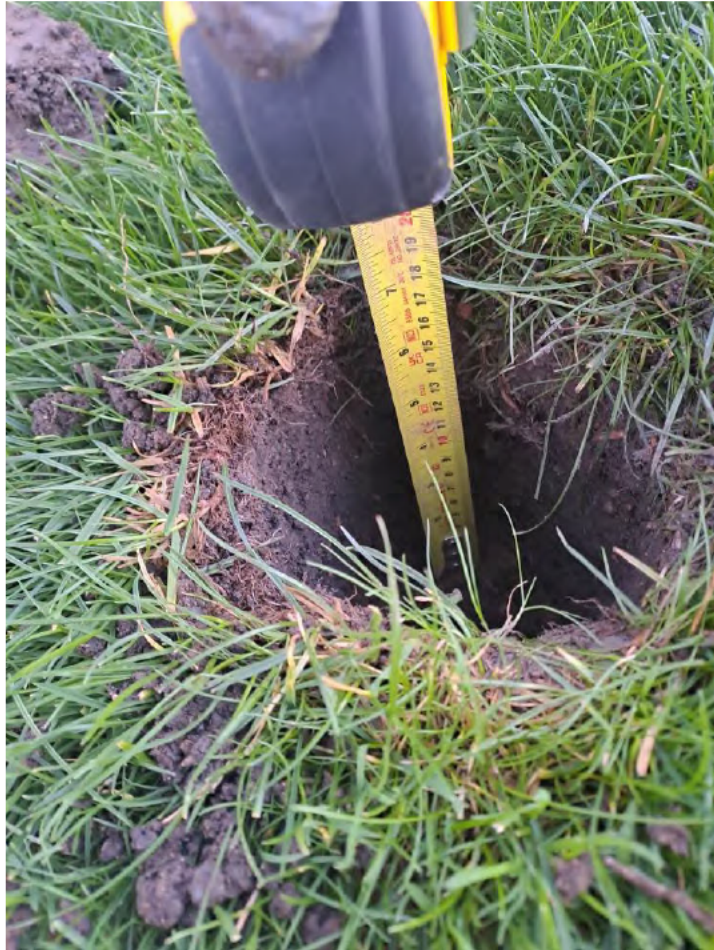
PROJECT NAME	30 Radford Way	CLIENT	Clontara Developments Ltd
TITLE	Topsoil validation Photoplan – November 2023	FIGURE	3
Photo 3: TP6 shown to a depth of 0.17mbgl.		Photo 4: Arisings from TP6.

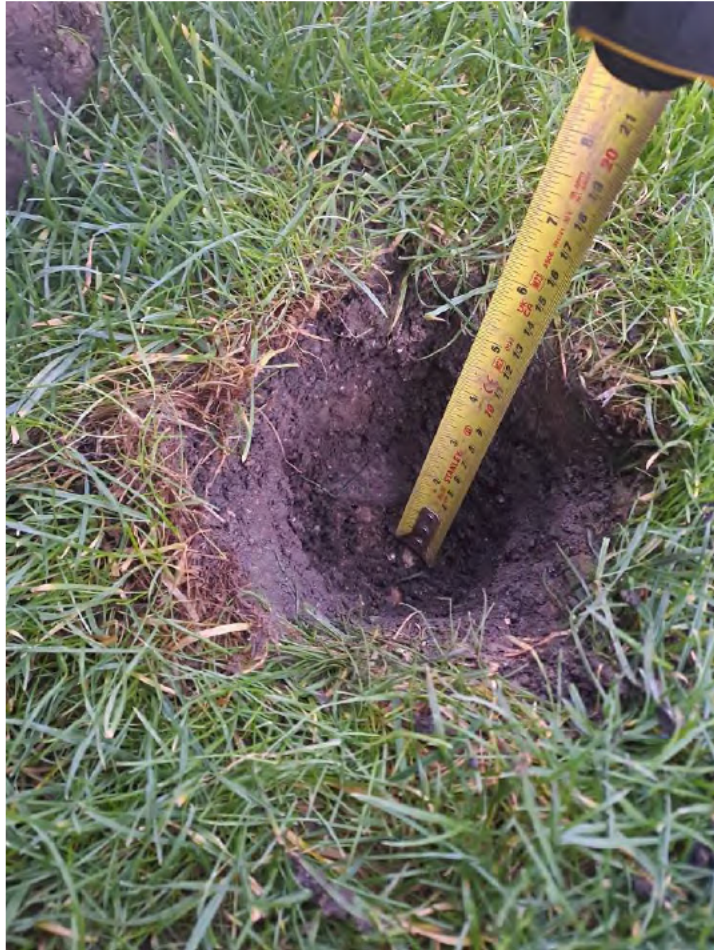
PROJECT NAME	30 Radford Way	CLIENT	Clontara Developments Ltd
TITLE	Topsoil validation Photoplan – November 2023	FIGURE	3
Photo 5: TP7 shown to a depth of 0.15mbgl.		Photo 6: Arisings from TP7.

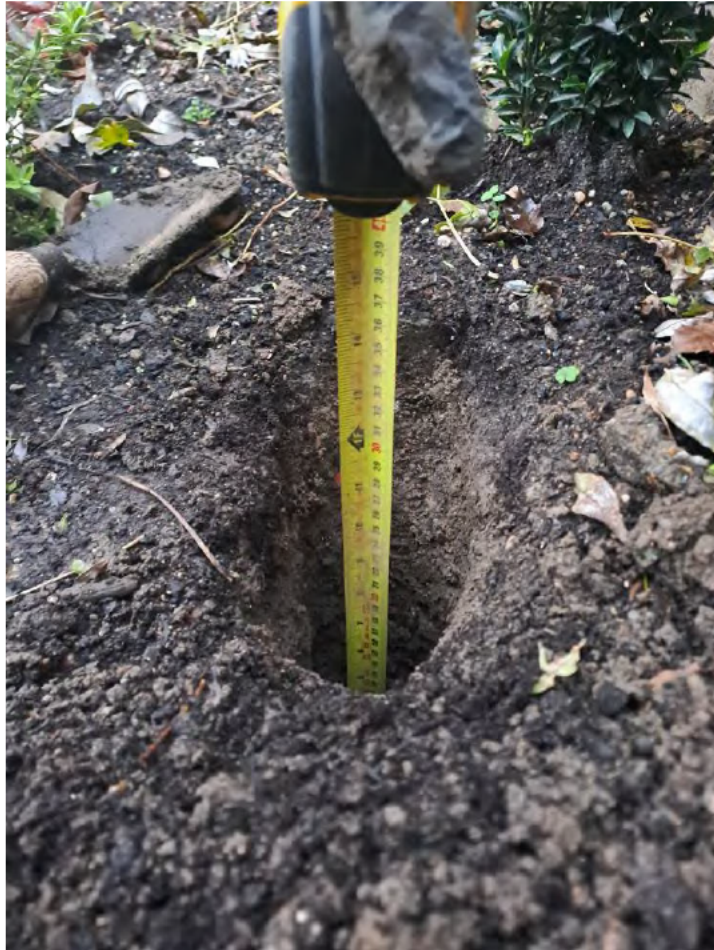
PROJECT NAME	30 Radford Way	CLIENT	Clontara Developments Ltd
TITLE	Topsoil validation Photoplan – November 2023	FIGURE	3
Photo 7: TP1 shown to a depth of 0.35mbgl.		Photo 8: Arisings from TP7.

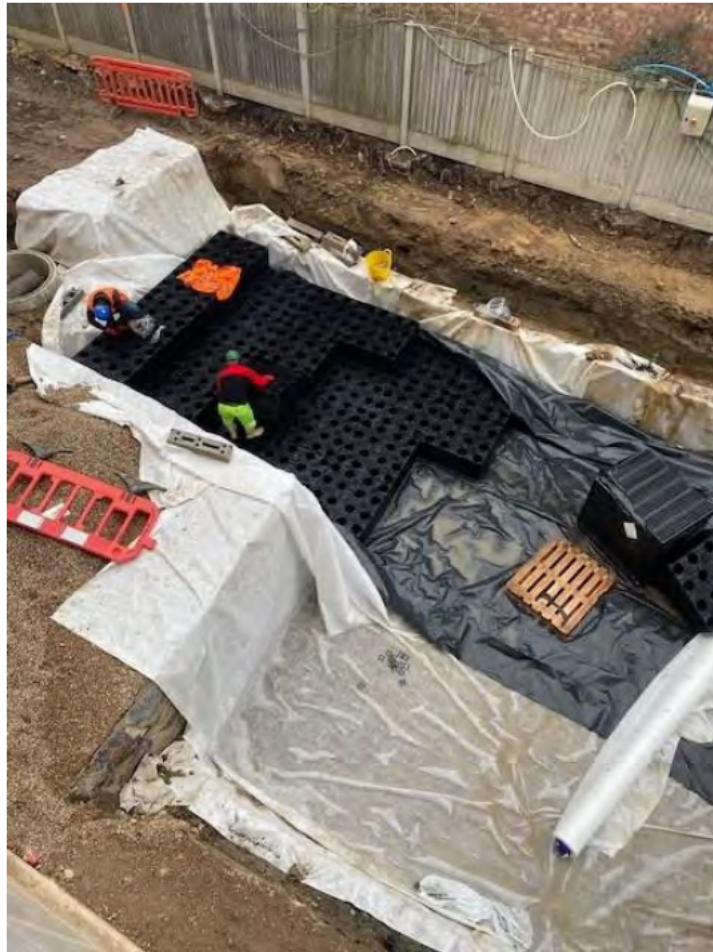
PROJECT NAME	30 Radford Way	CLIENT	Clontara Developments Ltd
TITLE	Hotspot Removal Photographs	FIGURE	4
Photo 1: Removal of soil and installation of drainage infrastructure.		Photo 2: Backfilled excavation.

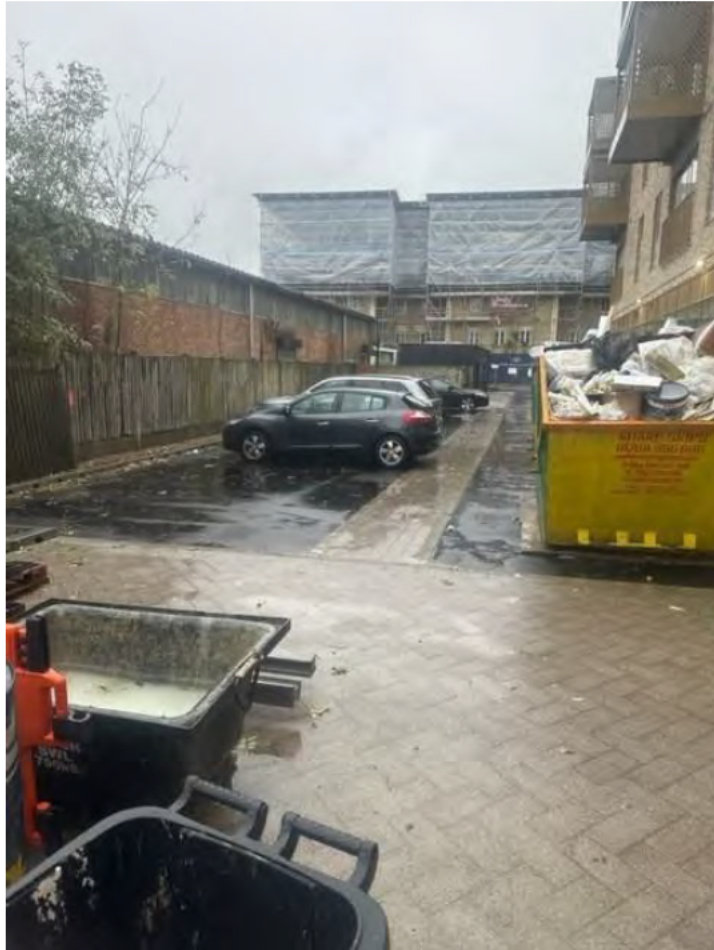
PROJECT NAME	30 Radford Way	CLIENT	Clontara Developments Ltd
TITLE	Hotspot Removal Photographs	FIGURE	4
Photo 3: Hard cover across the finished area.		Photo 4: Hard cover across the finished area.

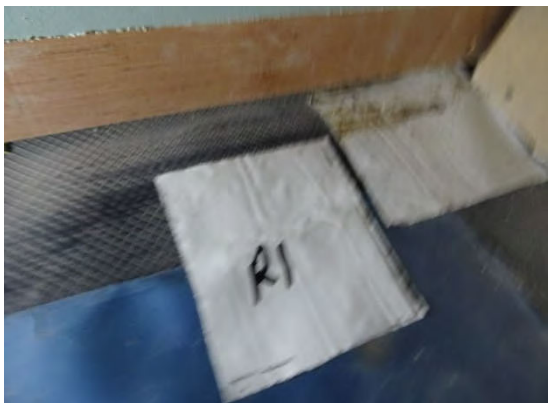
13	Showing the patch repair adopted to seal the previously shown seam defect	14	Again, showing an awkward sealing detail to service entries in a tight space
15	Again, more retro fit sealing to internal walls and again showing the removed plaster	16	The sealing detail adopted for a wall end
17	Overview of the the membrane installation in the communal area	18	Showing the GR SAM and additional marked up puncture repairs to previously installed DPC
