**Development Plot on  
Southgate Street,  
Long Melford**

**VALIDATION MONITORING REPORT AND  
UPDATED REMEDIATION STRATEGY**

Client: Willowwalk (Thaxted)  
Developments Ltd

Our Ref	Fi03088 CL 023a
Date	June 2023
Page	1

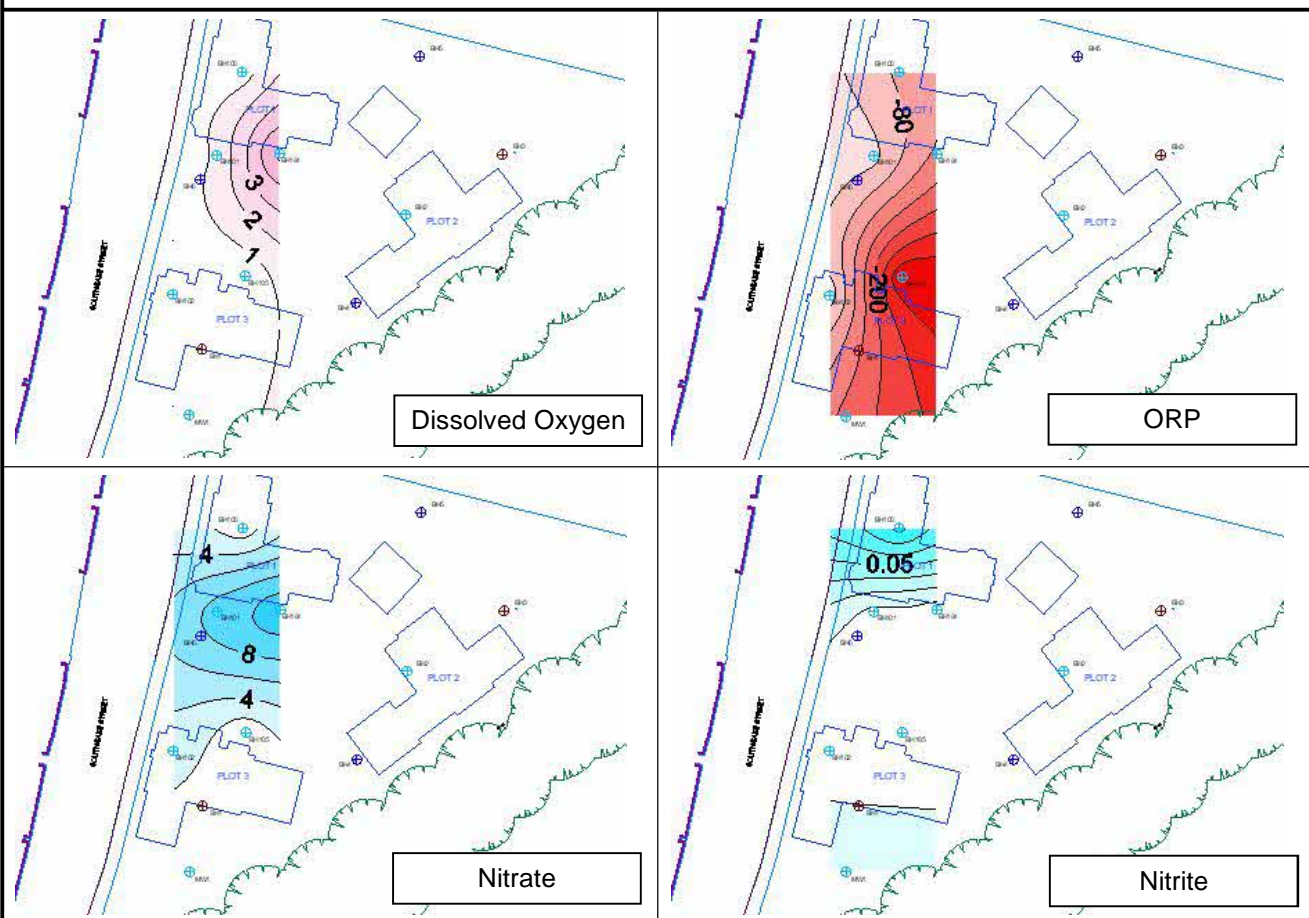
**Figure Three: Plots of Selected Natural Attenuation Indicators**

- We conclude that there are potential lines of evidence for microbial degradation occurring in groundwater under the site. However there appears to be some other effect around BH104 which may be masking the extent of the microbial degradation in this area.
