**Situation Report for  
Downs Garage (former),  
Southgate Street, Long Melford**

Please find below our update on site conditions and proposed actions to address the historical contamination issues at the former Downs Garage site in Long Melford.

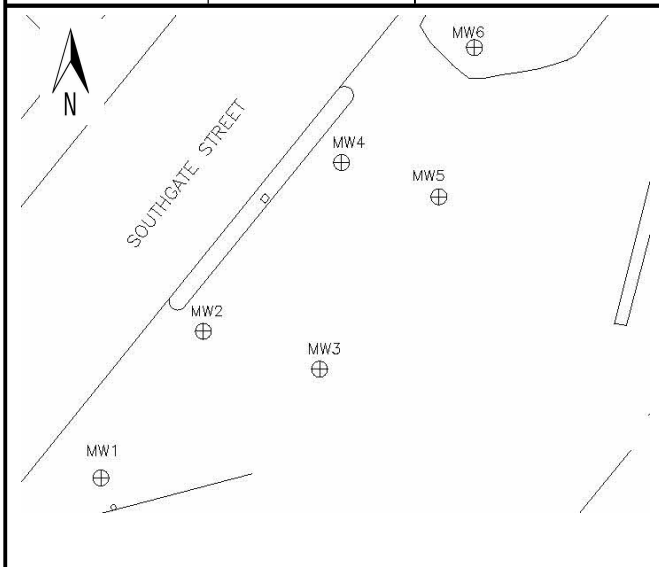
1.2	Reinstatement of Excavations and Installation of Wells	Six monitoring wells were installed (to a maximum depth of 3.7m) once all excavation works had been completed, to enable us to verify the impact of the remedial actions on groundwater quality (within the River Terrace Deposits). No monitoring wells have, as yet, been installed into the underlying chalk aquifer.	Wells installed November 2018.

1.7	Validation of Remedial Works	Two rounds of groundwater monitoring and sampling have been carried out since the remedial excavation was completed. The results of the monitoring has confirmed no free-phase is present, but the chemical analysis indicates residual dissolved phase hydrocarbons remain present (albeit at reduced concentrations).	Monitoring and sampling carried out during May and November 2019

Figure One: Existing Monitoring Wells (MW1-MW6) (installed November 2018, post remedial excavation)

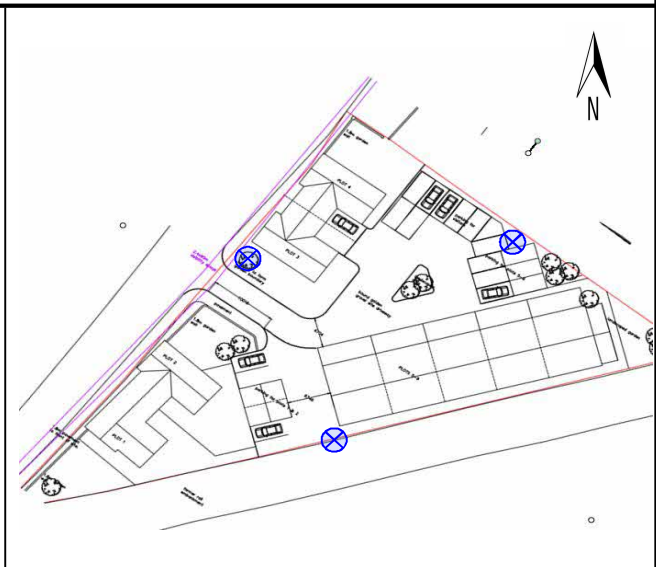
Figure Two: Proposed location of new deeper wells, installed into chalk aquifer.

Drilling	<p>We propose to construct 3No. additional deeper boreholes into the underlying Upper Chalk Formation (a Principal Aquifer) using rotary drilling methods. Appropriate drilling methods will be adopted to ensure the risk of any shallow hydrocarbon impact being allowed to migrate into the chalk is mitigated.</p> <p>Existing site data suggests that the surface of the chalk is present at ~7m below ground level. Boreholes are therefore likely to be installed to depths of at least 10m (potentially deeper, subject to site observations during drilling - boreholes will extend at least 3m in to the chalk). A site plan showing proposed borehole locations is provided below.</p>	
Monitoring Wells	River Terrace Deposits	The 6No. Existing monitoring wells (MW1-MW6) are to be retained to allow on-going quality review of shallow groundwater.
	Chalk Aquifer	<p>All three of the new boreholes will be completed as groundwater monitoring wells.</p> <p>Monitoring wells will be screened (with filter sock and a suitable gravel pack) from 0.5m below the surface of the chalk to the base of the borehole. From surface to the top of the screened section will comprise plain well material with a bentonite seal.</p>
