**Former Southgate Service
Station, Long Melford**

**DETAILED QUANTITATIVE RISK ASSESSMENT AND REMEDIATION
UPDATE REPORT**

Client: Willowwalk (Thaxted)
Developments Ltd

Report	FI03088 CL 016 Rev1
Date	February 2019
Page	1

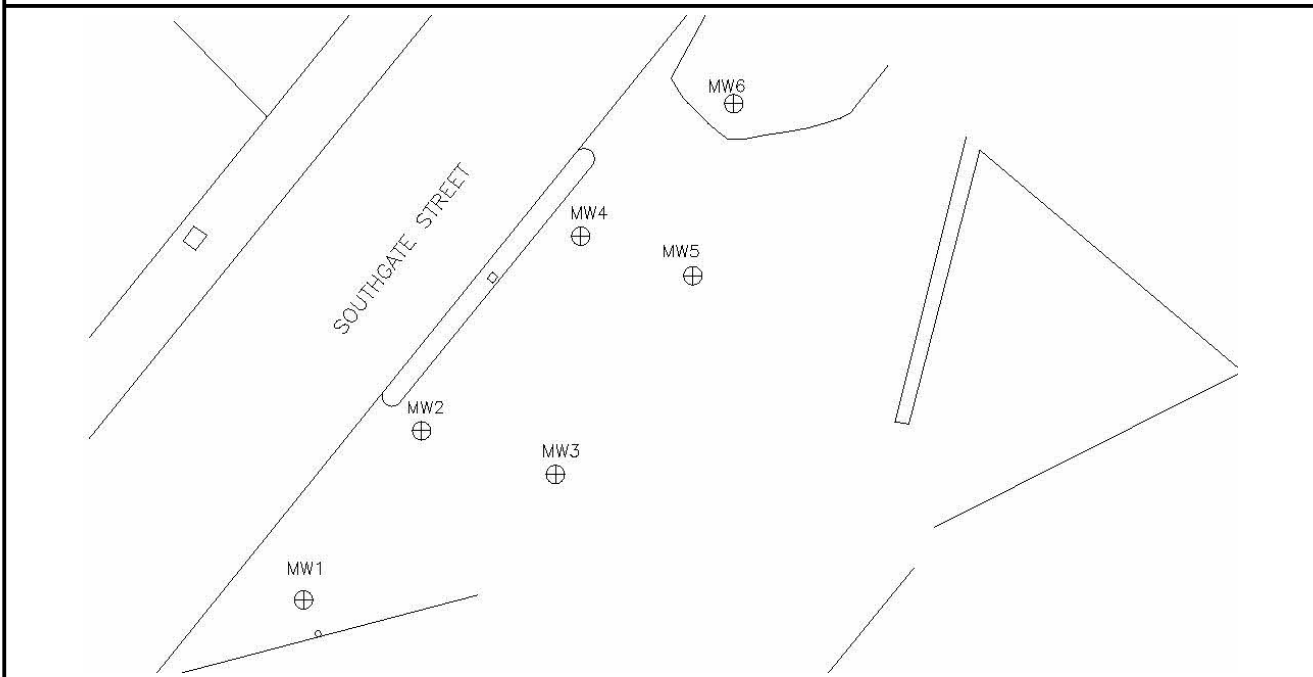
Figure Four: Monitoring Wells - November 2018

The locations of groundwater monitoring wells remaining at the site in November 2018 are shown in Figure Four below.
