Tree Condition Report

The Cottage (Now known as
St Monica's Road "The Burrow")
Kingsdown
Deal
CT14 8AZ

02/02/2019

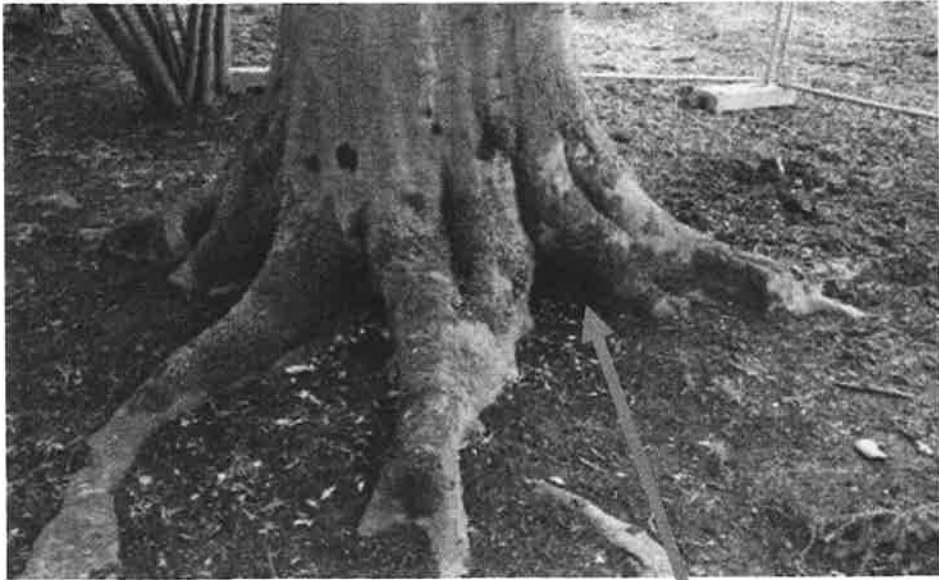
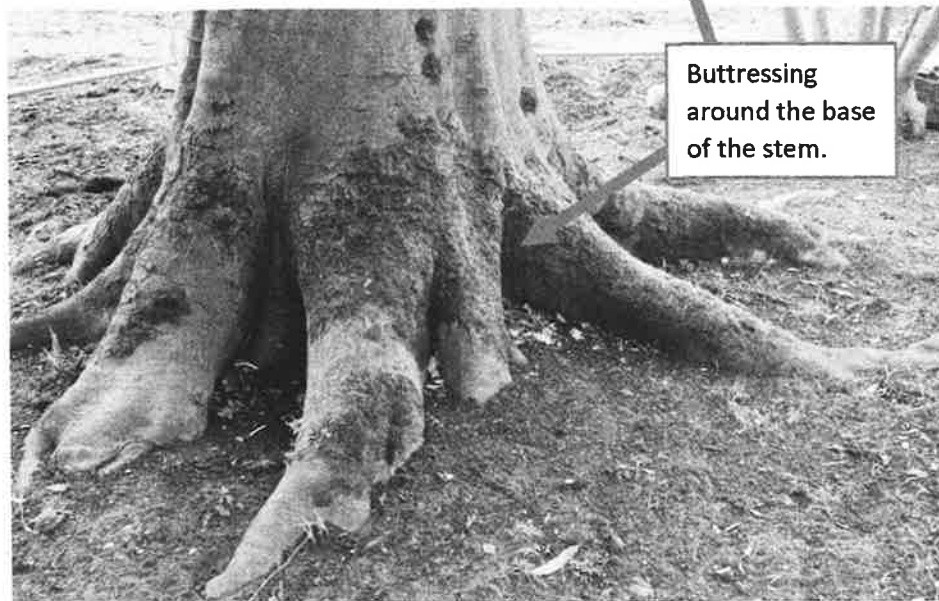
Photo 1 & 2.

- 4.7. Base of stem showing signs of buttressing, not significant at this time **(see photo 1&2 appendix 3).**
- 4.8. The main stem splits into multiple stems at 4.5m above ground level, the largest of these multi stems, west facing, has four woodpecker holes at 5m to 6m above ground level **(see photo 3 & 4 Appendix 3).**

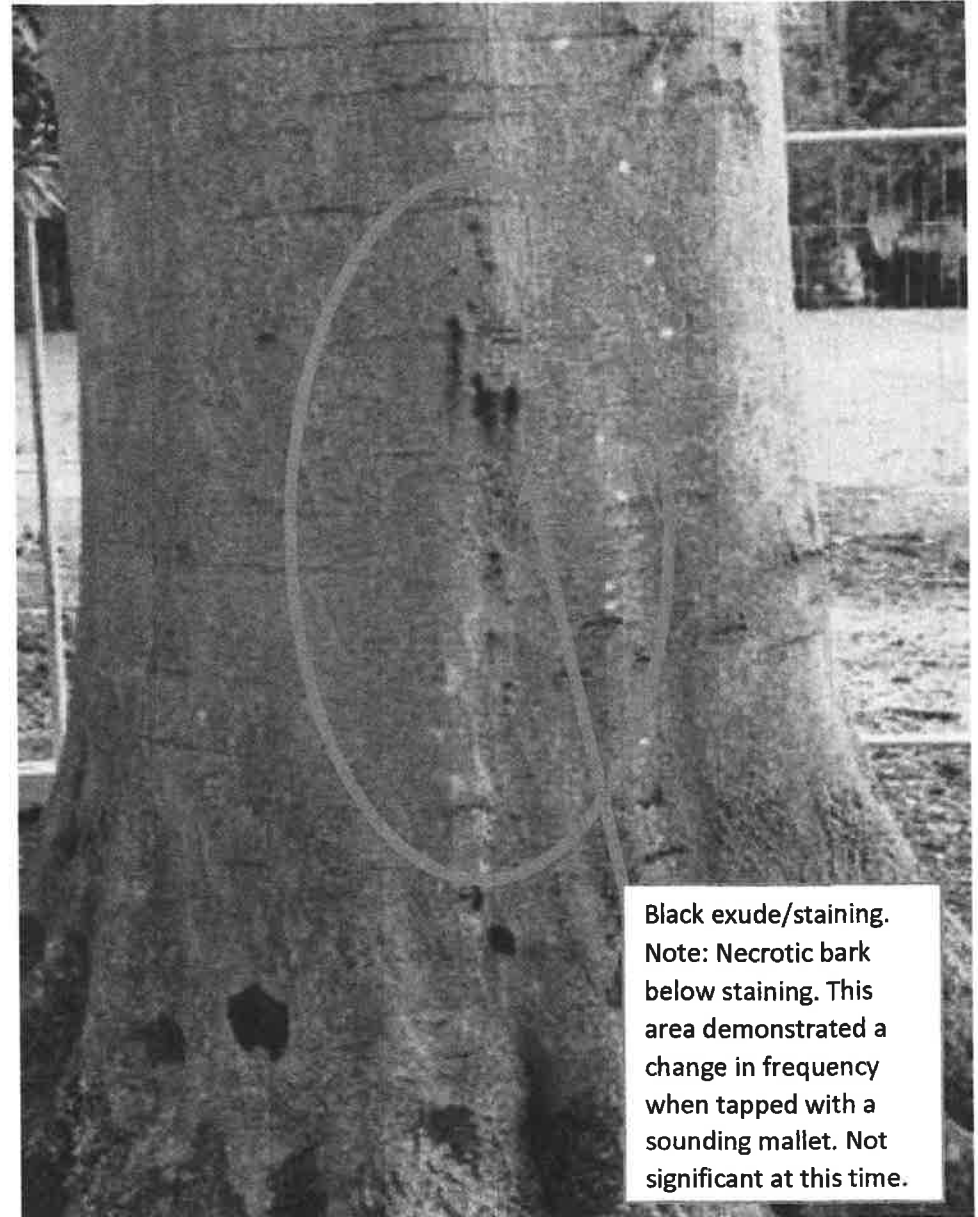
Photo 3.

- 4.6. There is black staining on the main stem, north facing, at 1.6m above ground level. A sounding mallet was used, slight change in frequency to area with black staining **(see photo 3 Appendix 3).** No change in frequency on the rest of the main stem to 2m above ground level.

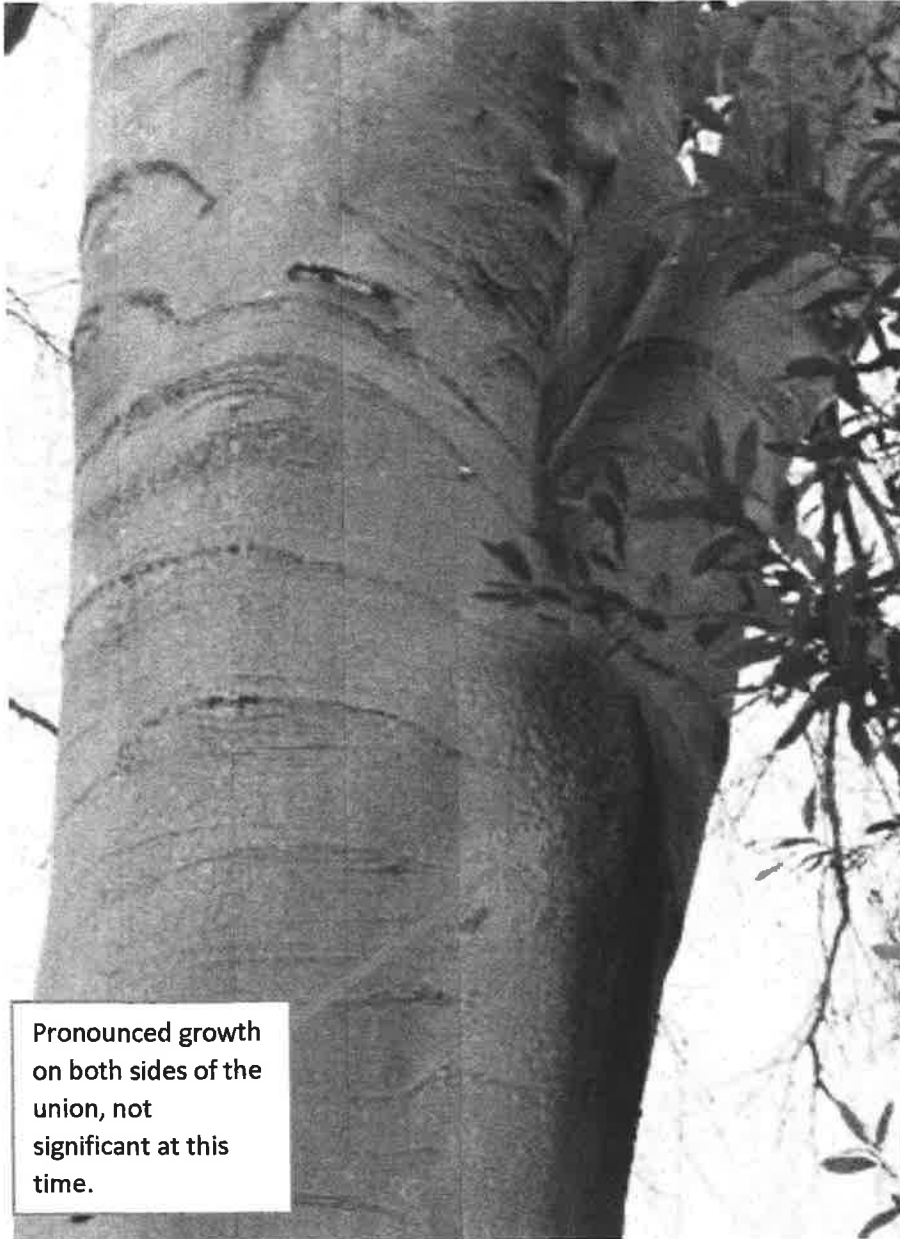
Photo 4.

- 4.9. The union to the main stem is showing signs of reaction growth, also known as elephant ears **(see photo 4 Appendix 3).**
- 4.10. A climbing inspection was carried out to determine the extent of the decay in the holes, a borescope/endoscope was used to look inside the woodpecker holes. The horizontal cavity in the stem measured no deeper than 20cm into the stem. the stem had a SD (stem diameter) estimated to be 50cm. The vertical decay in the stem was estimated to no deeper then 25cm from the first hole from ground level. The decay from the first hole did not link up with the decay in the second hole from ground level. It was not possible to determine whether the top two woodpecker holes (A & B) were linked via decay internally **(see photo 5 Appendix 3).**

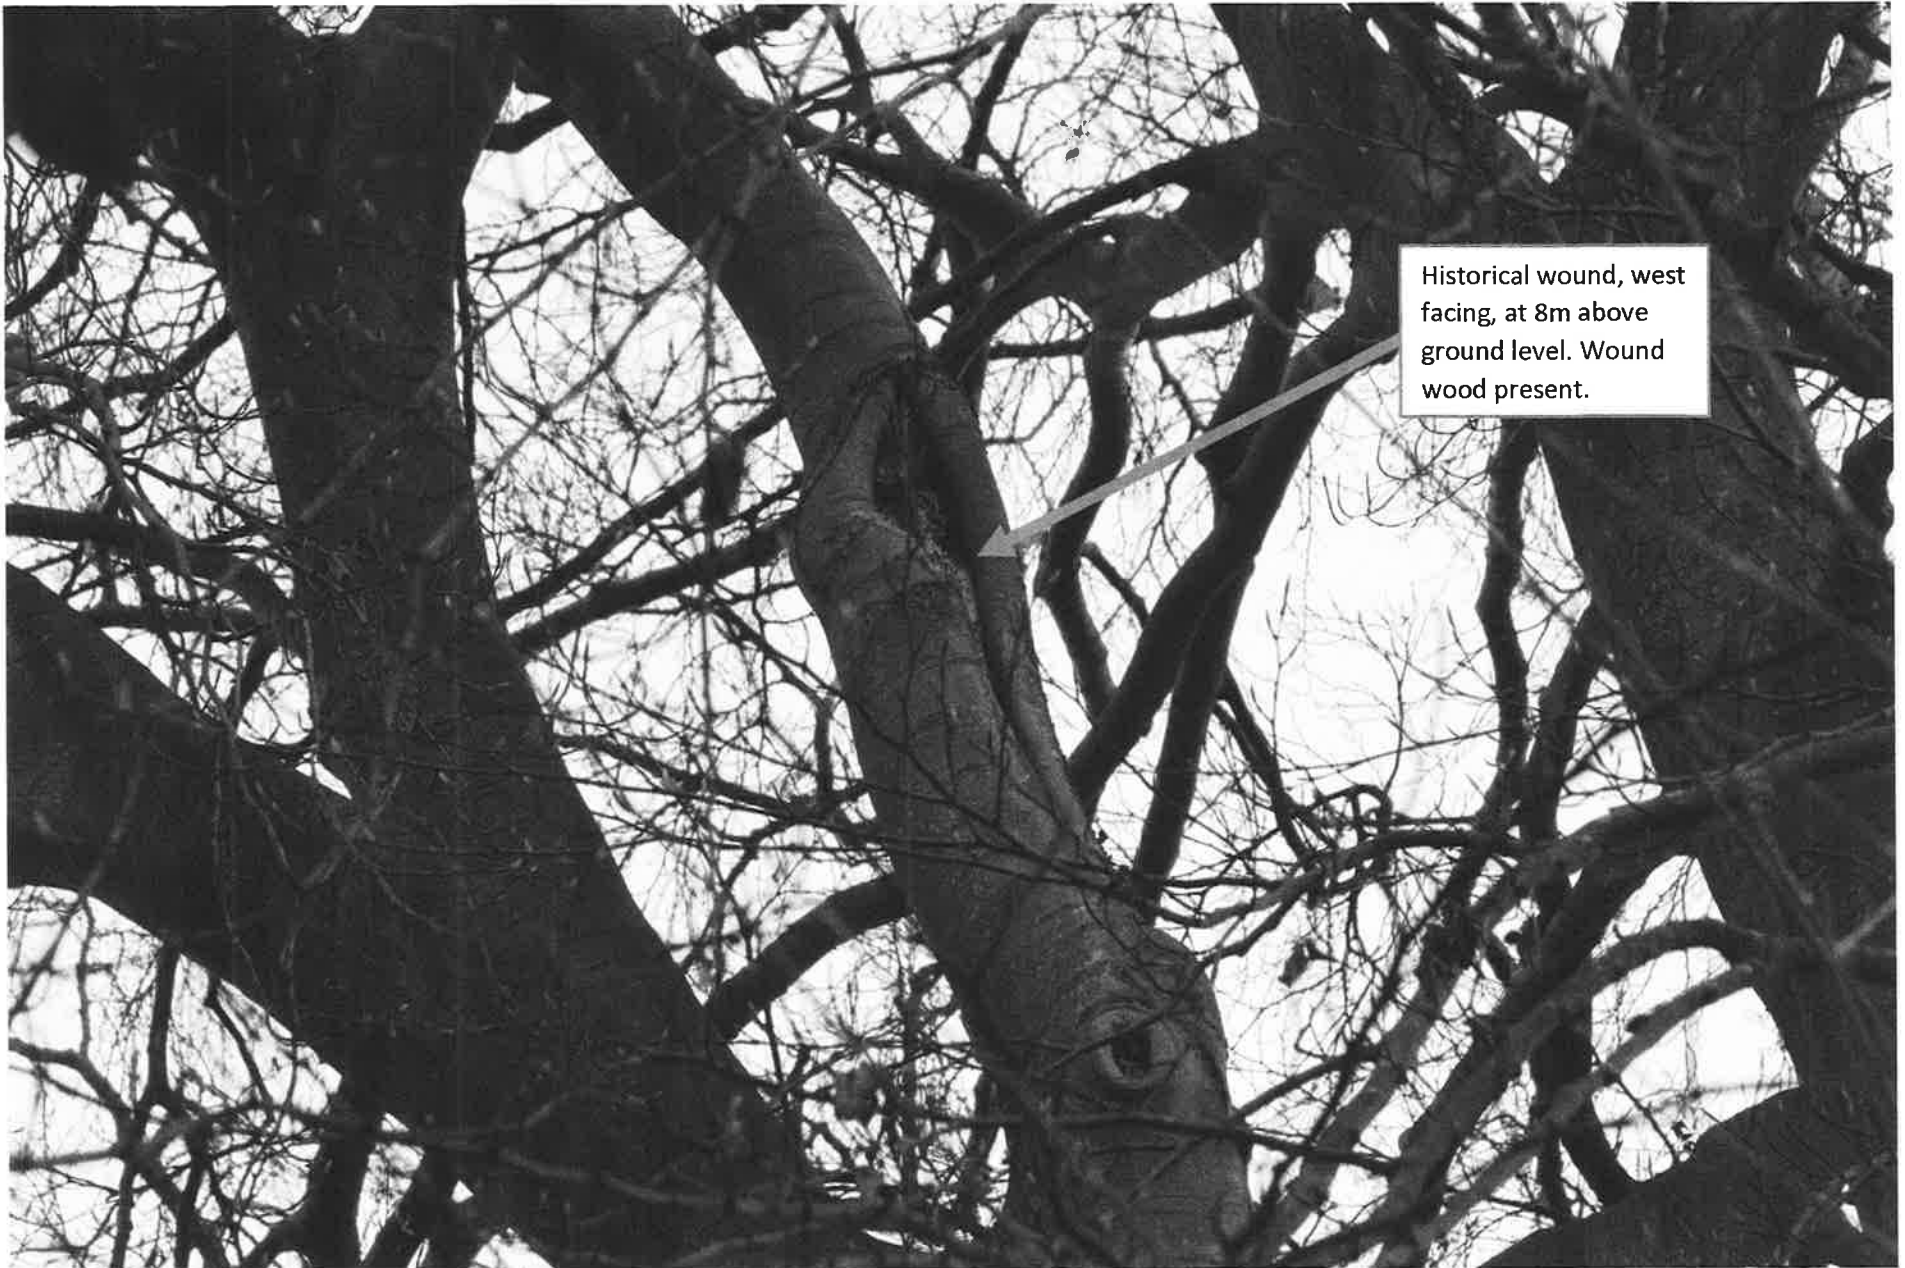
Photo 6.

- 4.12. There is a historical wound to a limb, west facing, on the north side of canopy at 8m, reaction wood is present (see photo 6 Appendix 3).

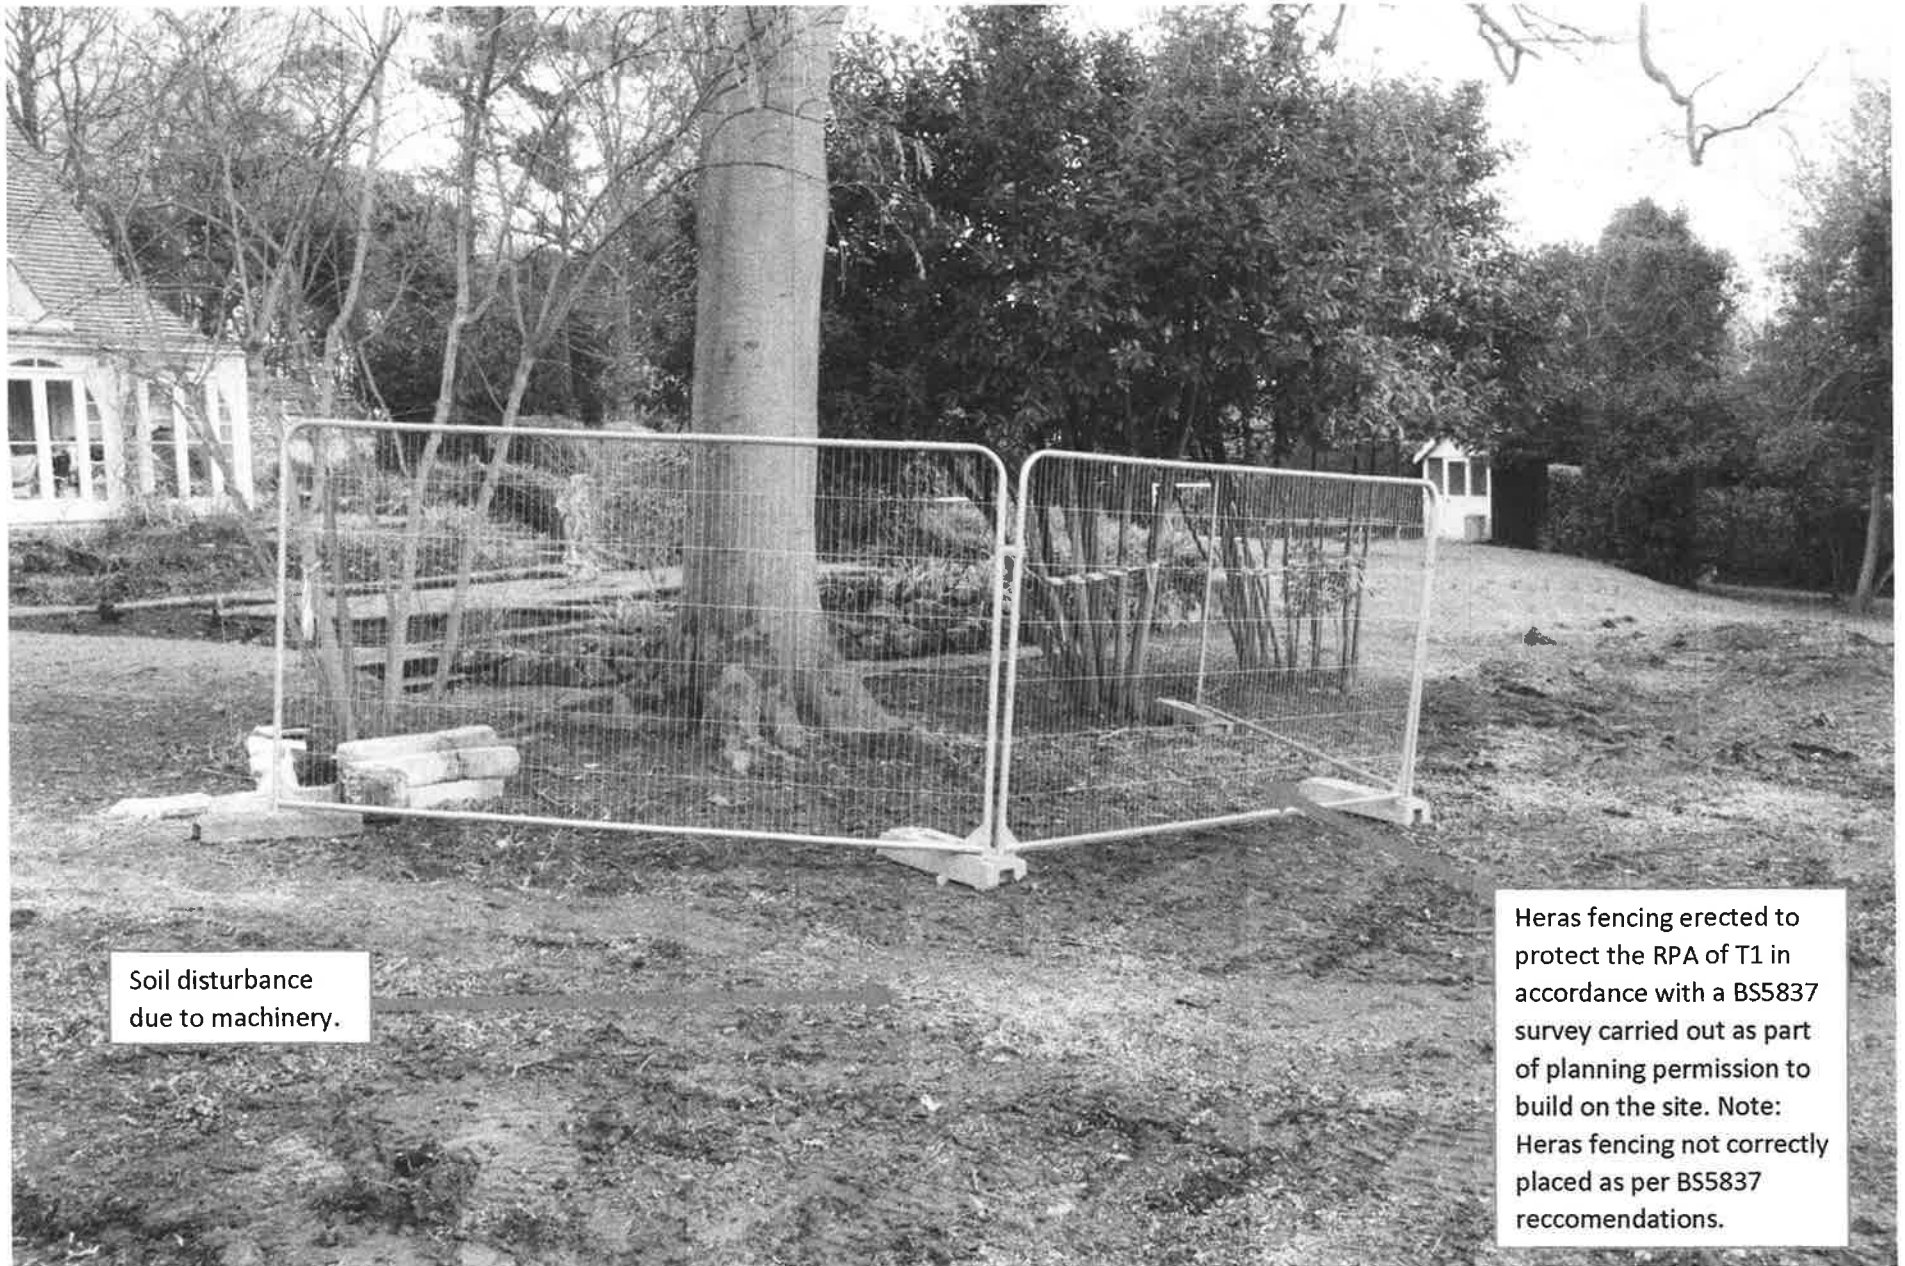
Photo 8

- 4.5. The RPA (root protection area) was set out for T1 in the BS5837 survey, however, the RPA has not been adhered to by the contractor at time of this survey. Heras fencing has been placed approximately 2.5m from the base of the tree, this is not correct as the BS5837 survey provided in accordance with planning permission for the site states the RPA fencing should be placed at approximately 10m from the base of the tree **(see photo 8 Appendix 3).**
