56 High Street, Debenham, Suffolk.

A schedule of timber repairs to the south elevation.

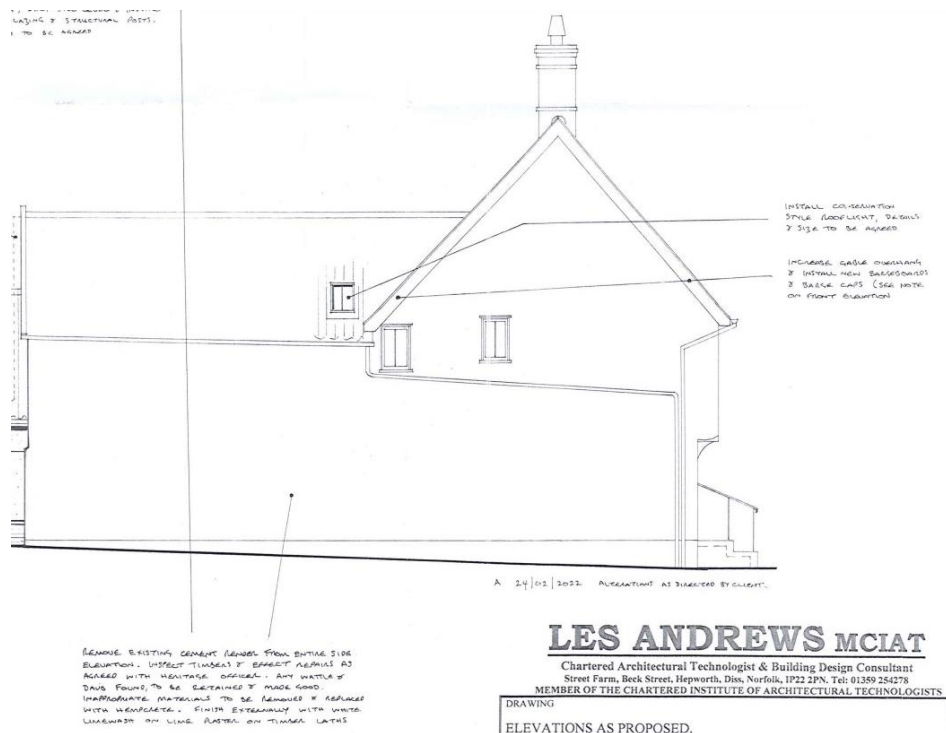
South (side) elevation.

The works to the south elevation have already been indicated on the submitted drawings but to further clarify there are the following observations and points to make.

The entire elevation is currently covered in a cement render – this is due for removal and our task is to carry out any necessary repairs before the elevation is re-covered in a new lime-based render (see comments from Sadler Traditional Building).

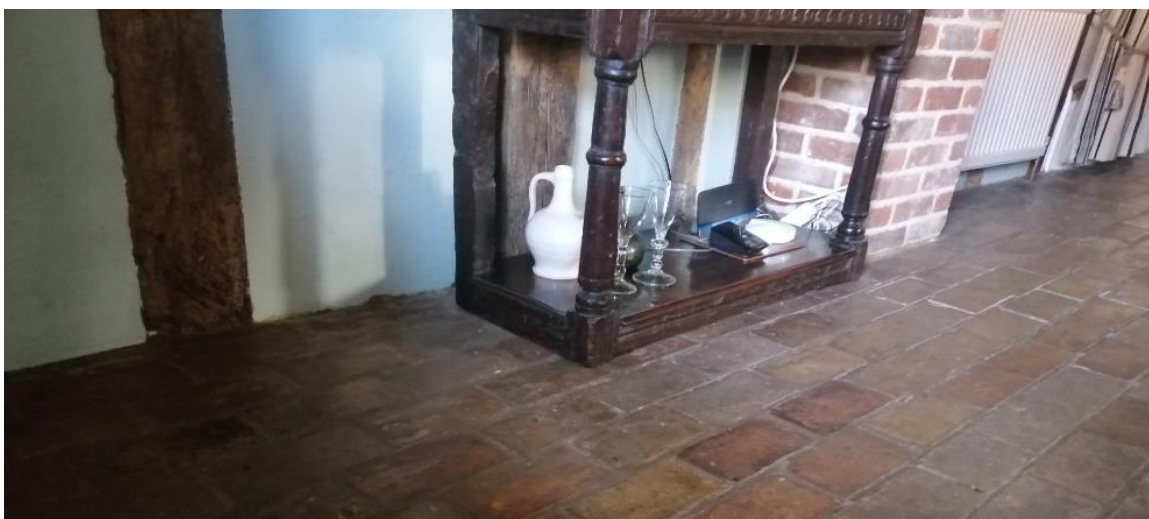
Viewed from inside, much of the framing has been heavily altered and the sole plate to the main range - under the floor level (below) will almost certainly need replacement.

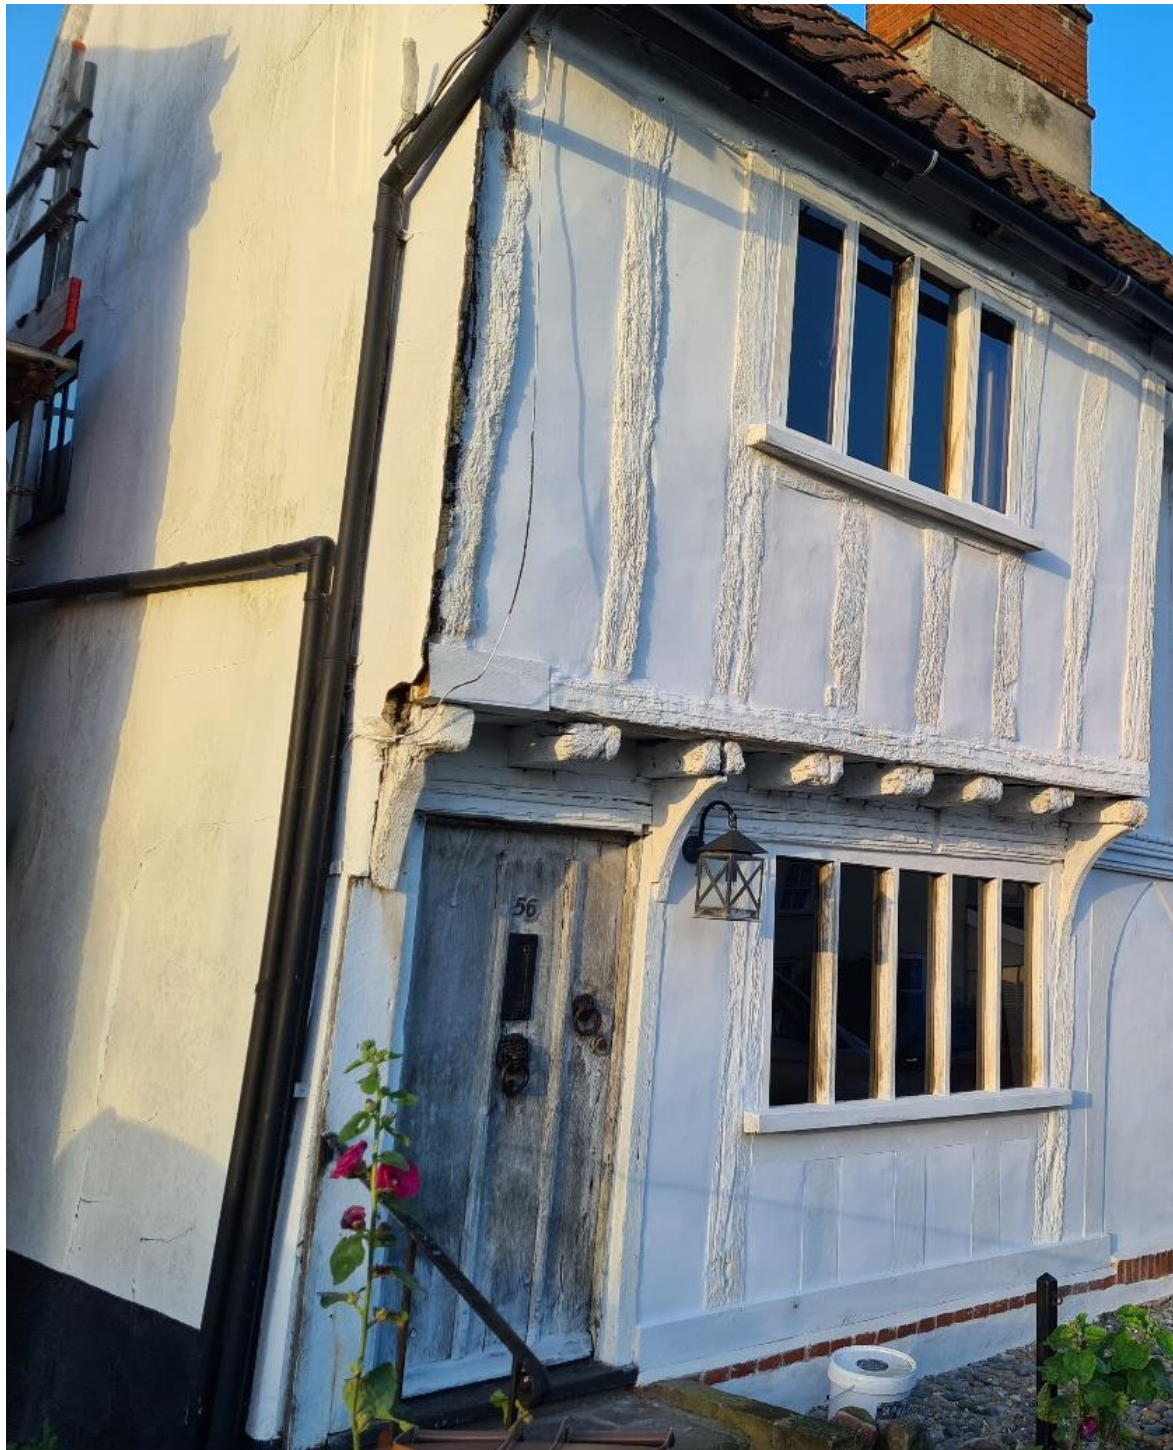
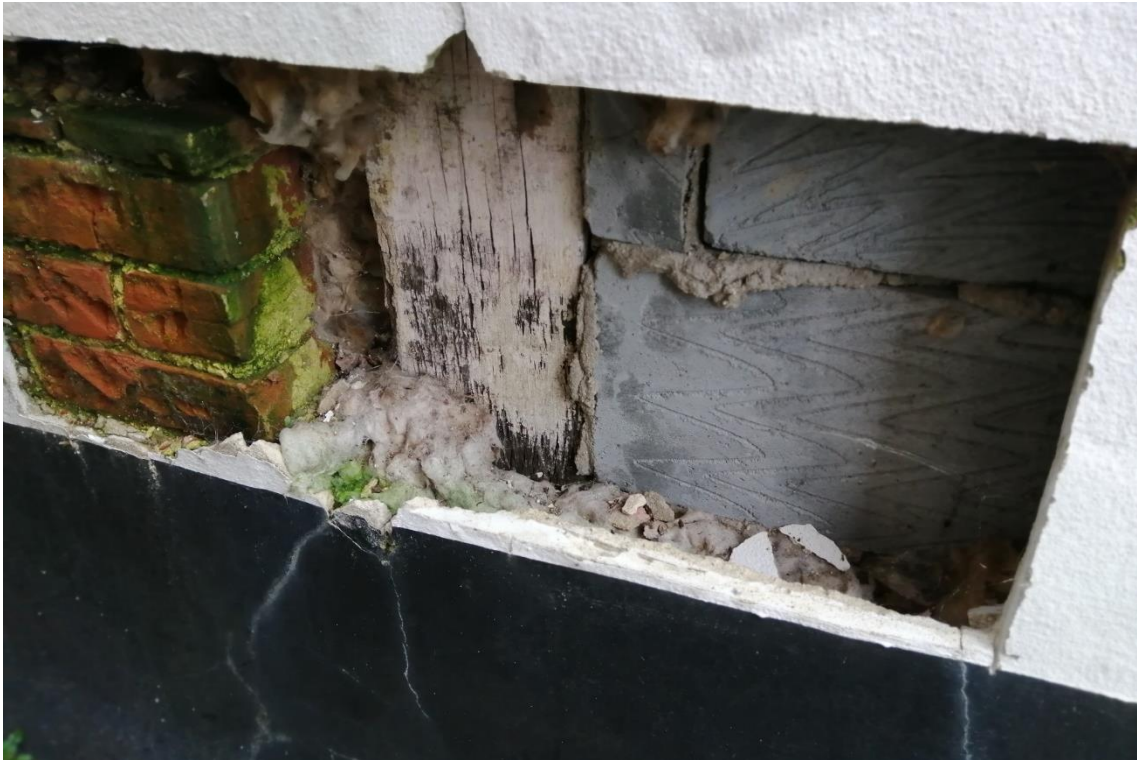
The southern corner posts are highlighted as needing further investigation, possible repair, or even replacement. During the course of the works to the front elevation, the first floor post appeared to be in reasonable condition but the south face is yet to be seen (below). The ground floor post is still obscured by a fake timber plank and render. Given the position of rainwater pipes adjacent to this pair of timbers, there is likely to be some decay at the bottom but further investigation will guide us. Once work commences, this will be one of the first areas for us to resolve whilst maintaining access and security via the main entrance as well as ensuring adequate rainwater disposal.

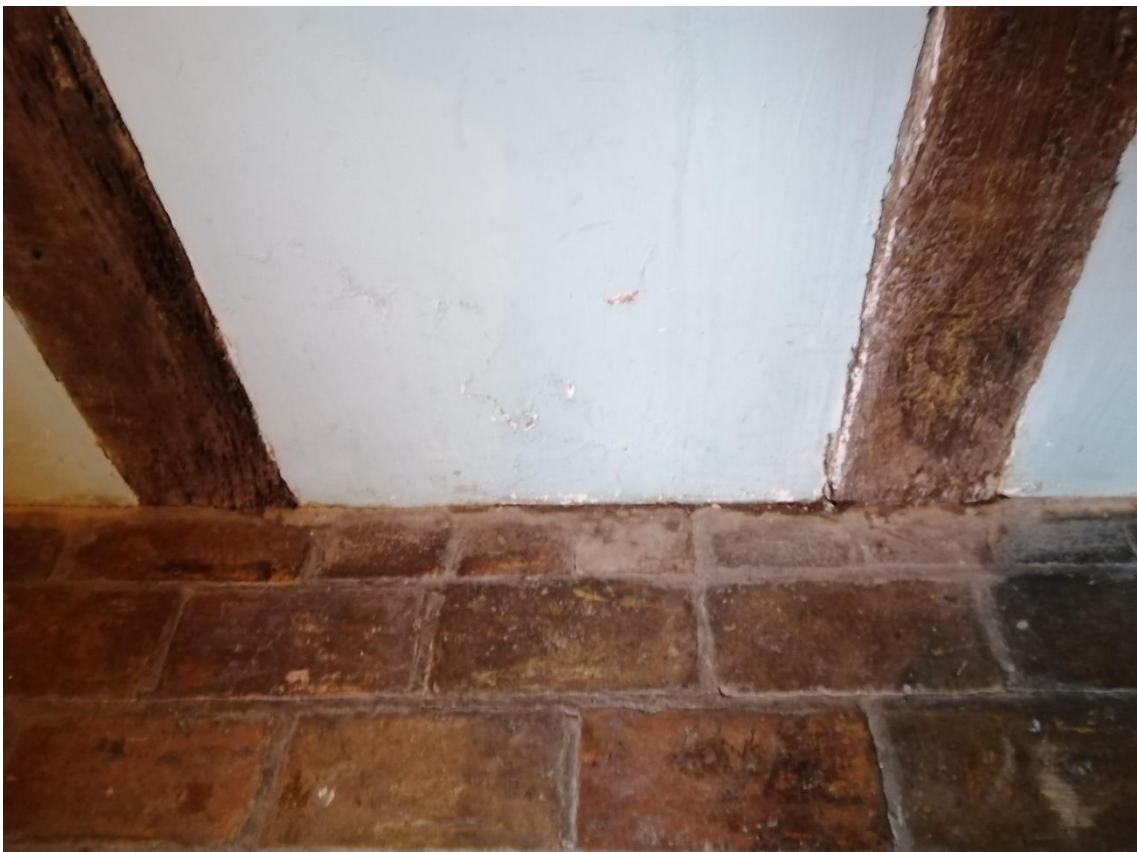
Sections of render have been removed to give some limited insight into the frame condition – the sole plate (if it still exists!) is under concrete and the infill panels appear predominantly modern. Any defective historic timbers will be repaired as appropriate using hidden splints and face-patches primarily but scarfs if required. Once the studs and posts have been repaired a new sole plate will be fitted in sections and the components pegged together.

Any face patches would utilise air dried oak of good quality, the decayed surface would be dressed back to a point where it becomes sound, ideally below the line of the render but no more than is necessary, so it is hard to quantify until the timbers are exposed and cut into. The patches would be fixed to the existing components with a marine adhesive and stainless steel fixings that are then pelleted over so they are essentially invisible. Any irregularities to the shape of the historic timbers would be copied onto the new sections so that visually they are less obvious as well as more likely to shed water as opposed to directing it into the joint.
