**BOYD COURT, DOWNSHIRE WAY,
BRACKNELL**

**PRELIMINARY BAT ROOST
ASSESSMENT**

Report No: RT-MME-153754-05

Date: February 2021

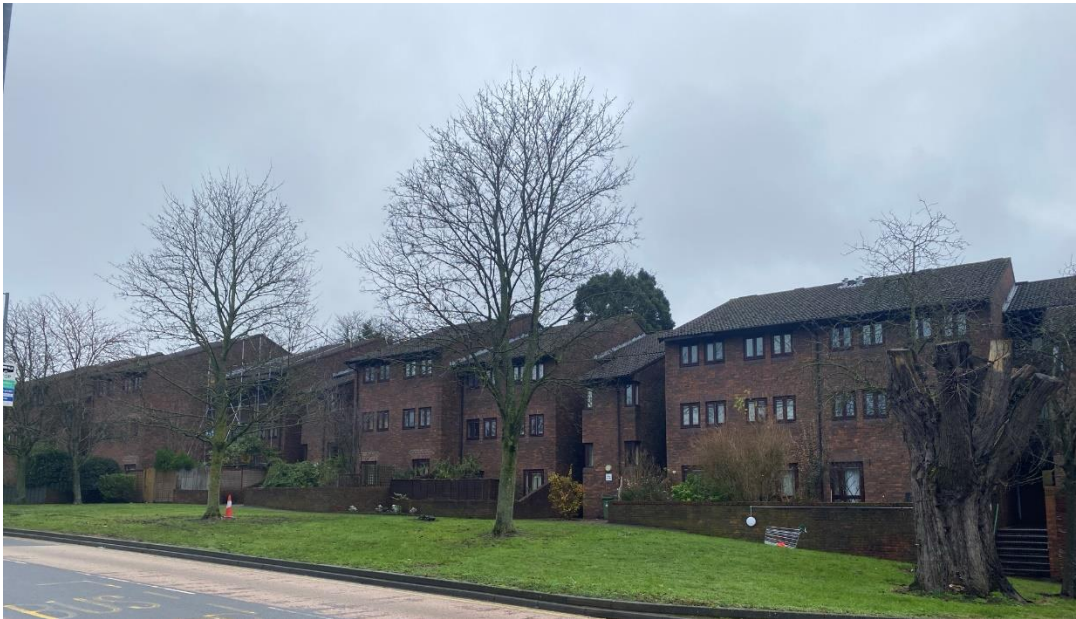
Plate 4.1: Overview of B1 Building (Western Elevation)

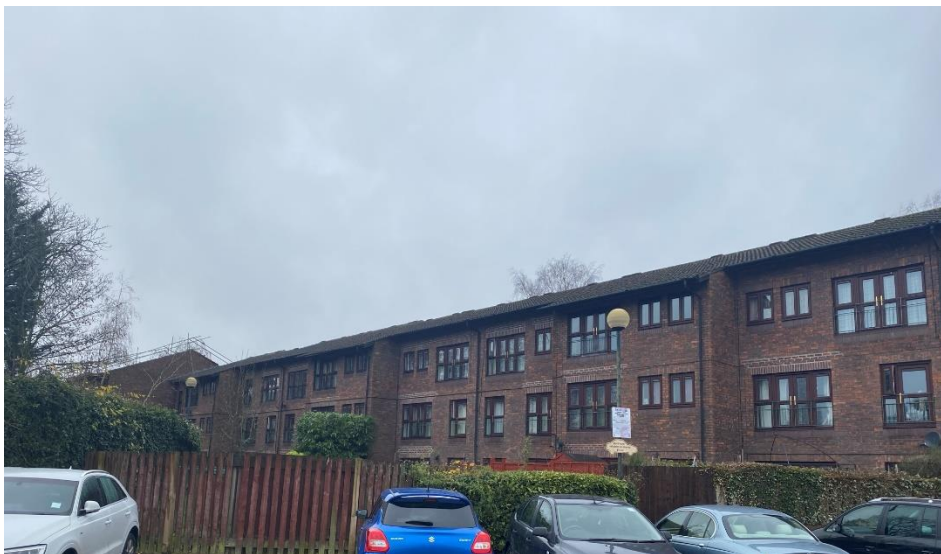
Plate 4.2: Overview of B1 Building (Eastern Elevation)

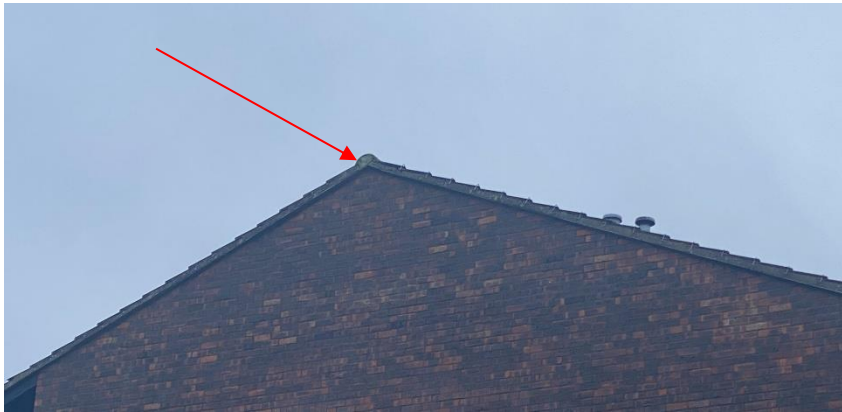
It was not possible to inspect the lifted roof tiles, lifted ridge tiles, missing mortar between ridge tiles (Plate 4.3) and brickwork and lifted lead flashing around the base of the chimney (Plate 4.4) due to the height at which these were located and as such it was not possible to establish if bats had used these features to enter a roost location at the time of surveying. No evidence of roosting bats, e.g. droppings, urine staining, feeding remains or scratch marks, was recorded within the features that could be fully inspected during the survey.

Plate 4.3: Missing mortar on the ridge tile (Northern Elevation)

B1, B2, B4 and B5 Building at Boyd Court have been identified as having moderate potential to support roosting bats. Bat Surveys: Good Practice Guidelines published by the Bat Conservation Trust (Collins, 2016) recommends that for structures with moderate bat roosting potential two separate survey visits (consisting of one dusk emergence and a separate dawn re-entry survey) be undertaken during the bat emergence/re-entry survey season to determine the presence/absence of roosting bats within these buildings. The bat emergence/re-entry survey season extends from May to September. At least one of the surveys should be undertaken during the peak season for emergence/re-entry surveys between May and August. Should this survey confirm the presence of roosting bats, it will be necessary to undertake additional surveys in order to inform a Natural England licence application. In addition, should the survey identify the presence of significant levels of bat activity at the site, it may be necessary to undertake further survey visits to comprehensively assess the value of the site to bats.

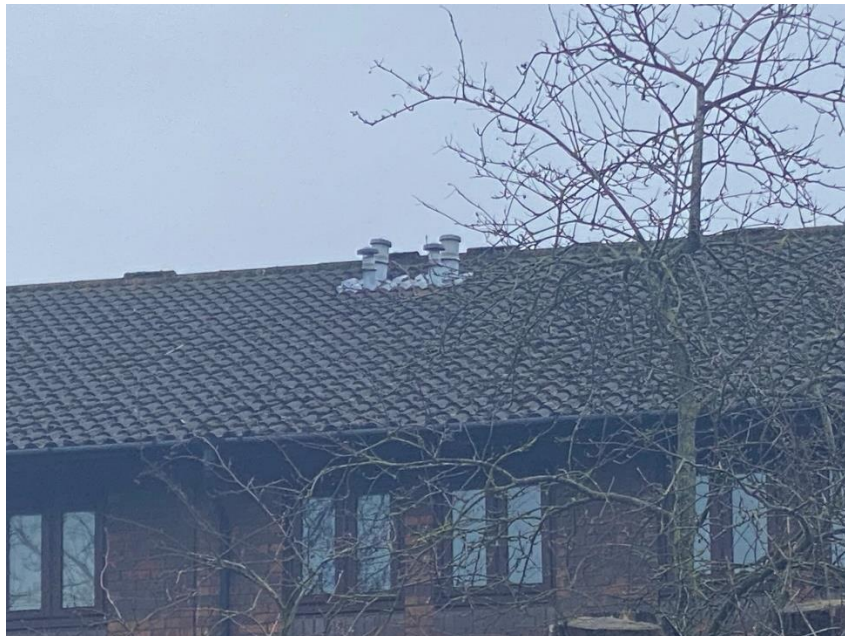
Plate 4.4: Lifted Lead Flashing at the Base of Steel Chimneys (Western Elevation)

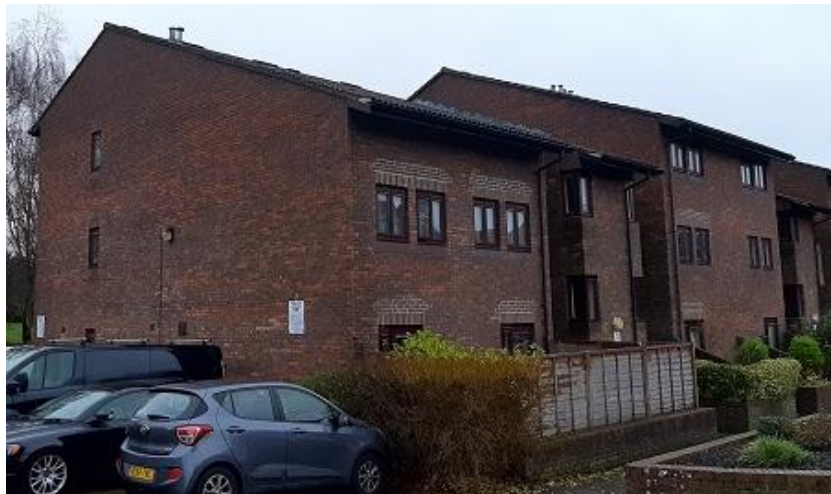
Plate 4.5: Overview of B2 Building (South-Eastern Elevation and Part of Northern Elevation)

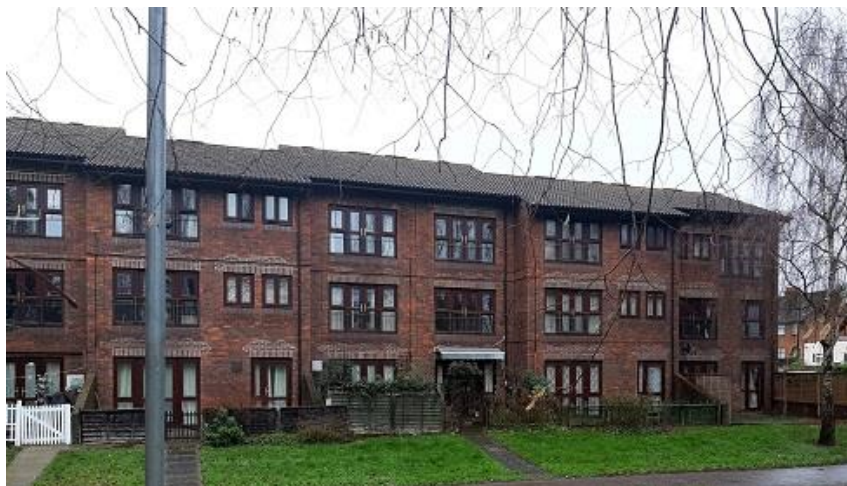
Plate 4.6: Overview of Southern Elevation

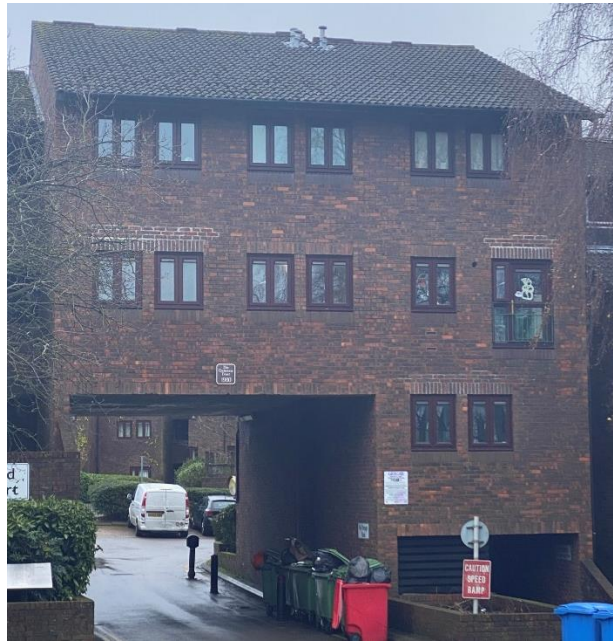
Plate 4.7: Vehicular access to Boyd Court (Western Elevation)

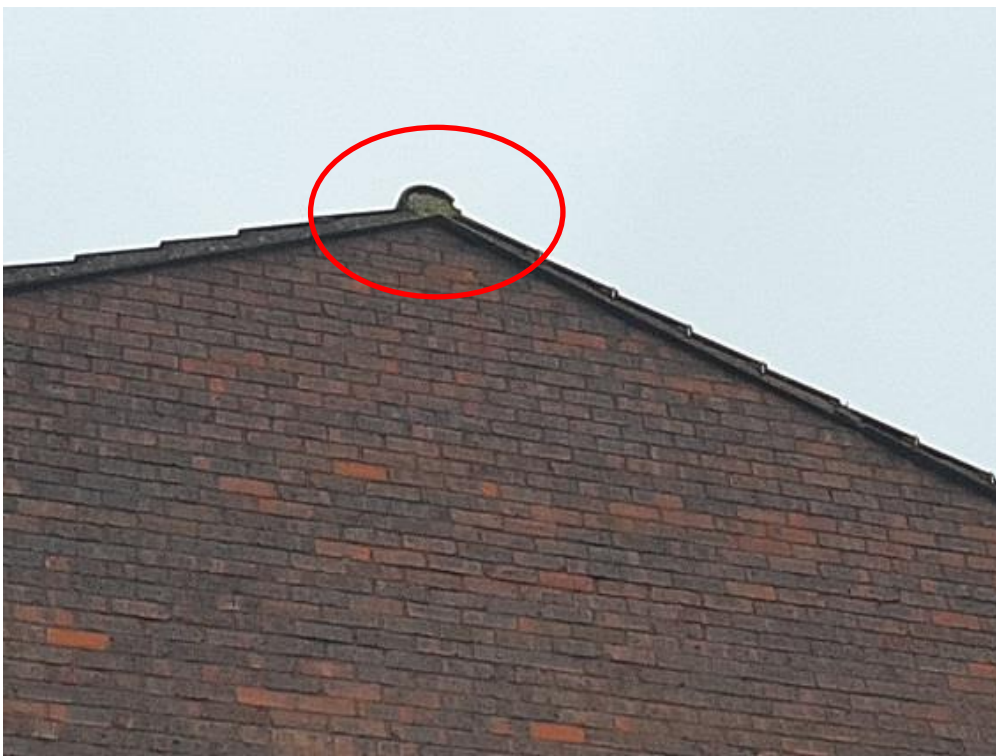
It was not possible to inspect the missing mortar between ridge tiles and brickwork (Plate 4.8) and lifted lead flashing around the base of the chimney due to the height at which these were located and as such it was not possible to establish if bats had used these features to enter a roost location at the time of surveying. No evidence of roosting bats, e.g. droppings, urine staining, feeding remains or scratch marks, was recorded within the features that could be fully inspected during the survey.

Plate 4.8: Missing Mortar Between Ridge Clay Tiles and Brick Wall (South-eastern Elevation)

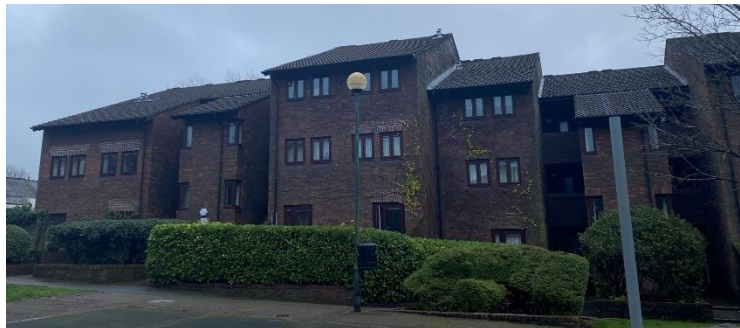
Plate 4.9: Overview of B3 Building (Western Elevation)

The Preliminary Bat Roost Assessment has been identified that the B3 Building to have a low potential to support roosting bats due to limited potential roosting features recorded. Two potential features were noted during the survey that could not be fully inspected due to the height of these features. Additionally, it was not possible to inspect the any loft voids that could be present inside the buildings. However, during external inspection no evidence of roosting bats, e.g. droppings, urine staining, feeding remains or scratch marks, was recorded within the noted features.

has been identified as having low potential to support roosting bats. Bat Surveys: Good Practice Guidelines, published by the Bat Conservation Trust (Collins, 2016), recommends for structures with low bat roosting potential that at least one survey (consisting of either a dusk emergence survey or a dawn re-entry survey) be undertaken during the peak season for emergence/re-entry surveys (May to August) to determine the presence/absence of roosting bats within the building. Should this survey confirm the presence of roosting bats, it will be necessary to undertake additional surveys in order to inform a Natural England licence application. In addition, should the survey identify the presence of significant levels of bat activity at the site, it may be necessary to undertake further survey visits to comprehensively assess the value of the site to bats.

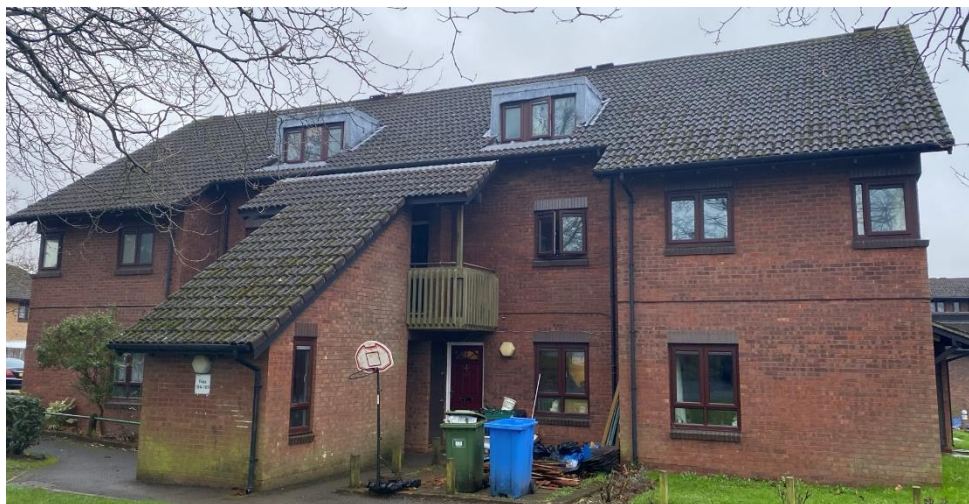
Plate 4.10: Overview of the Northern Elevation

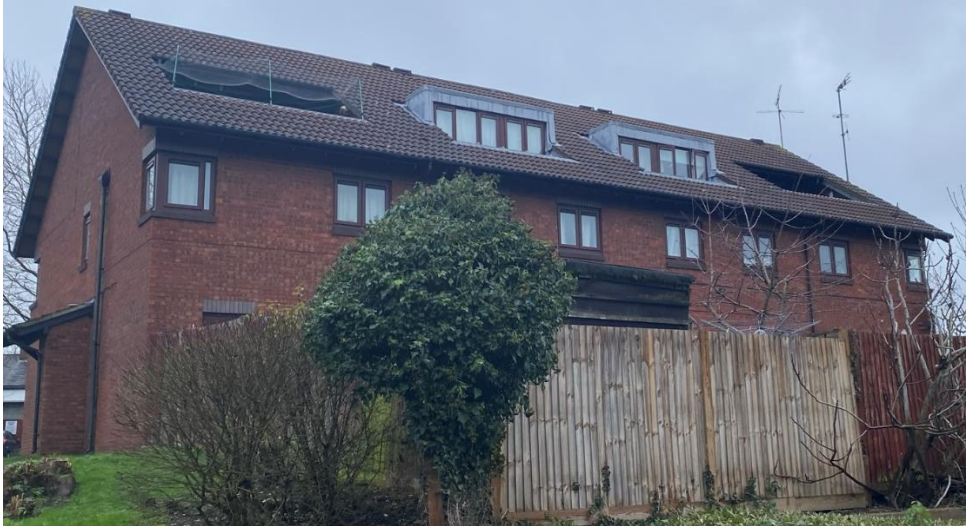
Plate 4.11: Overview of the Southern Elevation

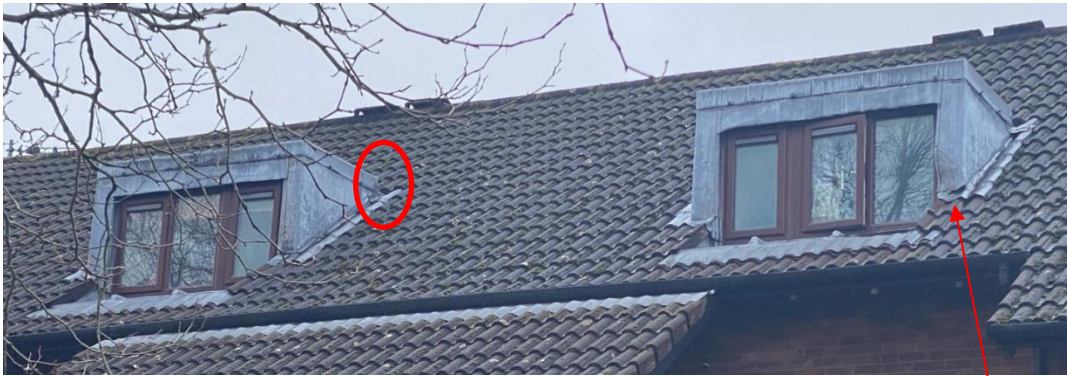
The roof tiles were in generally good condition and no lifted tiles were noted on all elevations of the building. The dormer windows double glazed uPVC windows which had been fitted with led flashing roofing and sides to join the roofing tiles. It was noted that the lead flashing was lifted and exposed many potential ingress points for fauna to enter.

Plate 4.12: Gaps Noted Between Led Flashing and the Roof Tiles (North Elevation)

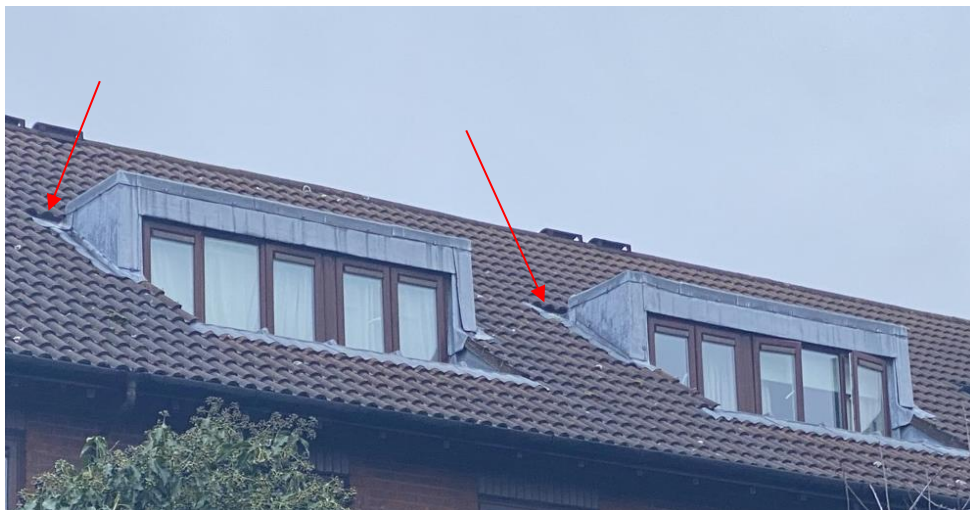
Plate 4.13: Gaps Noted Between Roof Tiles and Led Flashing (Southern Elevation)

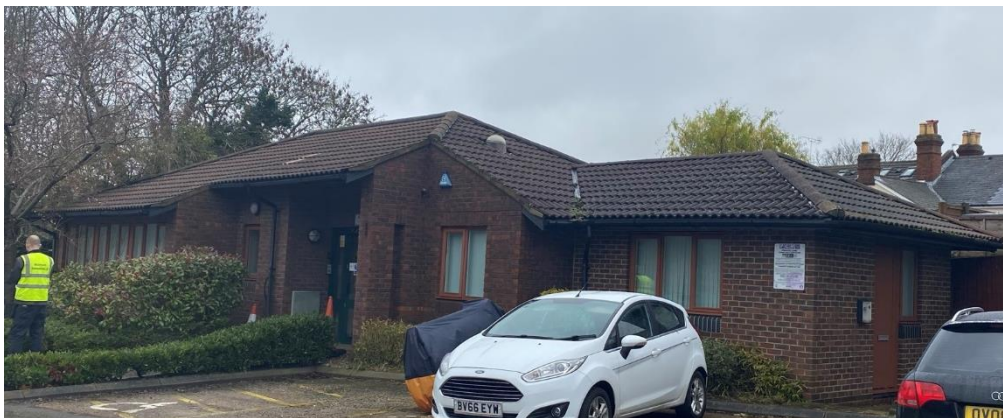
Plate 4.14: Overview of B5 Building (Southern Elevation)

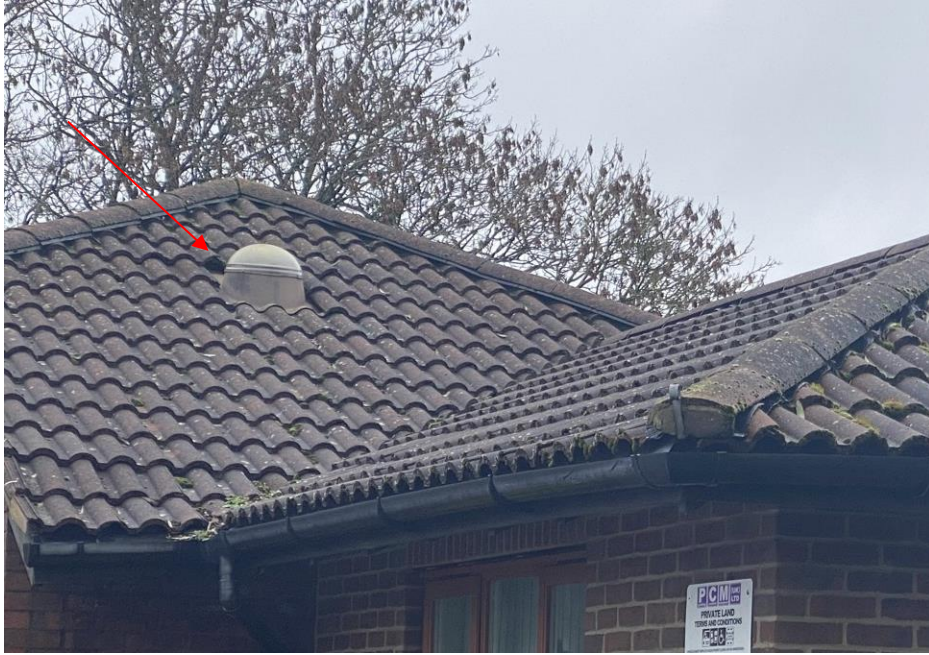
The roof was hipped with clay tiles and with air chimneys in place. The tiles were in generally good condition throughout however one roof tile was recorded to be missing near to the air chimney on the eastern elevation (Plate 4.16). The soffit boxes were fitted tightly and showed no ingress points on eastern and western elevation, however on the southern elevation, the gap between soffit box and the brick wall and the soffit box was large enough to be used by fauna to enter (Plate 4.17). The brick walls were in good condition and showed no missing bricks or mortar. The double-glazed windows and uPVC window frames were all intact and showed no gaps/crevices. The door frames were tightly fitted within the brickwork and showed no gaps or crevices on the day of the survey.

Plate 4.16: Missing Clay Tile Near the Air Chimney (Eastern Elevation)

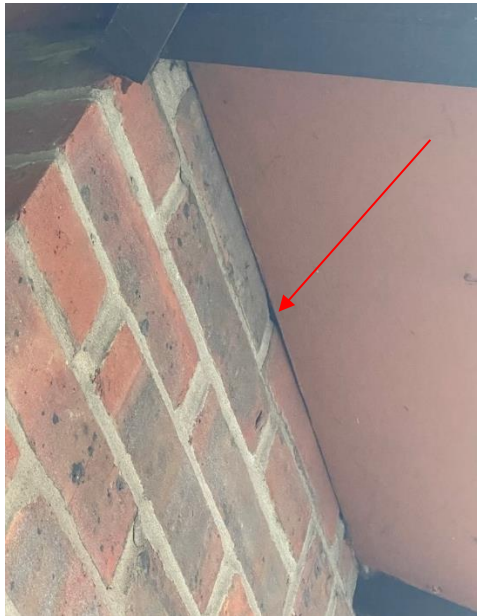
Plate 4.17: Gap Between Soffit Box and the Brick Wall (Southern Elevation)

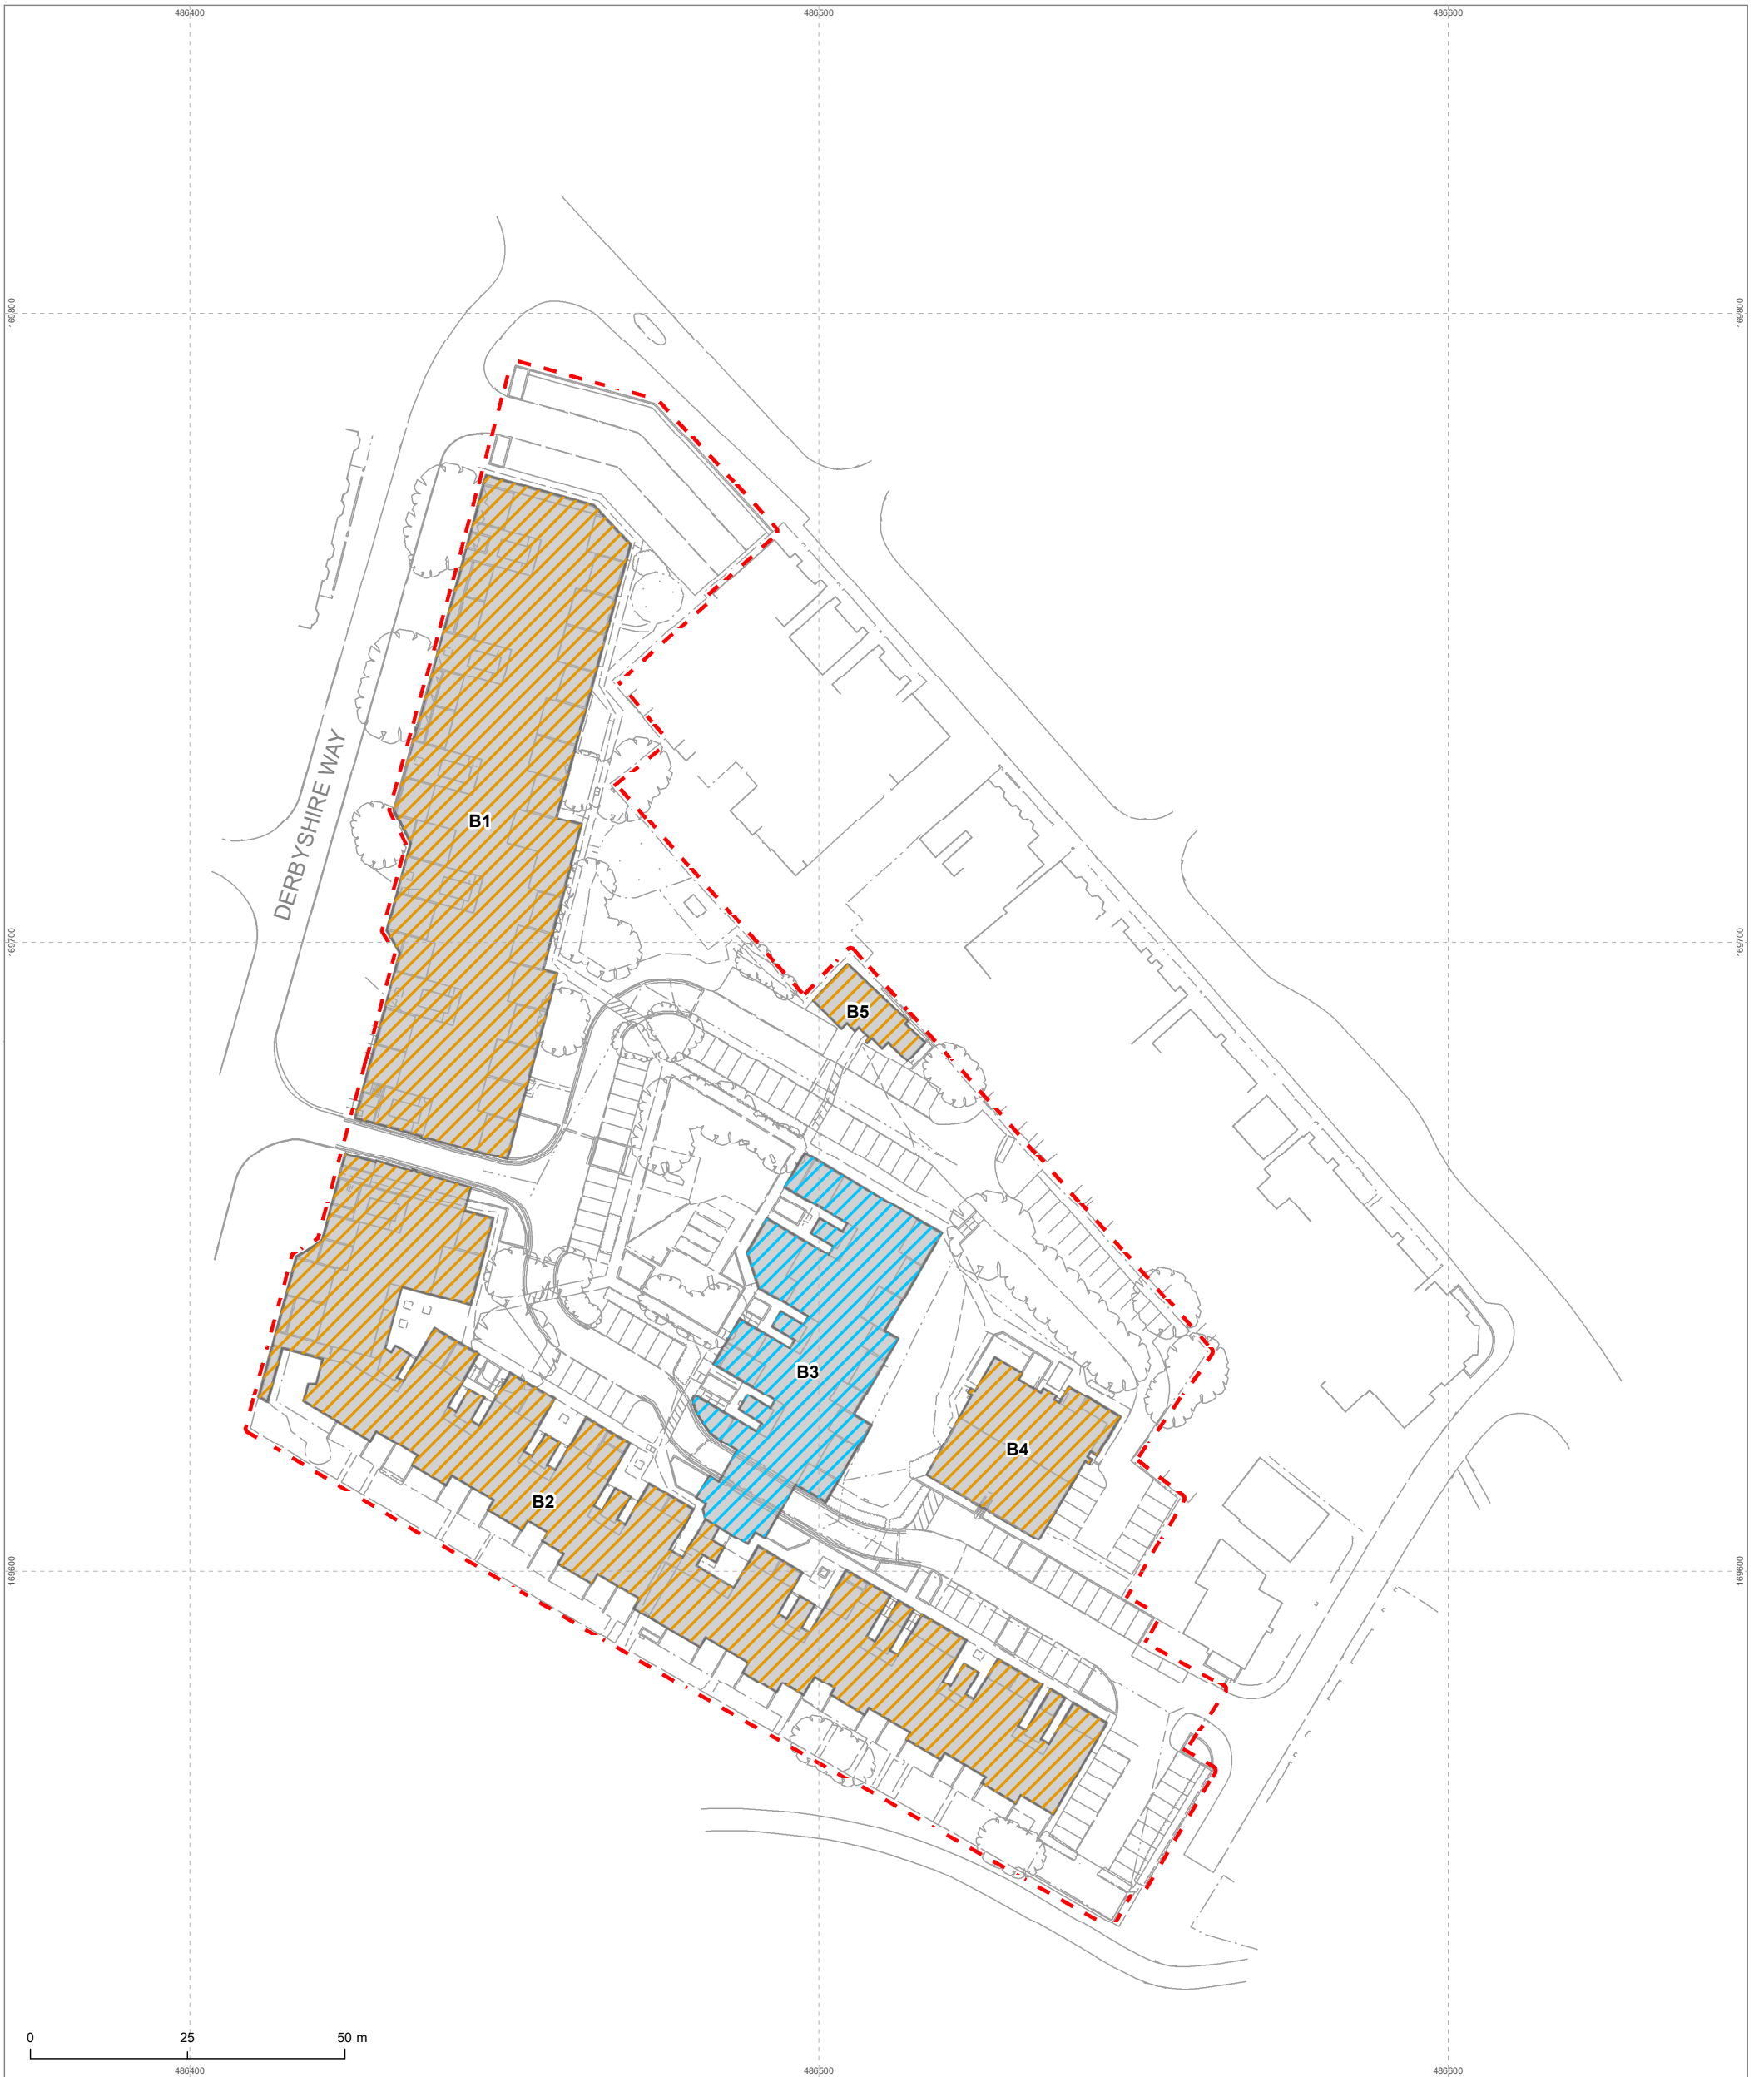
Drawing C153754-05-01 – Preliminary Bat Roost Assessment

The Preliminary Bat Roost Assessment was conducted on 21st December 2020 by Margarita Smoldareva (Ecological Consultant). Drawing C153754-05-01, illustrating the layout of the buildings on site and the results of the survey is provided in Chapter 7.
